Fluvial Geomorphological Assessment of Oshawa Creek and Evaluation of Erosion Mitigation Strategies at Prioritized Sites

Thomas Street to Wentworth Street West

Palmer Project #

1510206

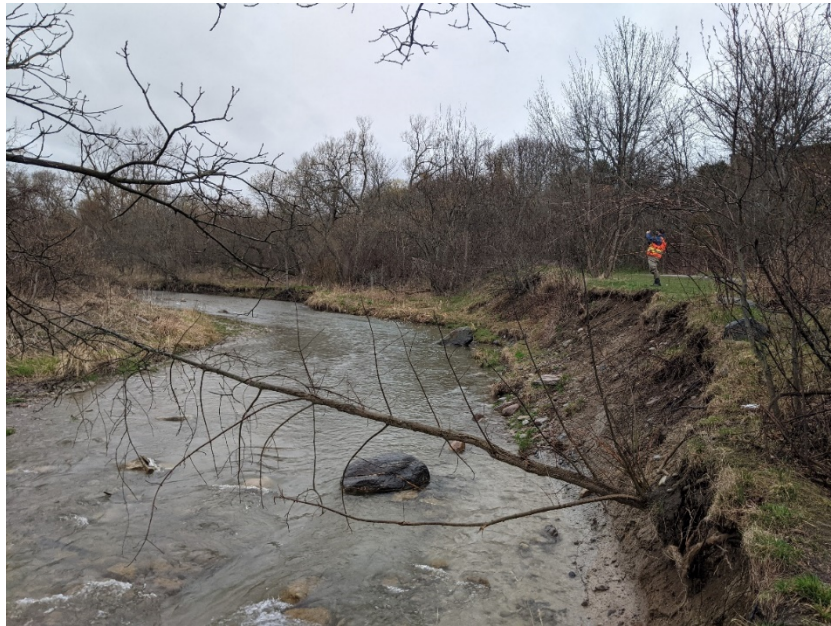
Photo 1. *Channel eroding high, fill-formed terrace along the outer bank of a meander (Site 5). Upstream view.*

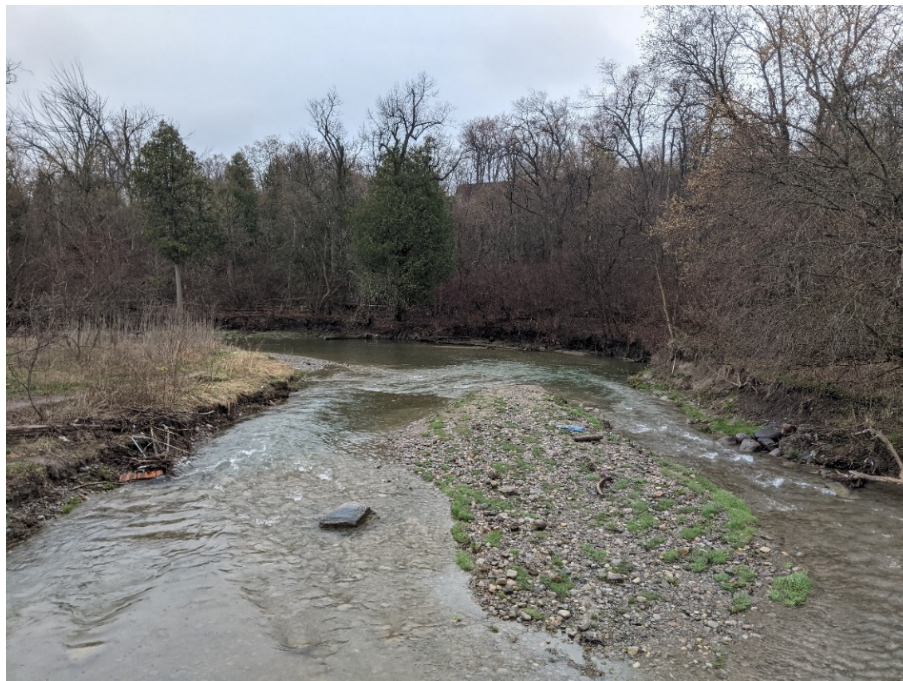
Photo 2. *A riffle at Site 4 formed by a medial bar that bifurcates flow toward a pool immediately downstream at the apex of a meander. Downstream view.*

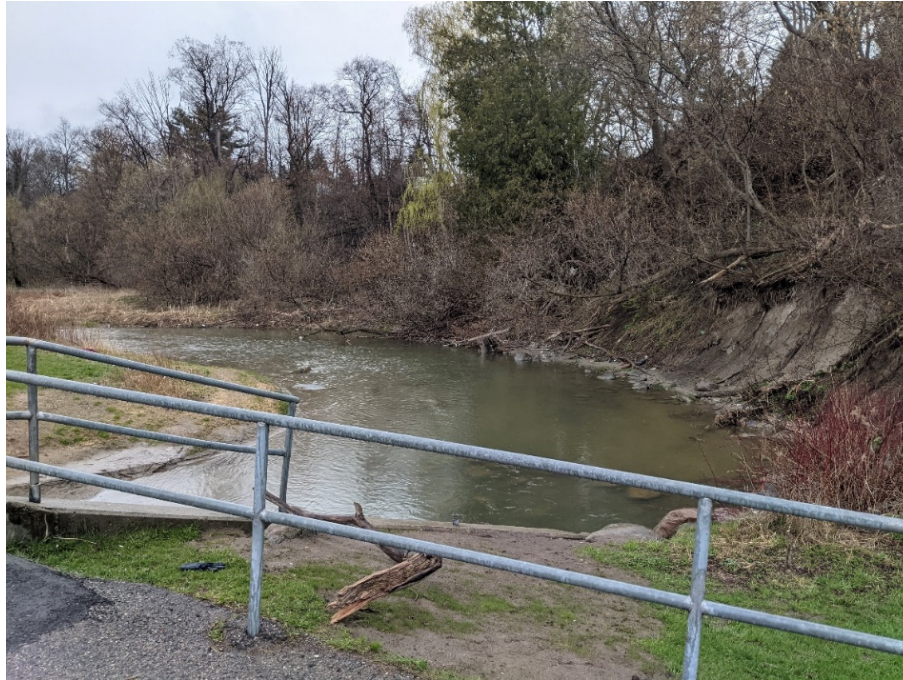
Photo 3. Valley wall contact along the outer bank of the meander at Site 3. Upstream view.

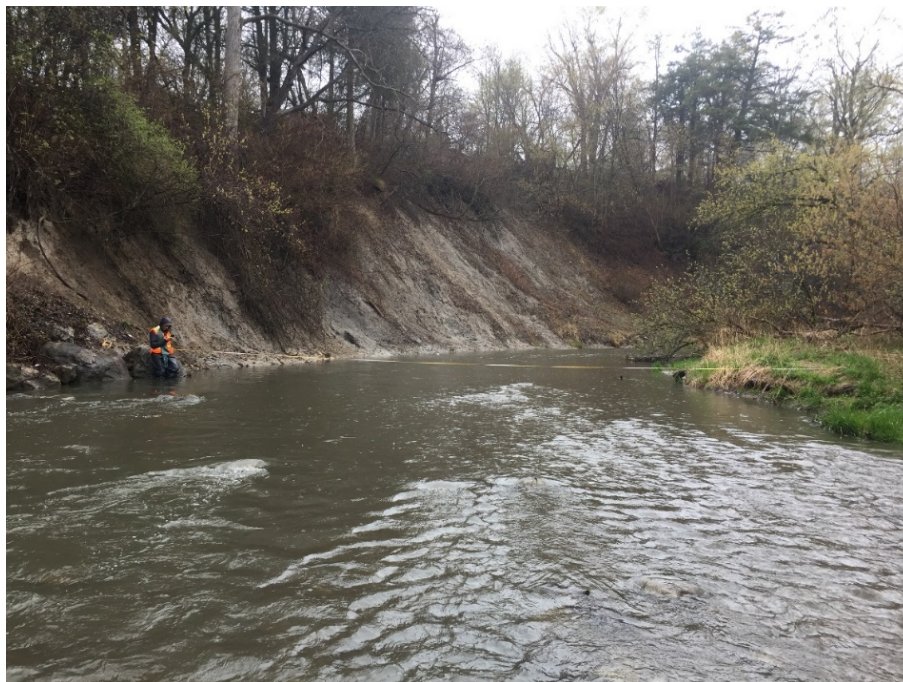
Photo 4. Valley wall contact along the outer bank of the meander at Site 6. Upstream view. Person for scale.

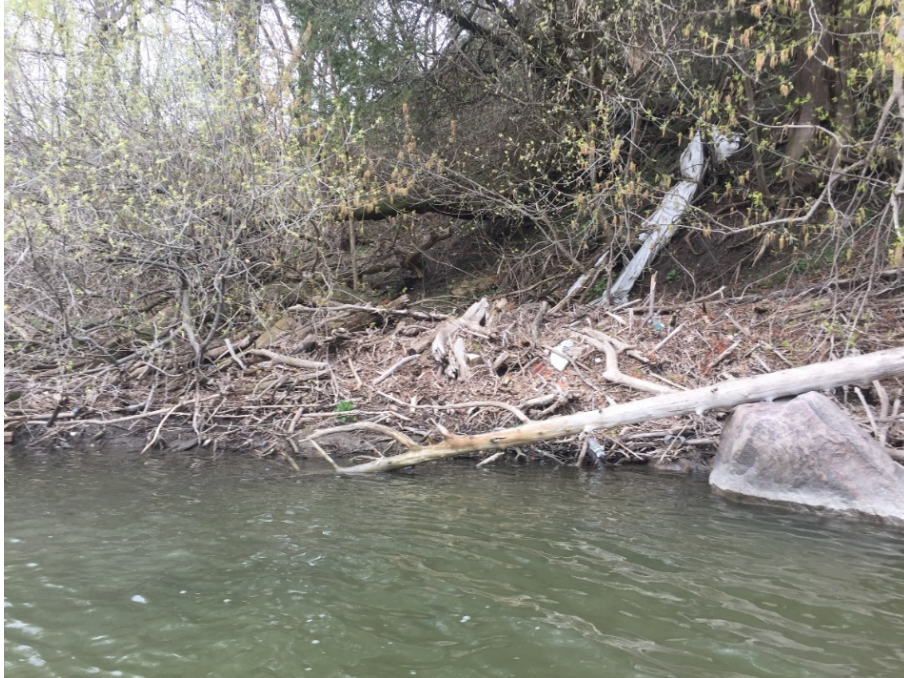
Photo 5. *Woody debris in the channel and overbank deposition of organic debris near Site 3. View of left (east) bank.*

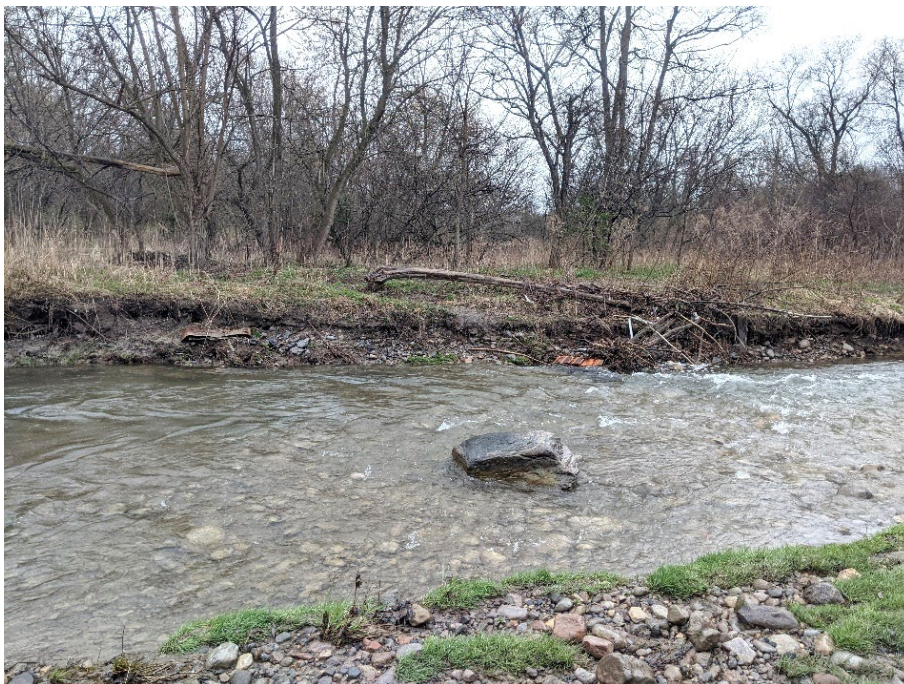
Photo 6. *Low, undercut bank exposing an elevated armoured layer at Site 4. Flow from left to right.*

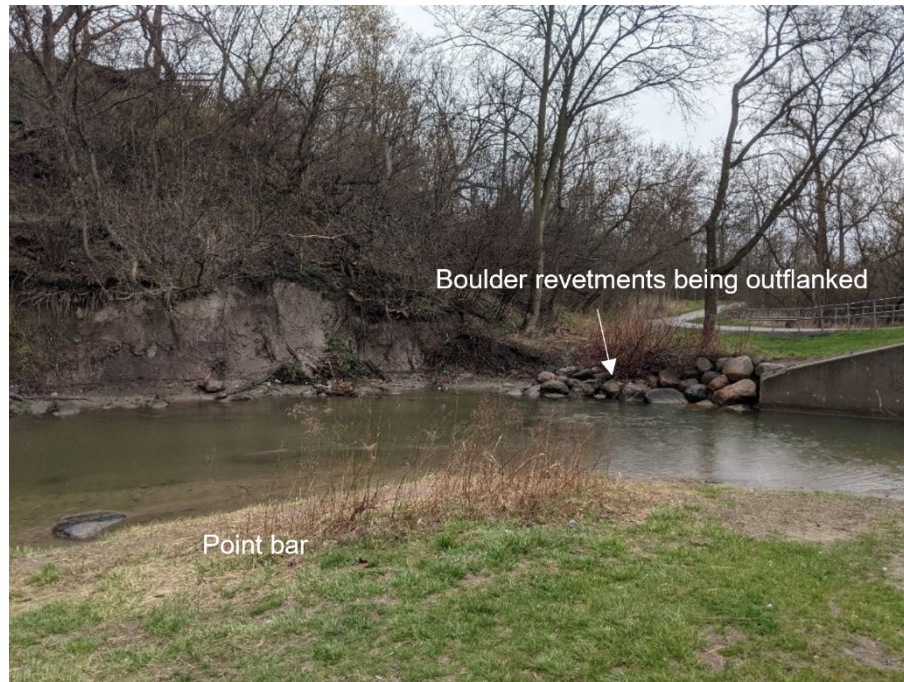
Downstream transfer of energy from the erosion-resistant valley wall has started to outflank and undermine the boulder revetment protecting the bridge abutment (**Figure 1; Photo 7**). The bridge is located immediately downstream of the meander apex, where erosive energy is naturally concentrated, with its left (outer bank) abutment set back much closer to the thalweg than its right (inner bank) abutment. The siting and skew of the bridge abutments exacerbate erosion along the outer bank. The bridge abutment along the outer bank projects into the channel, creating a point of erosion concentration. If bridge abutments were shifted approximately 10 m to the south, erosion risk to the bridge would have been significantly reduced. A deep scour pool has formed along the outside of the meander, exacerbated by a point bar that has formed along the inner bank. The scour pool extends downstream, beneath the pedestrian bridge, the left abutment of which is at risk of being undermined.

Photo 7. *Bank revetment upstream of pedestrian bridge being outflanked at the downstream limit of an erosive scarp, along the Site 3 valley wall contact. Downstream view.*

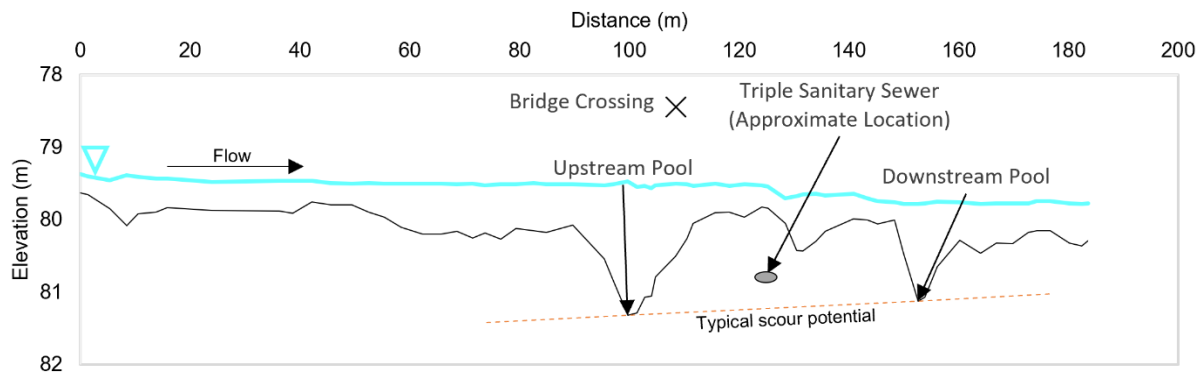
The gradient at Site 4 is 0.62%, notably steeper than at other sites, and the reach-scale average (0.44%). Two deep pools define the upstream (1.66 m deep) and downstream (1.40 m deep) limits of Site 4. A reasonable approximation of typical bed scour potential along this particular section of channel is the grade-line tangent to the bottoms of the deepest pools. Longitudinal adjustments are likely to occur at least within the envelope between the channel bed and this maximum pool depth grade line. The grade-line tangent to the bottoms of the pools is currently 0.16 m below the bottom of the sanitary pipe, such that the sanitary pipe is within the area of scour potential and potentially at risk of exposure and damage (**Figure 8**).

Figure 8. *Longitudinal profile of bed morphology encompassing Site 4, created from local level-rod survey data referenced to 2019 LiDAR-derived elevations. Obvert of sanitary sewer is 0.9 m below the bed and 0.16 m above the grade line, tangential to upstream and downstream pools (representing typical scour potential).*

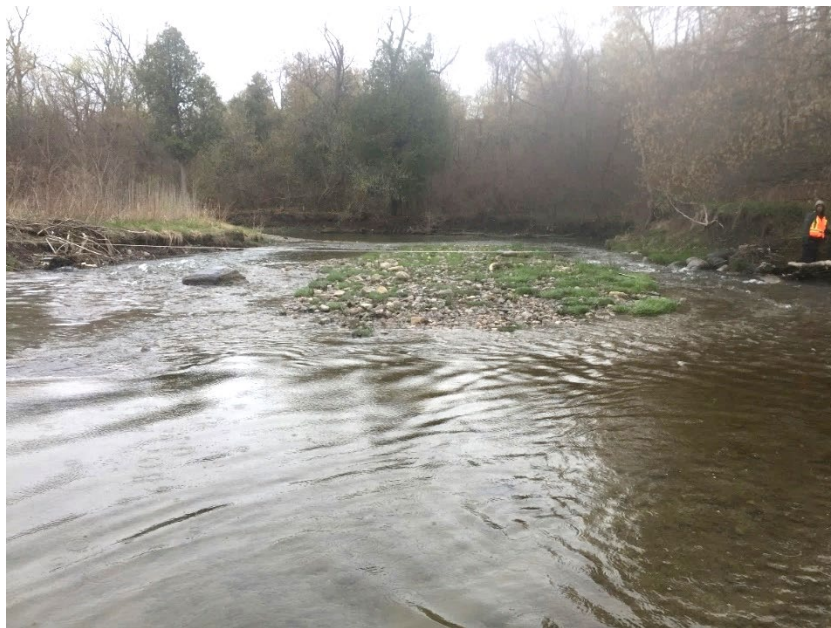
Photo 8. *A medial bar overtop of the sanitary sewer bifurcates flow, concentrating erosion along both banks. Downstream view.*

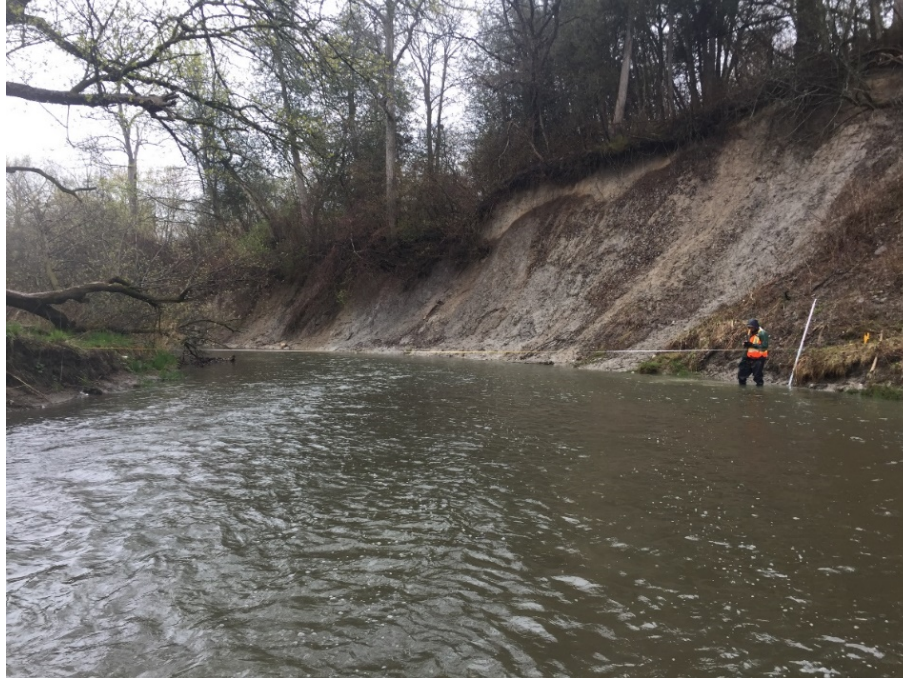
Photo 9. An actively eroding scarp, approximately 100 m long and up to 17 m high, along the western valley wall at Site 6. Downstream view.

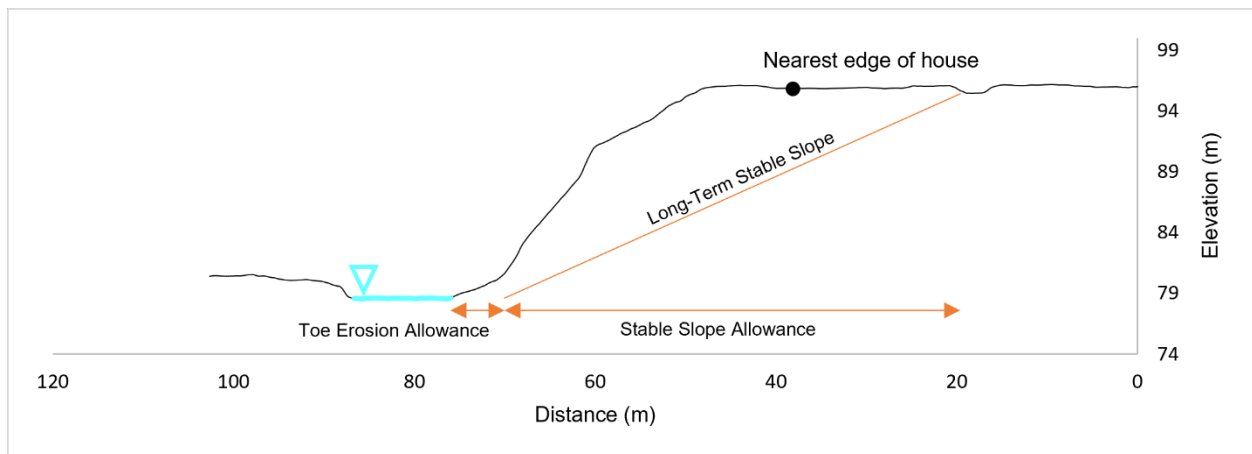
Figure 10. Downstream view of LiDAR-derived cross-section of west side of valley at Site 6, showing the toe erosion allowance (6 m) and the stable slope allowance (51 m) projected into tableland with private residences.

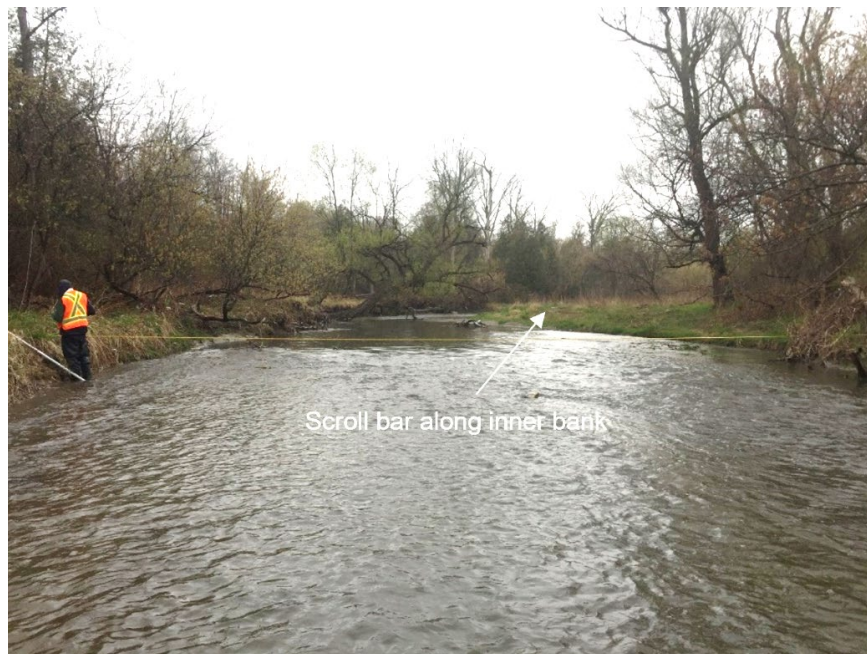
Photo 11. *Upstream view of channel approaching Site 6. A low, gentle eastern bank maintains good floodplain connectivity and helps attenuate flood energy. Upstream view.*

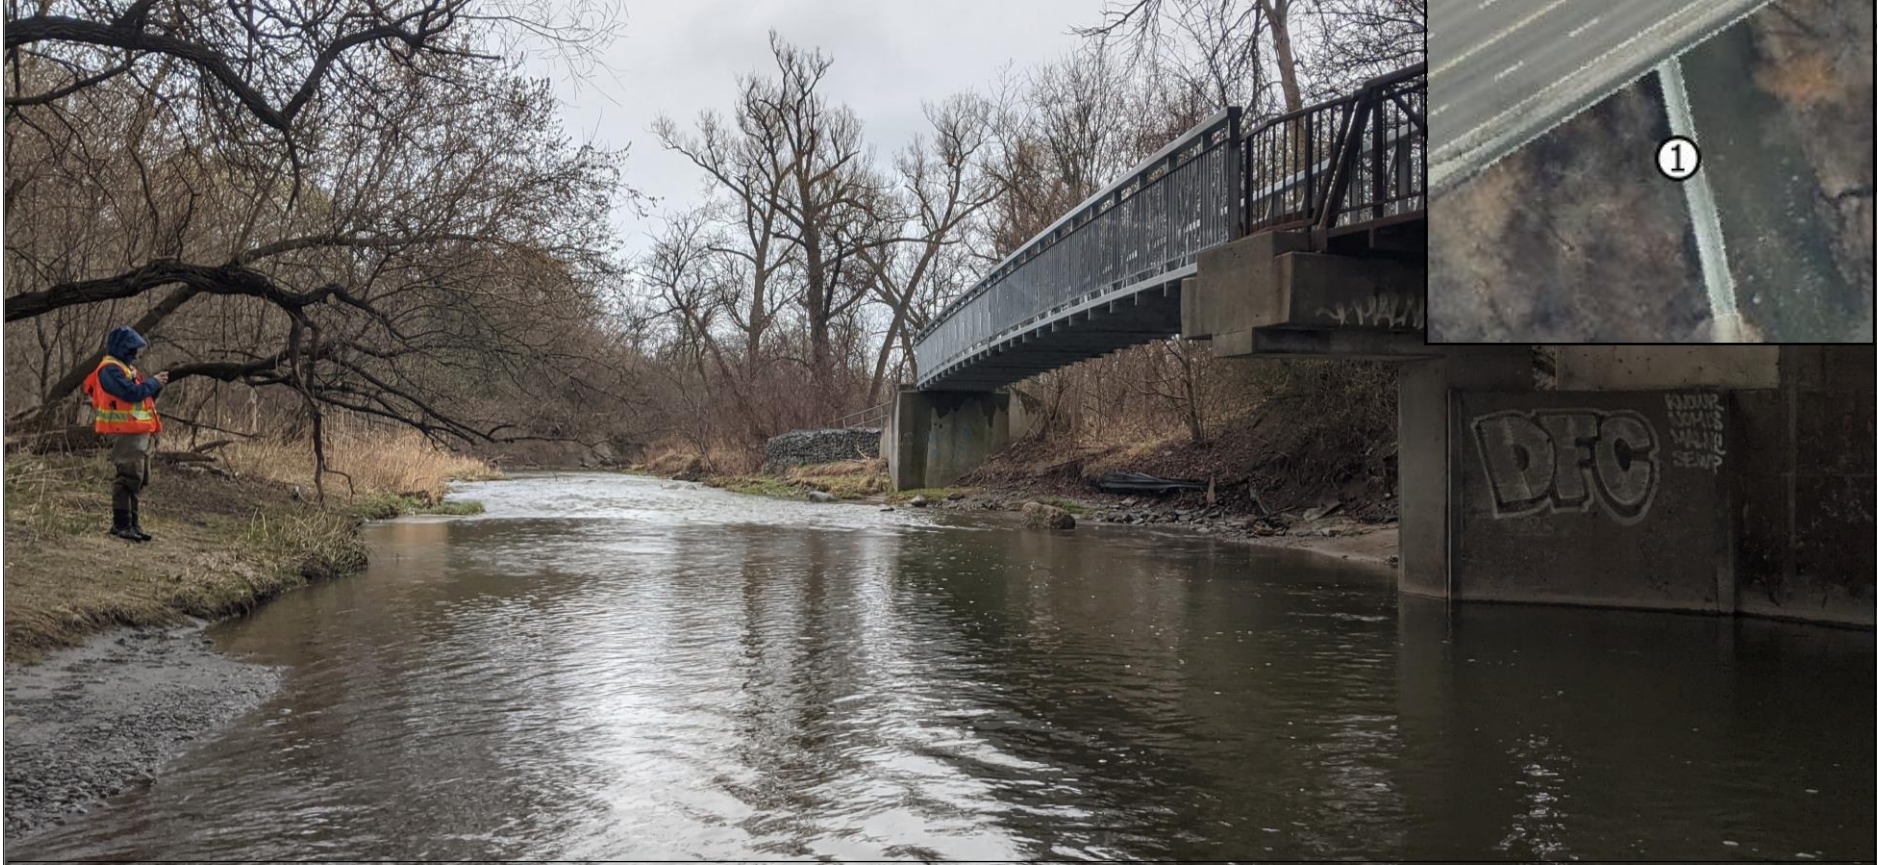
Erosion along right bank, beneath the elevated section of trail. Flood flows interact with the bridge abutment. Ongoing erosion could eventually cause footings of the pedestrian walkway to be undermined and outflanked. Downstream transfer of energy from smooth concrete bridge abutments may be exacerbating scour. Risk is low, so only ongoing monitoring is recommended. Flow: bottom to top.

Feature at Risk:	Distance to Feature	Condition of Bank and/or Existing Erosion Protection:	Mechanism(s) of Failure:	Risk	Recommended Action(s):
Site 1	Elevated pedestrian walkway	0 m (contact)	Minor erosion at toe of bank	Undermining and outflanking	Low	Do nothing – continue to monitor.

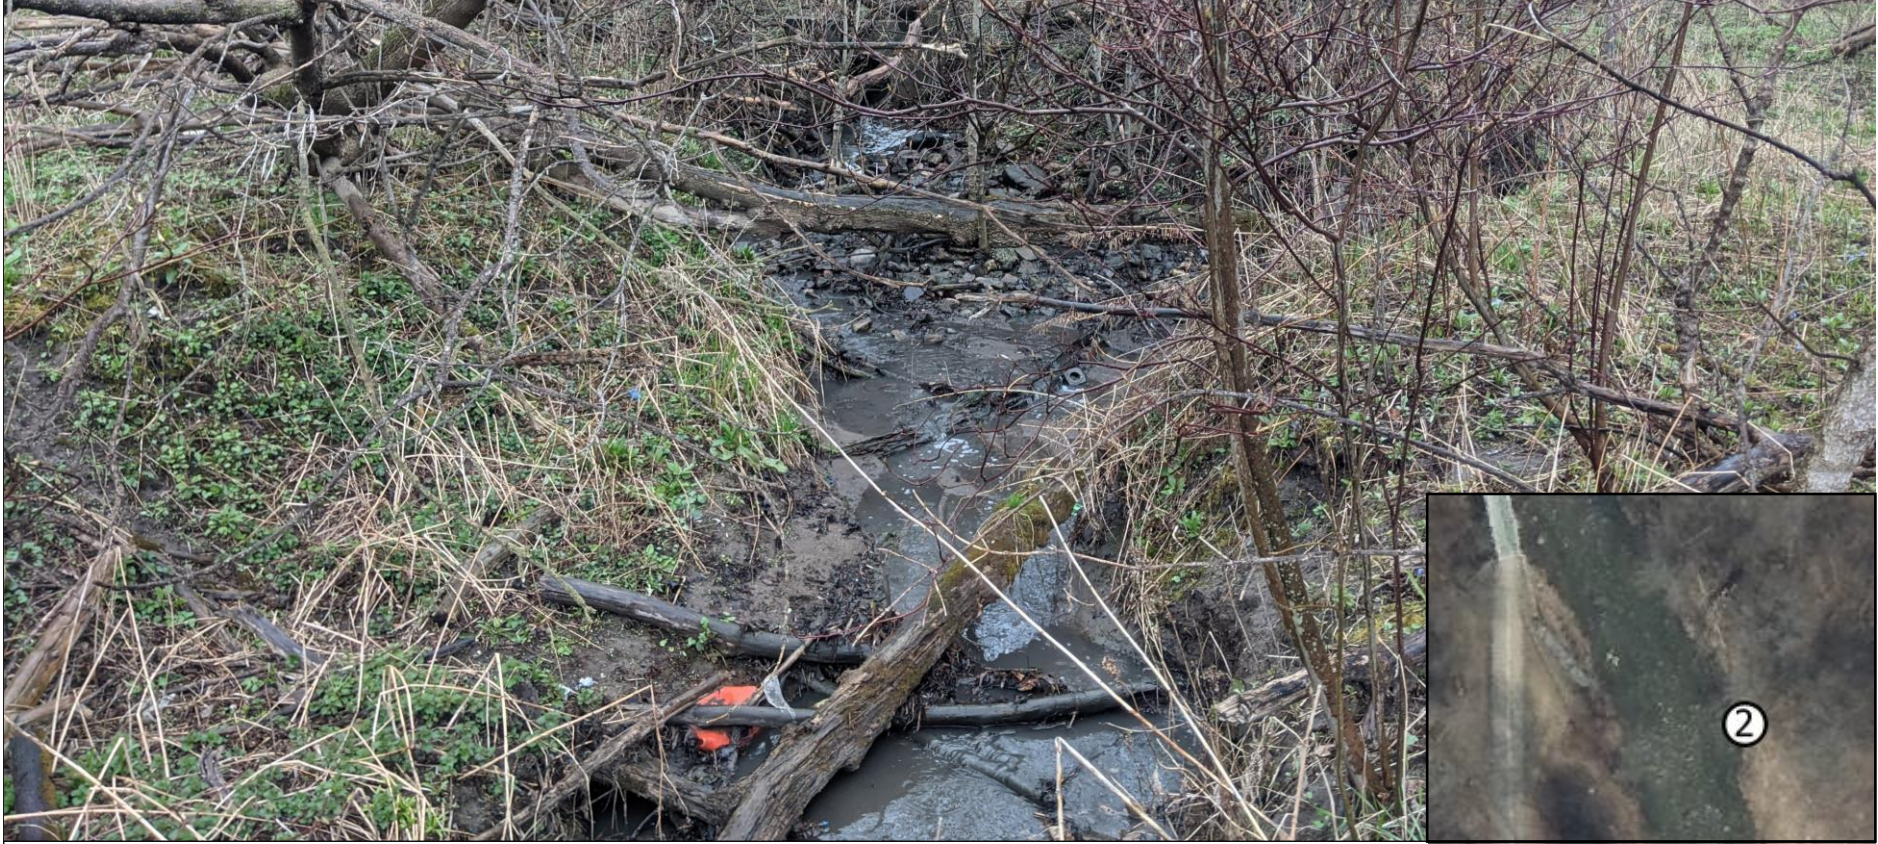
Stormwater outfall located approximately 5 m from the creek has incised (down-cut) a small outflow channel into the floodplain. The outfall is not at risk from fluvial scour and is sufficiently setback from the watercourse. Grey-coloured, turbid water was discharging from the outfall during both field visits. Water quality may be a concern. Flow: top to bottom.

Feature at Risk:	Distance to Feature	Condition of Bank and/or Existing Erosion Protection:	Mechanism(s) of Failure:	Risk	Recommended Action(s):
Site 2	Stormwater outfall	5 m	Minor erosion	Undermining	Low	Do nothing - monitor

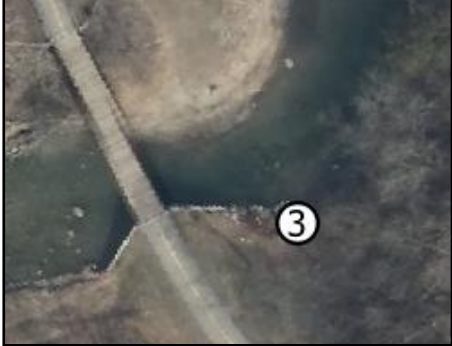
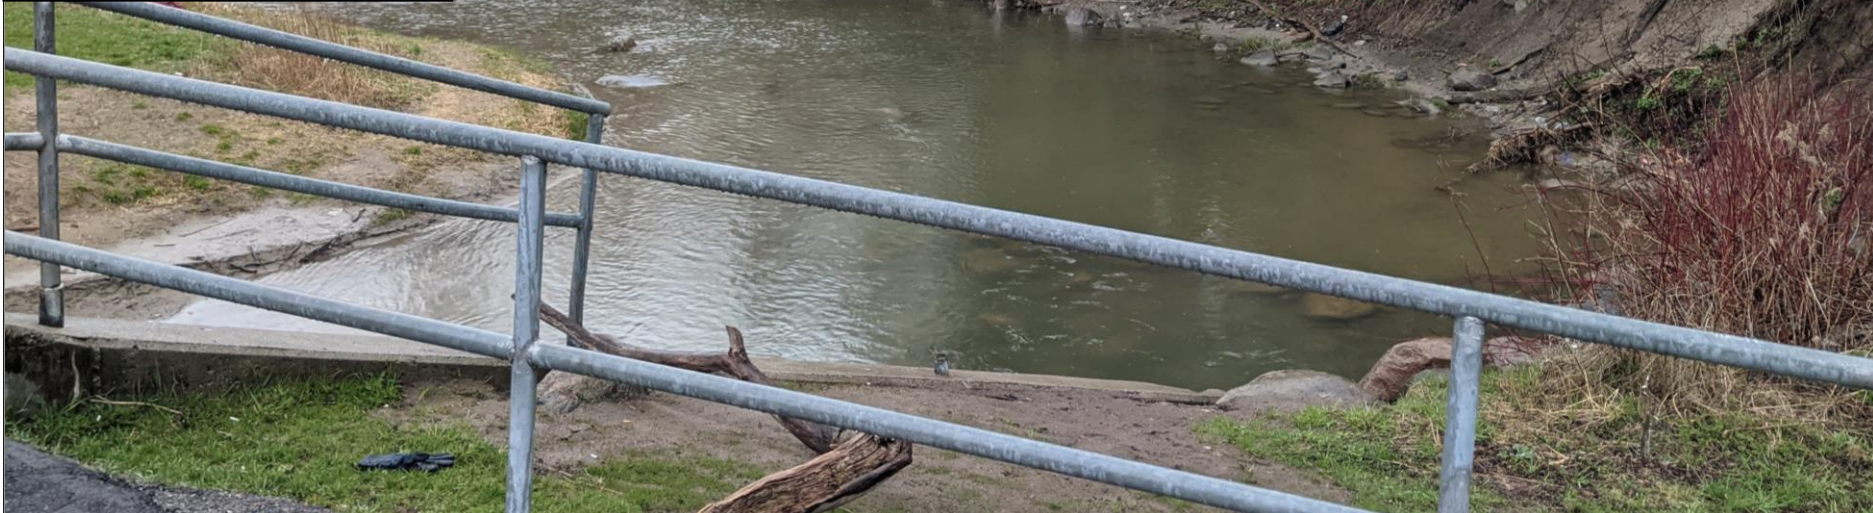
Straightening of the previously sinuous channel has accelerated flow toward the outer bank of a meander in contact with the eastern valley wall. The upstream portion of the valley wall contact remains vegetated and exhibits no obvious signs of instability, but toe erosion along the downstream portion has forced the construction of a boulder bank revetment to protect a pedestrian bridge immediately downstream. A deep scour pool has formed along this outer bank/revetment. The bridge abutments are now at risk of being outflanked and/or undermined. Flow: top to bottom.

Feature at Risk:	Distance to Feature	Condition of Bank and/or Existing Erosion Protection:	Mechanism(s) of Failure:	Risk	Recommended Action(s):
Site 3	Pedestrian bridge and private property on valley crest	0 m (contact)	Functional, but deteriorating	Outflanking and/or undermining	High	Design and construct protection for toe of valley wall and bridge

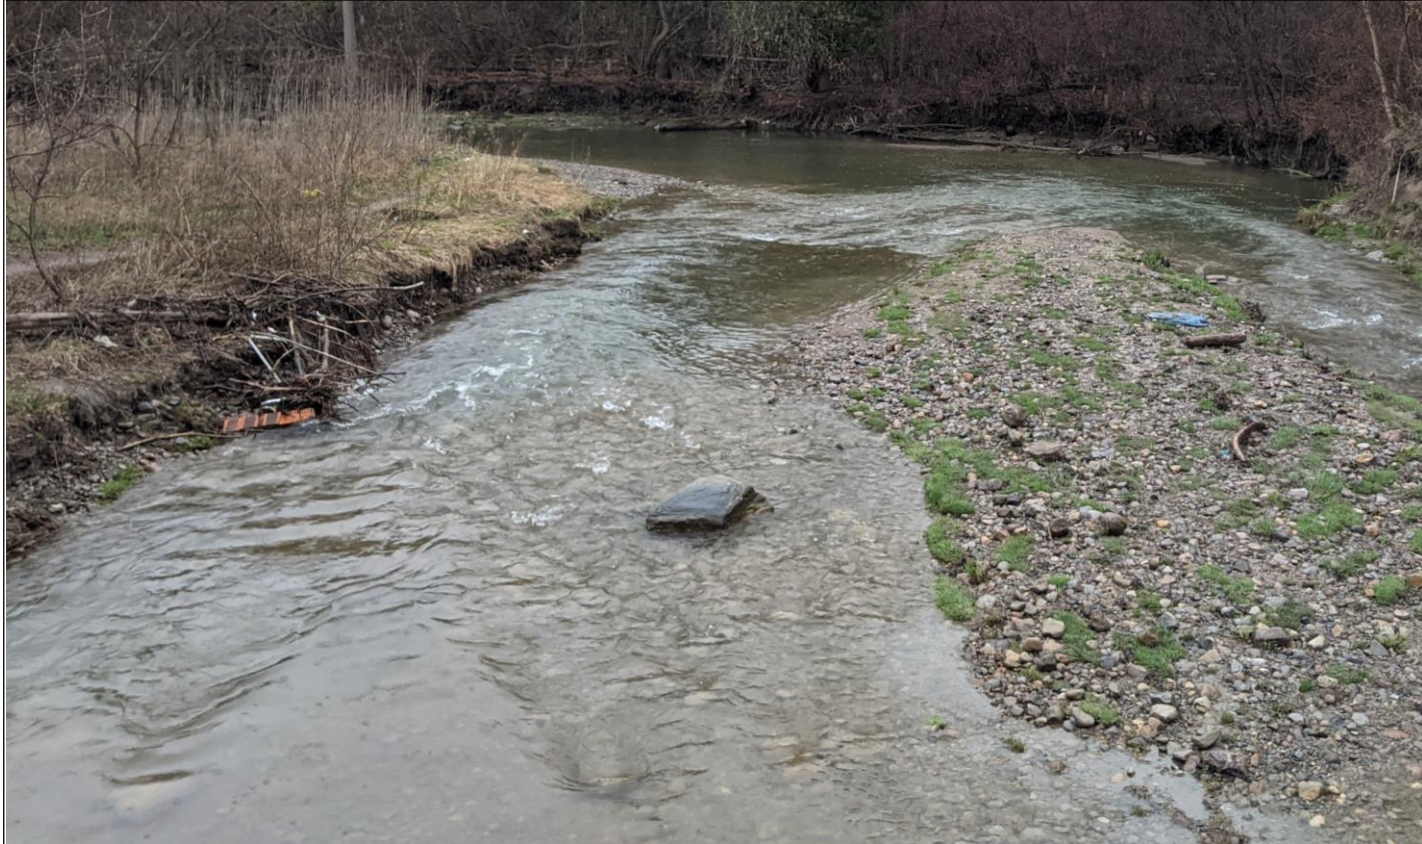
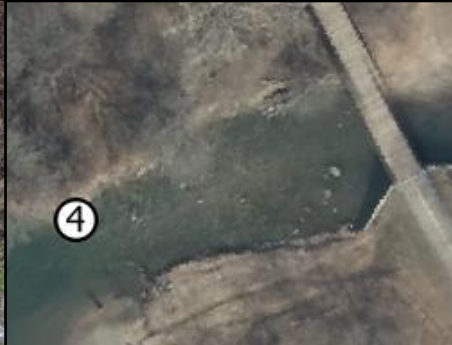
A sanitary sewer without concrete encasement diagonally crosses the channel at a depth of approximately 0.9 m. A prominent medial bar overtop of the sewer bifurcates flow and has promoted erosion of both banks as well as the beds of the split channels. Additionally, downstream migration of the medial bar could significantly reduce the thickness of cover over the sanitary sewer. Flow: bottom to top.

Feature at Risk:	Distance to Feature	Condition of Bank and/or Existing Erosion Protection:	Mechanism(s) of Failure:	Risk	Recommended Action(s):
Site 4	Sanitary sewer	0.9 m (depth of cover)	Steep, eroded banks; no protection from continued bed scour	Bed scour and medial bar migration	Moderate	Protect sanitary sewer (based on assumed works to be completed at Site 3)

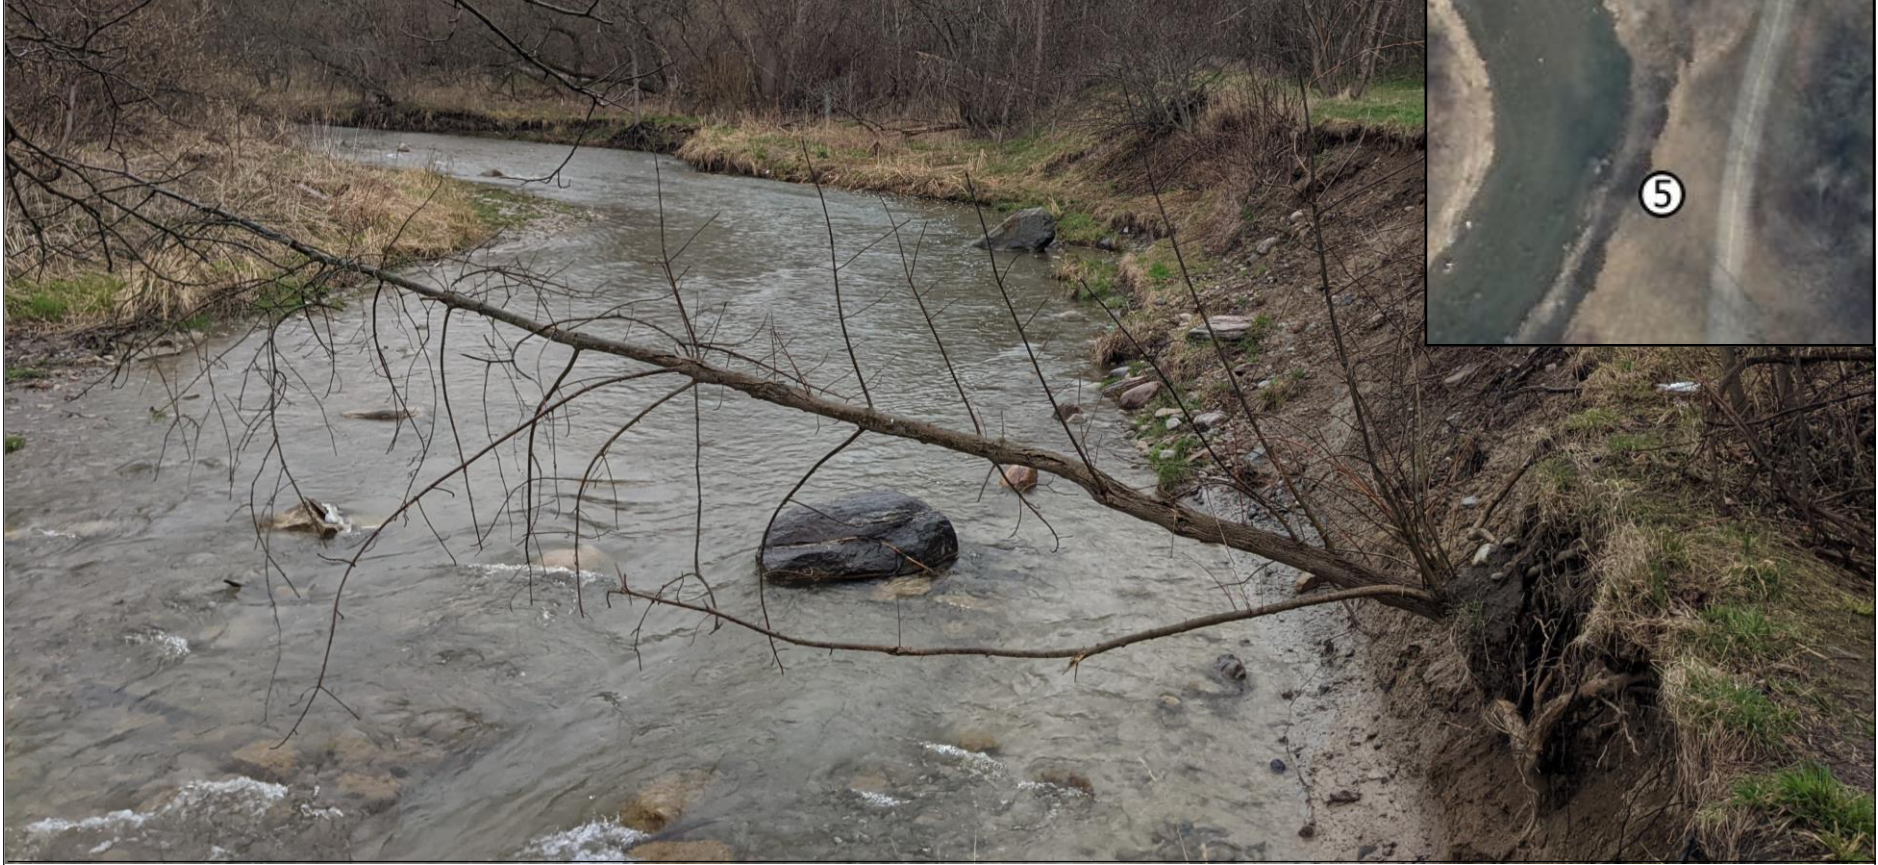
Feature at Risk:	Distance to Feature	Condition of Bank and/or Existing Erosion Protection:	Mechanism(s) of Failure:	Risk	Recommended Action(s):
Site 5	Joseph Kolodzie Oshawa Creek Bike Path	10 m	Eroded unprotected bank	Undermining	Low	Riparian plantings and continue to monitor

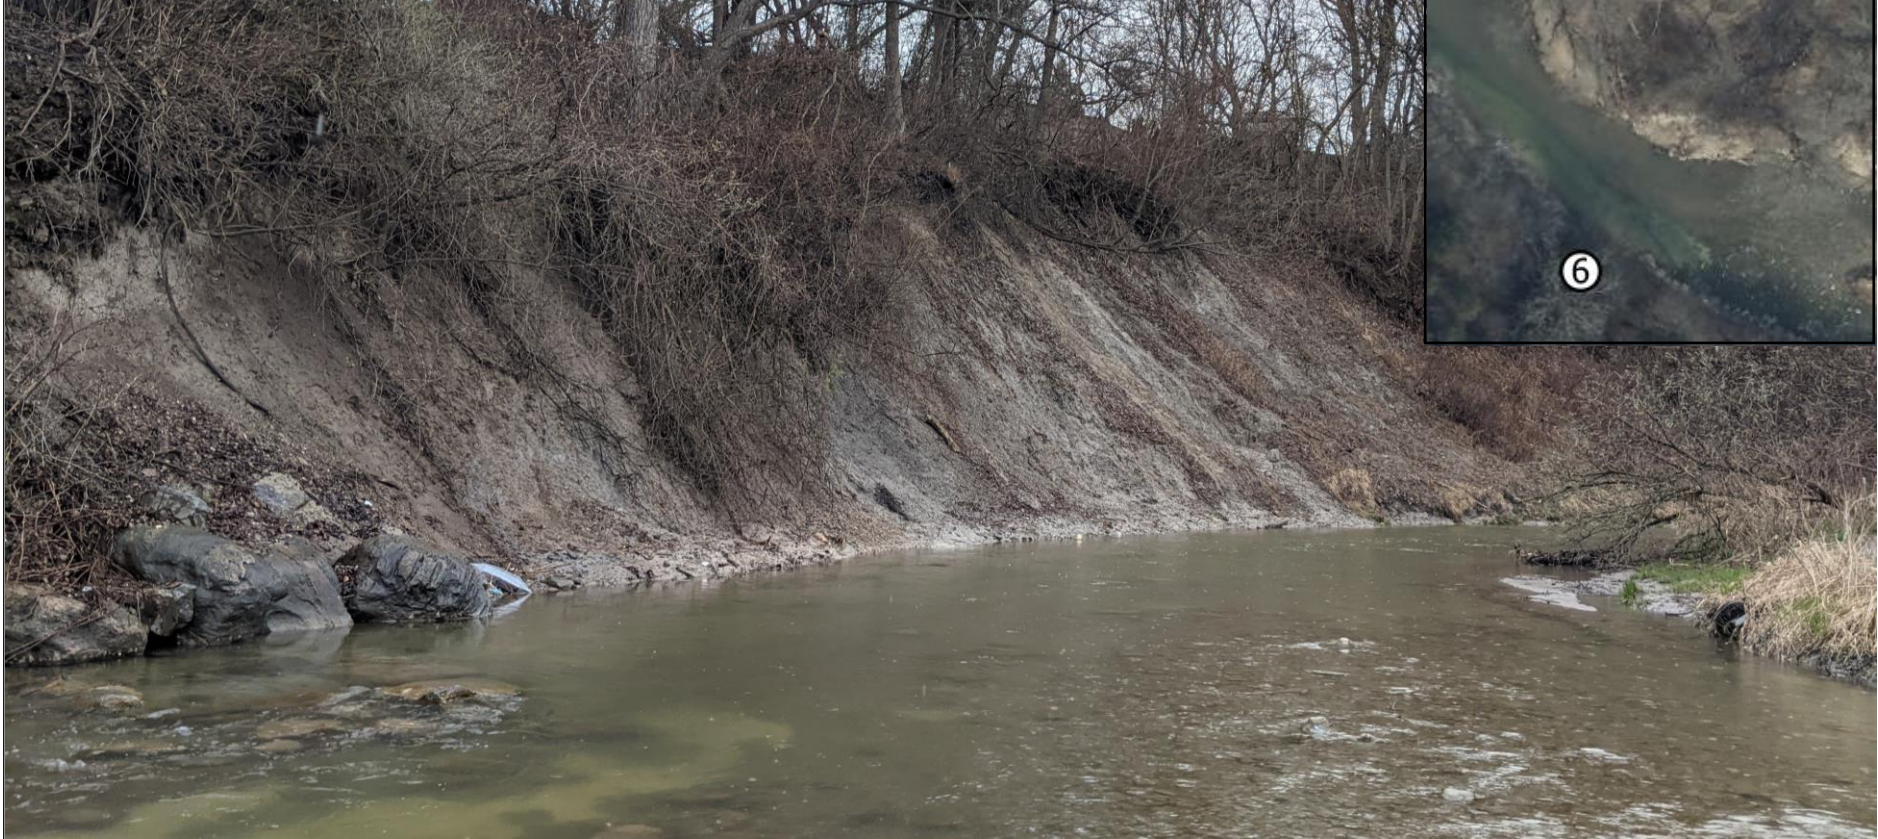
Feature at Risk:	Distance to Feature	Condition of Bank and/or Existing Erosion Protection:	Mechanism(s) of Failure:	Risk	Recommended Action(s):
Site 6	Property at edge of adjacent tableland	10 m	Approximately 18 m high, 150 m long erosion scar along lower valley wall	Repeated fluvial scour and mass movements	High	Design and implement measures to protect valley wall from continued fluvial interaction

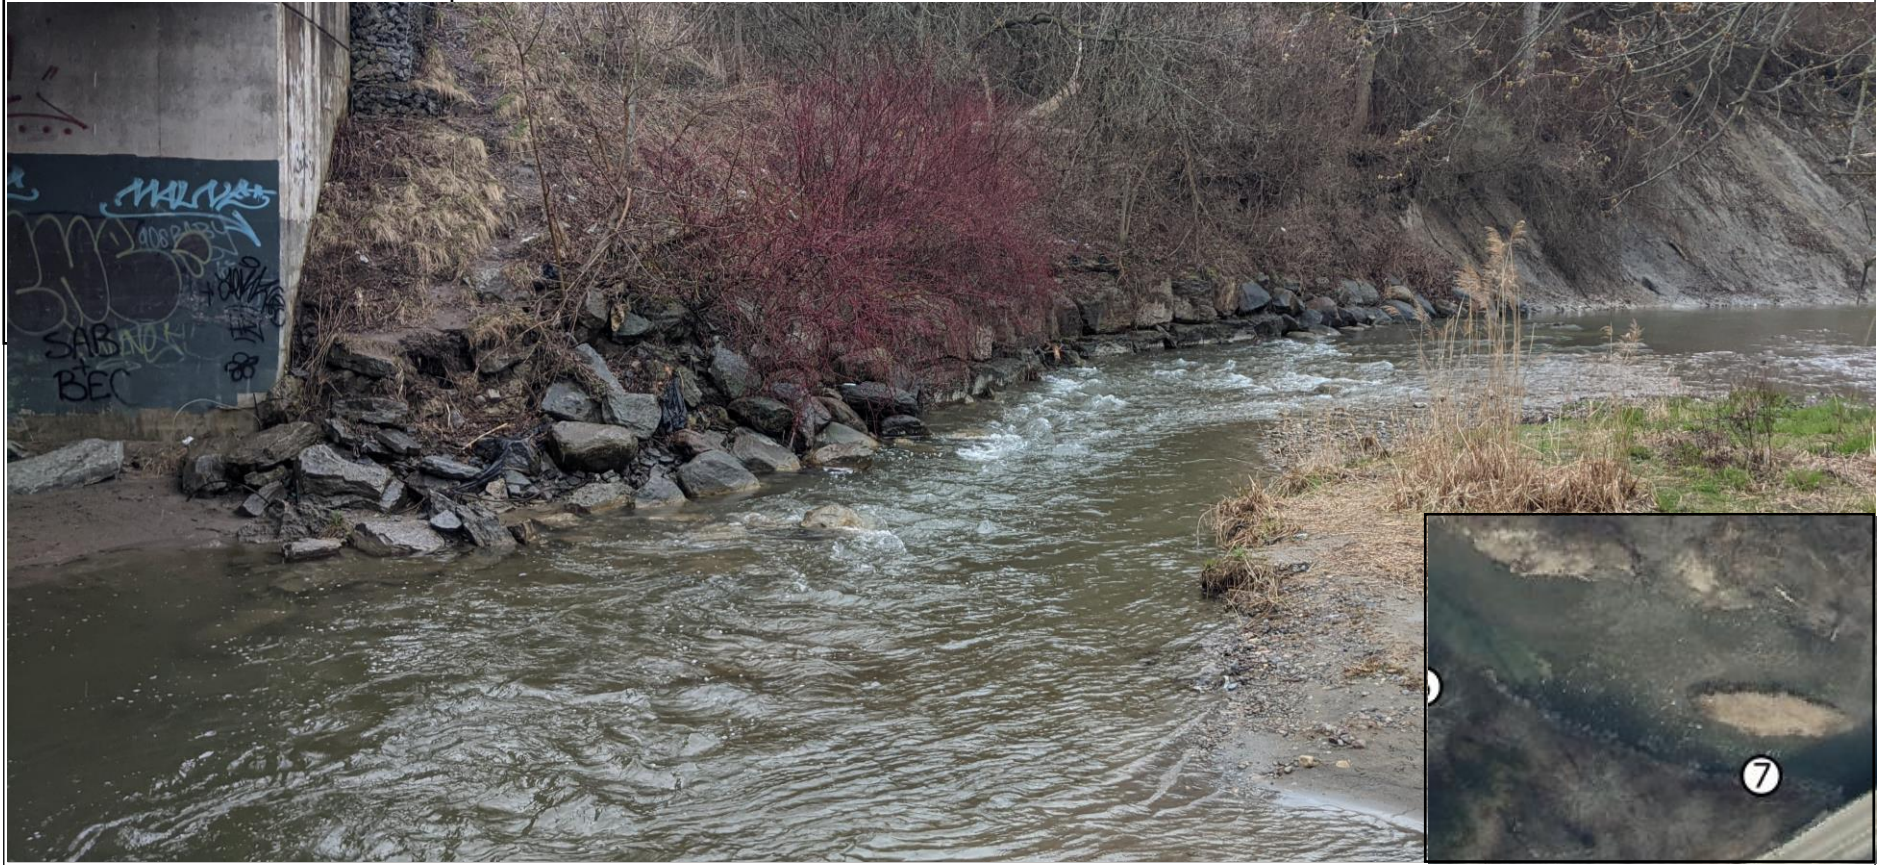
Feature at Risk:	Distance to Feature	Condition of Bank and/or Existing Erosion Protection:	Mechanism(s) of Failure:	Risk	Recommended Action(s):
Site 7	Western bridge footing	0 m (contact)	Functional	Outflanking and/or undermining	Low	Do Nothing – continue to monitor
