HERITAGE IMPACT ASSESSMENT

## Cedardale Public School

827 GORDON STREET  
OSHAWA, ONTARIO

ISSUE DATE: JULY 29, 2022

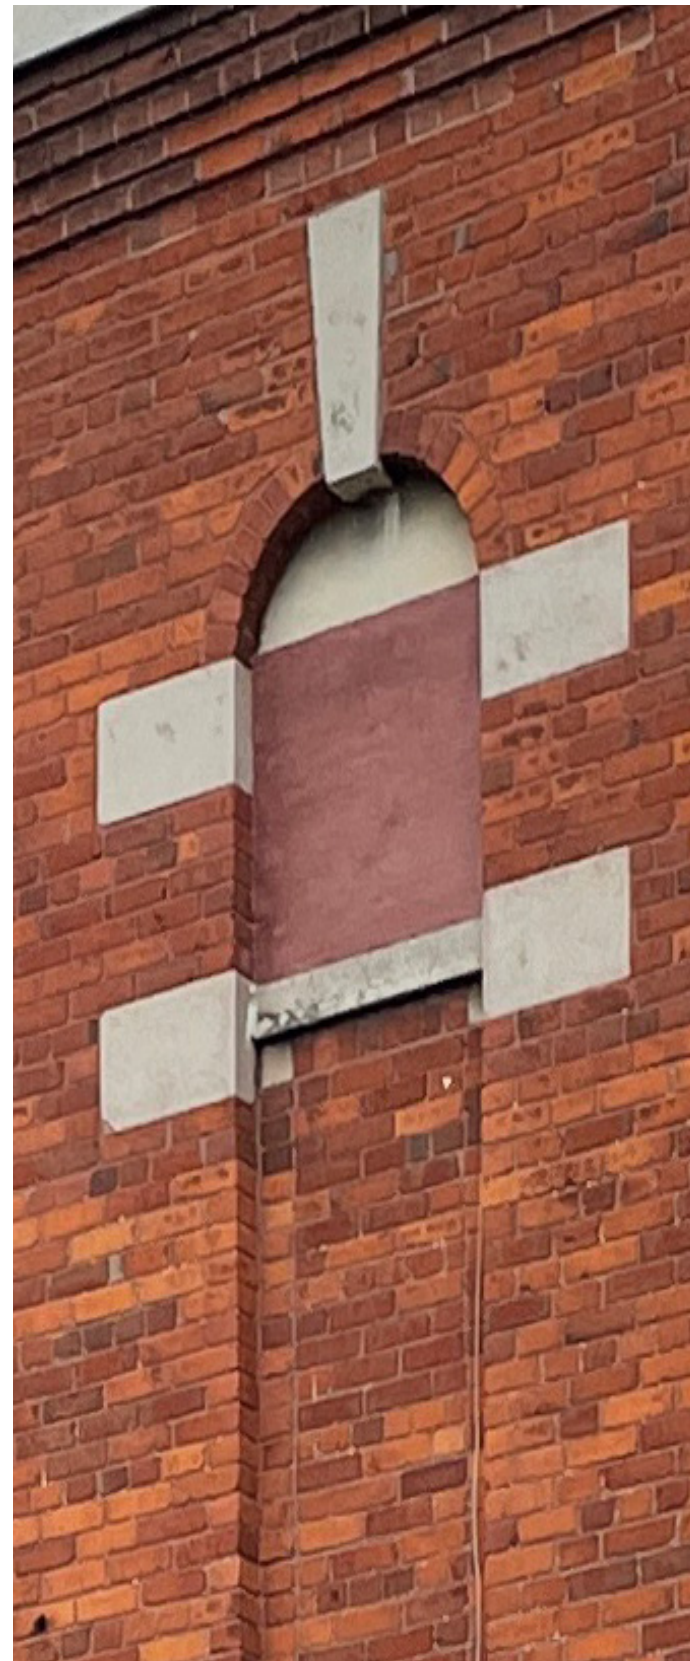
Figure 4: Brick and stone detailing around recessed window (boarded). EVOQ.

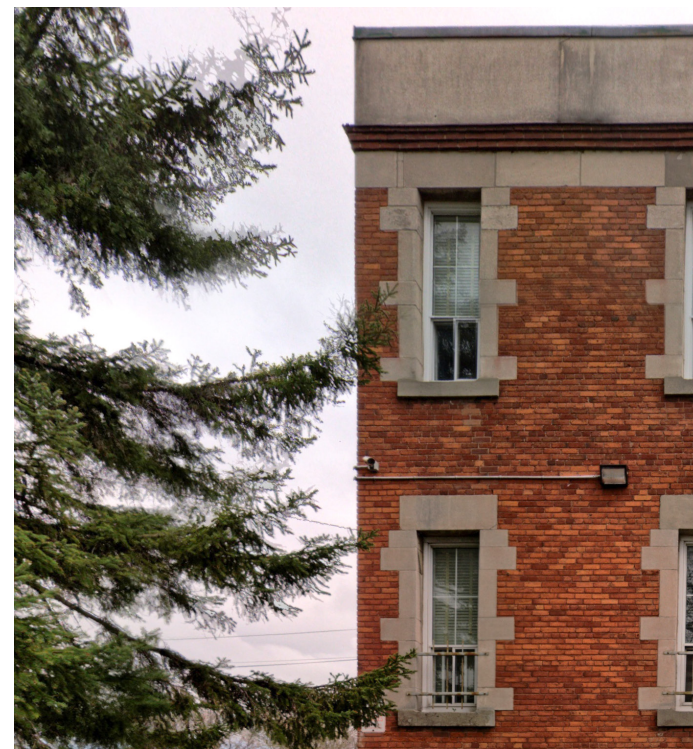
Figure 24: Window details, southwest facade. EVOQ.

The proposed development maintains the 1920 Stripped Classical building with its two storey volume. The building will be conserved, and it is recommended that future work consider envelope upgrades such as masonry repairs, reinstating boarded up windows and removing surface mounted cables.
