Geotechnical Investigation

Proposed Road Improvements on First Avenue (from Simcoe Street South to Drew Street) and McNaughton Avenue (from Drew Street to Ritson Road South), City of Oshawa, Ontario

GeoPro Project No.: 24-4656GH Report Date: May 2, 2024

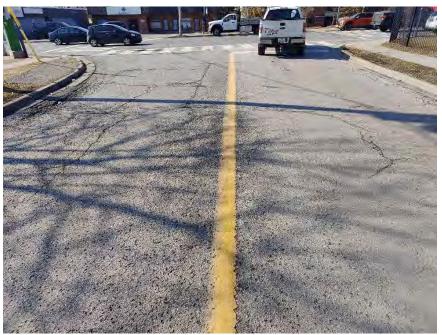
Photograph 1 - First Avenue, approximately 30 m East of Simcoe Street South, looking West, showing moderate to severe longitudinal and transverse cracking associated with slight to moderate random cracking, moderate to severe alligator cracking, moderate to severe pavement edge cracking, and moderate to severe pavement raveling.

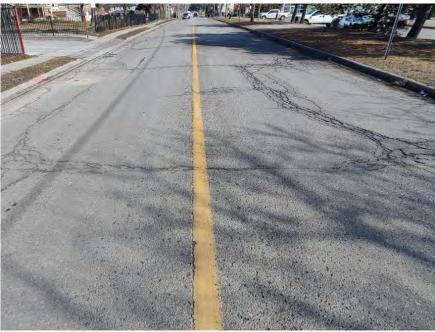
Photograph 2 – First Avenue, approximately 30 m East of Simcoe Street South, looking East, showing moderate to severe longitudinal and transverse cracking associated with moderate to severe alligator cracking, moderate random cracking, severe pavement edge cracking, and moderate to severe pavement raveling.

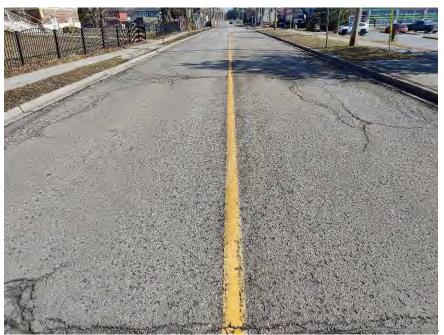
Photograph 3 – First Avenue, approximately 50 m East of Simcoe Street South, looking East, showing slight to moderate longitudinal and transverse cracking associated with moderate to severe alligator cracking, slight to moderate random cracking, severe pavement edge cracking, and moderate to severe pavement raveling.

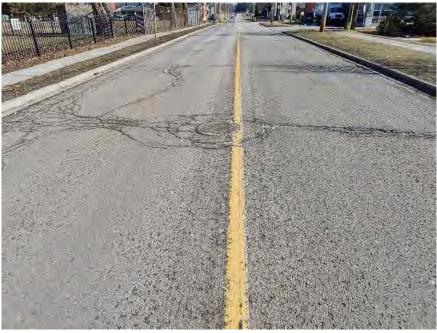
Photograph 4 – First Avenue, approximately 75 m East of Simcoe Street South, looking East, showing slight to moderate longitudinal and transverse cracking associated with moderate to severe alligator cracking, slight to moderate random cracking, severe pavement edge cracking, and moderate to severe pavement raveling. Noting moderate to severe alligator cracking around manhole.

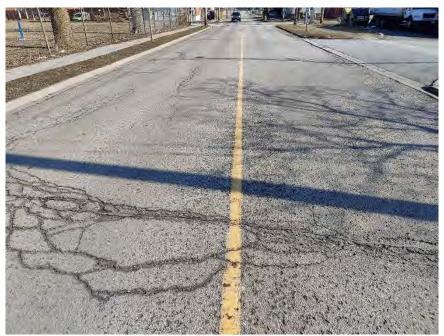
Photograph 5 – First Avenue, approximately 60 m West of Albert Street, looking East, showing moderate to severe longitudinal and transverse cracking associated with severe alligator cracking, slight to moderate random cracking, severe pavement edge cracking, slight pavement depressions, and moderate to severe pavement raveling.

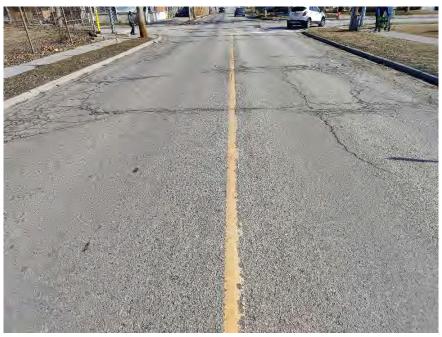
Photograph 6 – First Avenue, approximately 30 m West of Albert Street, looking East, showing moderate longitudinal and transverse cracking associated with moderate to severe alligator cracking, moderate random cracking, slight pavement depressions, severe pavement edge cracking, and moderate to severe pavement raveling.

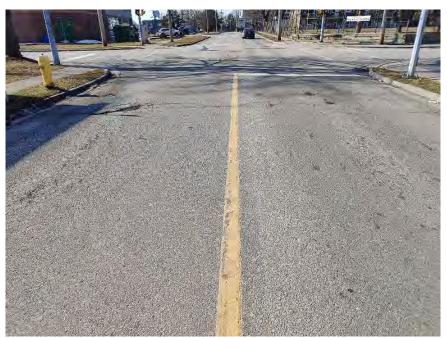
Photograph 7 – First Avenue, approximately 25 m East of Albert Street, looking West, showing moderate longitudinal and transverse cracking associated with moderate random cracking, slight alligator cracking, slight to moderate potholes, slight pavement edge cracking, and moderate pavement raveling. Noting moderate alligator cracking around manholes, slight random cracking around catch basin, and utility patching.

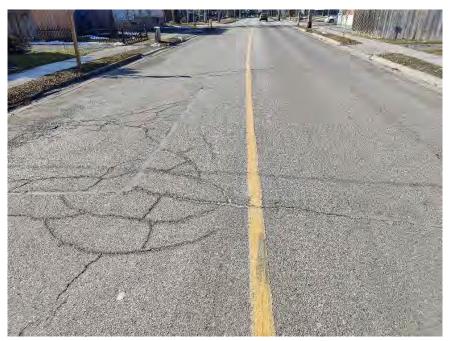
Photograph 8 – First Avenue, approximately 30 m West of Front Street, looking West, showing moderate longitudinal and transverse cracking associated with moderate alligator cracking, slight to moderate random cracking, slight pavement depression, slight to moderate block cracking, slight to moderate pavement edge cracking, and slight pavement raveling. Noting utility patching.

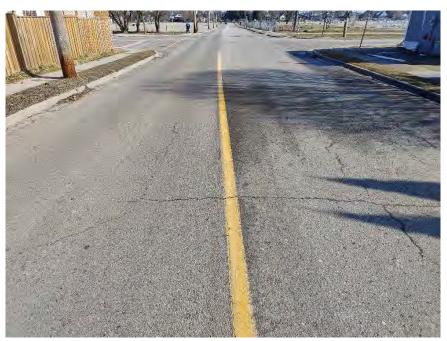
Photograph 9 – First Avenue, approximately 30 m West of Front Street, looking East, showing slight to moderate longitudinal and transverse cracking associated with slight random cracking, slight alligator cracking, slight to moderate pavement edge cracking, slight pavement rutting, and moderate to severe pavement raveling.

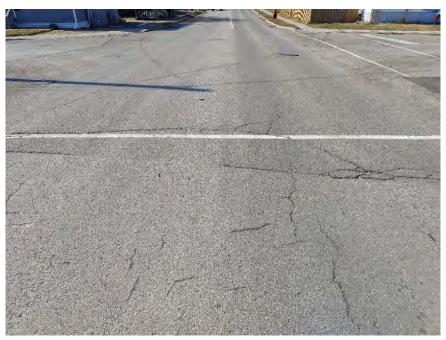
Photograph 10 – First Avenue, in the vicinity of the intersection of Front Street and First Avenue, looking West, showing moderate longitudinal and transverse cracking associated with moderate to severe random cracking, slight alligator cracking, moderate construction joint cracking, and slight to moderate pavement raveling. Noting slight to moderate random cracking around manholes.

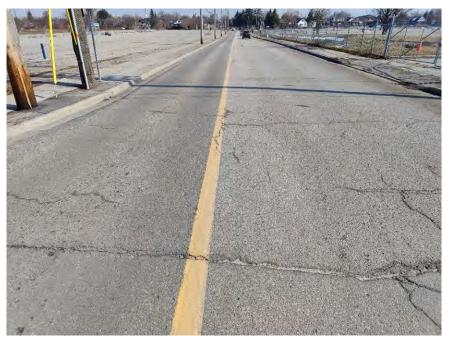
Photograph 11 – First Avenue, in the vicinity of the intersection of Front Street and First Avenue, looking East, showing moderate to severe longitudinal and transverse cracking associated with moderate random cracking, slight pavement edge cracking, and moderate pavement raveling.

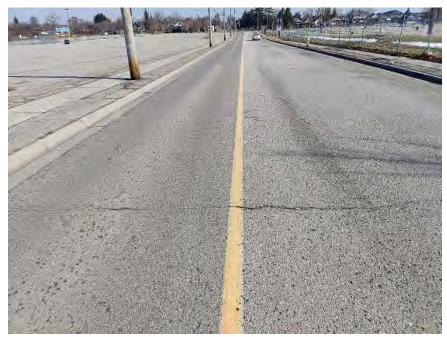
Photograph 12 – First Avenue, approximately 45 m East of Front Street, looking East, showing slight to moderate longitudinal and transverse cracking associated with slight random cracking, slight pavement edge cracking, slight pavement rutting, and moderate pavement raveling.

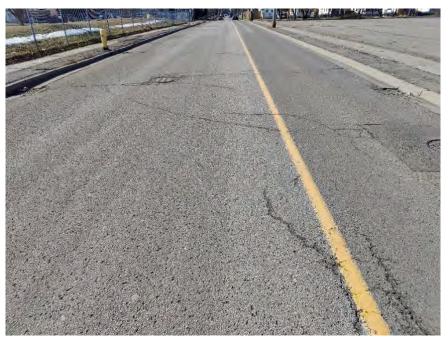
Photograph 13 – First Avenue, approximately 100 m East of Front Street, looking West, showing slight to moderate longitudinal and transverse cracking associated with slight random cracking, slight alligator cracking, slight pavement edge cracking, and moderate to severe pavement raveling. Noting moderate alligator cracking around manhole and catch basin, and utility patching.

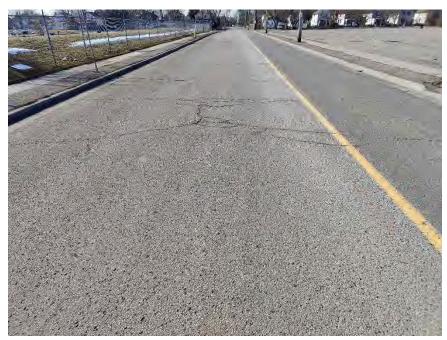
Photograph 14 – First Avenue, approximately 130 m East of Front Street, looking West, showing slight to moderate longitudinal and transverse cracking associated with slight to moderate alligator cracking, slight random cracking, slight pavement edge cracking, and moderate pavement raveling.

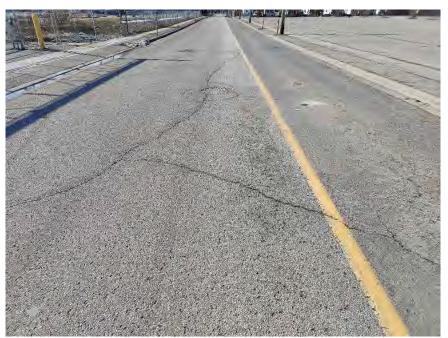
Photograph 15 – First Avenue, approximately 105 m West of Howard Street, looking West, showing moderate longitudinal and transverse cracking associated with moderate random cracking, slight pavement edge cracking, and moderate to severe pavement raveling. Noting moderate random cracking and patching around manholes.

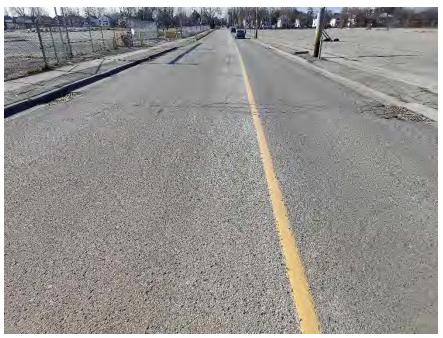
Photograph 16 – First Avenue, approximately 130 m East of Front Street, looking West, showing slight to moderate longitudinal and transverse cracking associated with moderate random cracking, slight to moderate alligator cracking, slight to moderate pavement edge cracking, and moderate to severe pavement raveling. Noting severe alligator cracking and slight random cracking around catch basins.

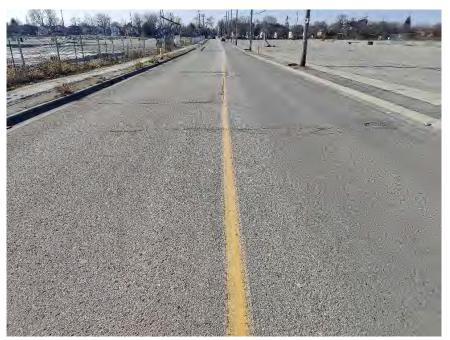
Photograph 17 – First Avenue, approximately 35 m West of Howard Street, looking West, showing moderate to severe longitudinal and transverse cracking associated with moderate random cracking, slight alligator cracking, slight pavement edge cracking, and moderate pavement raveling. Noting moderate random cracking around manholes.

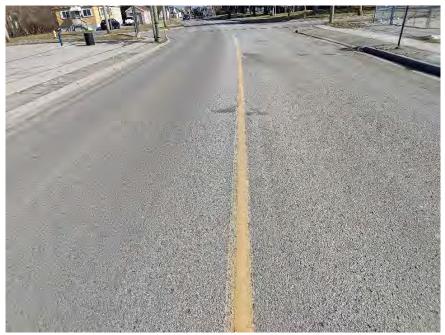
Photograph 18 – First Avenue, approximately 35 m West of Howard Street, looking East, showing slight to moderate transverse cracking, slight pavement edge cracking, and slight to moderate pavement raveling.

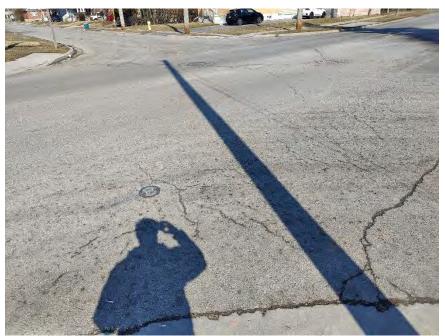
Photograph 19 – First Avenue, in the vicinity of the intersection of Howard Street and First Avenue, looking North, showing moderate to severe random cracking, slight pavement edge cracking, and moderate to severe pavement raveling. Noting severe alligator cracking around manholes and section of patching.

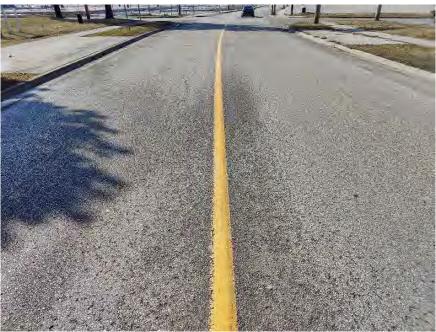
Photograph 20 – First Avenue, approximately 40 m East Howard Street, looking Southwest, showing slight longitudinal and transverse cracking, slight random cracking, slight pavement edge cracking, and slight to moderate pavement raveling.

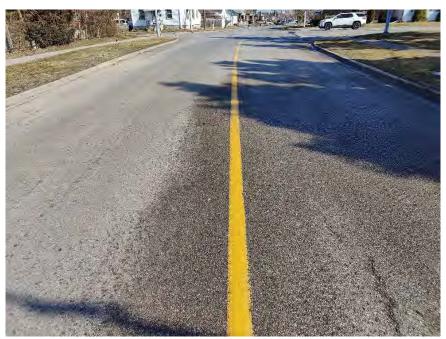
Photograph 21 – First Avenue, approximately 40 m East Howard Street, looking Northeast, showing slight to moderate longitudinal and transverse cracking associated with slight random cracking, slight alligator cracking, slight pavement edge cracking, and moderate pavement raveling.

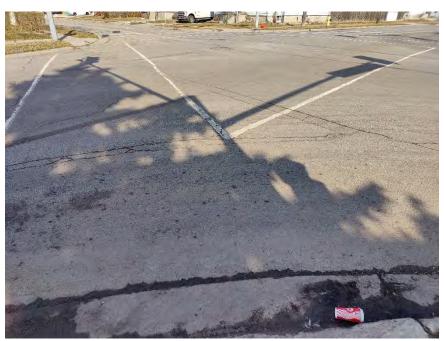
Photograph 22 – First Avenue, in the vicinity of the intersection of Drew Street and First Avenue, looking North, showing slight to moderate longitudinal and transverse cracking associated with moderate random cracking, slight to moderate alligator cracking, slight pavement edge cracking, moderate to severe construction joint cracking, and moderate pavement raveling. Noting severe alligator cracking around manholes and utility patching.

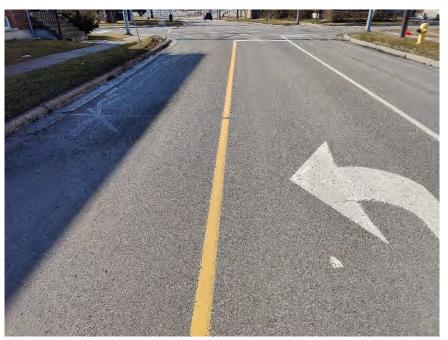
Photograph 23 – McNaughton Avenue, approximately 30 m East of Drew Street, looking West, showing slight to moderate longitudinal and transverse cracking associated with slight random cracking, slight pavement edge cracking, slight to moderate pavement rutting, slight to moderate pavement patching, and slight pavement raveling.

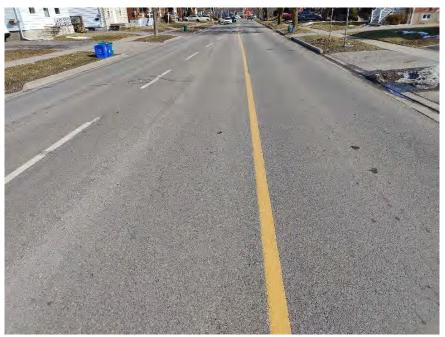
Photograph 24 – McNaughton Avenue, approximately 30 m East of Drew Street, looking East, showing slight to moderate longitudinal and transverse cracking associated with slight random cracking, slight pavement edge cracking, slight pavement rutting, and slight pavement raveling. Noting patching around manhole.

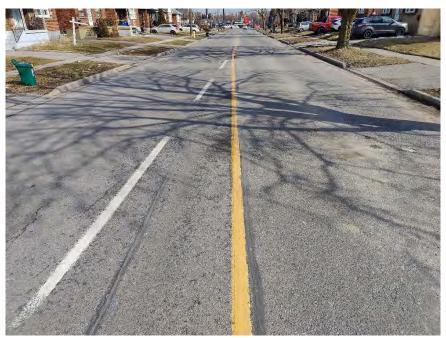
Photograph 25 – McNaughton Avenue, approximately 65 m East of Drew Street, looking East, showing moderate longitudinal cracking associated with slight random cracking, slight pavement edge cracking, slight to moderate pavement rutting, and slight to moderate pavement raveling.

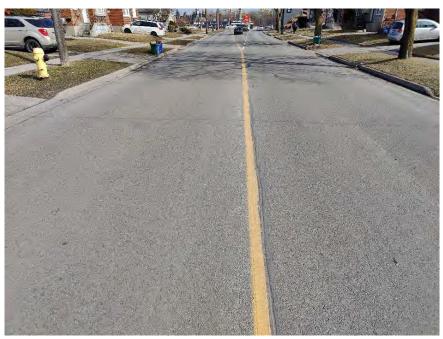
Photograph 26 – McNaughton Avenue, approximately 100 m East of Drew Street, looking East, showing slight longitudinal cracking associated with slight random cracking, and moderate pavement raveling. Noting moderate random cracking around manhole.

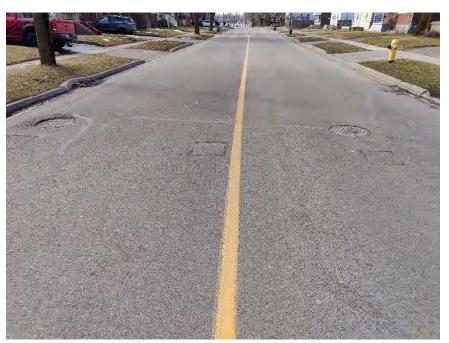
Photograph 27 – McNaughton Avenue, approximately 100 m West of Ritson Road South, looking West, showing slight longitudinal and transverse cracking, slight pavement edge cracking, and slight pavement raveling. Noting slight depression and random cracking around manholes and catch basins, and section of patching.

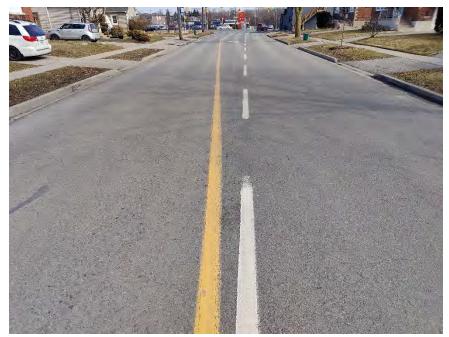
Photograph 28 – McNaughton Avenue, approximately 100 m West of Ritson Road South, looking East, showing slight to moderate longitudinal cracking, slight random cracking, and slight pavement raveling.

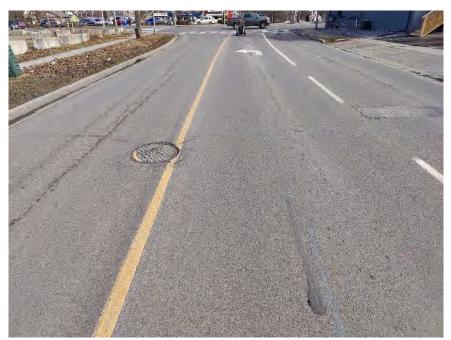
Photograph 29 – McNaughton Avenue, approximately 55 m West of Ritson Road South, looking East, showing slight to moderate longitudinal and transverse cracking associated with slight random cracking, slight pavement edge cracking, and moderate pavement raveling. Noting moderate random cracking around manhole and section of patching.
