Fluvial Geomorphological Assessment of Oshawa Creek and Evaluation of Erosion Mitigation Strategies at Prioritized Sites

Thomas Street to Wentworth Street West

City of Oshawa

October 8, 2021

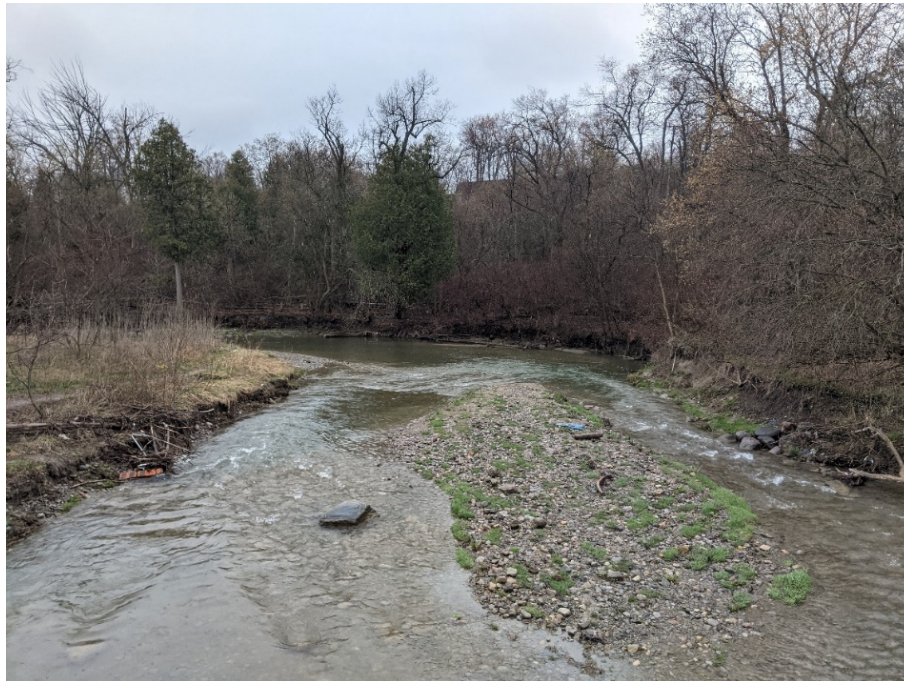
Photo 2. *A riffle at Site 4 formed by a medial bar that bifurcates flow toward a pool immediately downstream at the apex of a meander. Downstream view.*

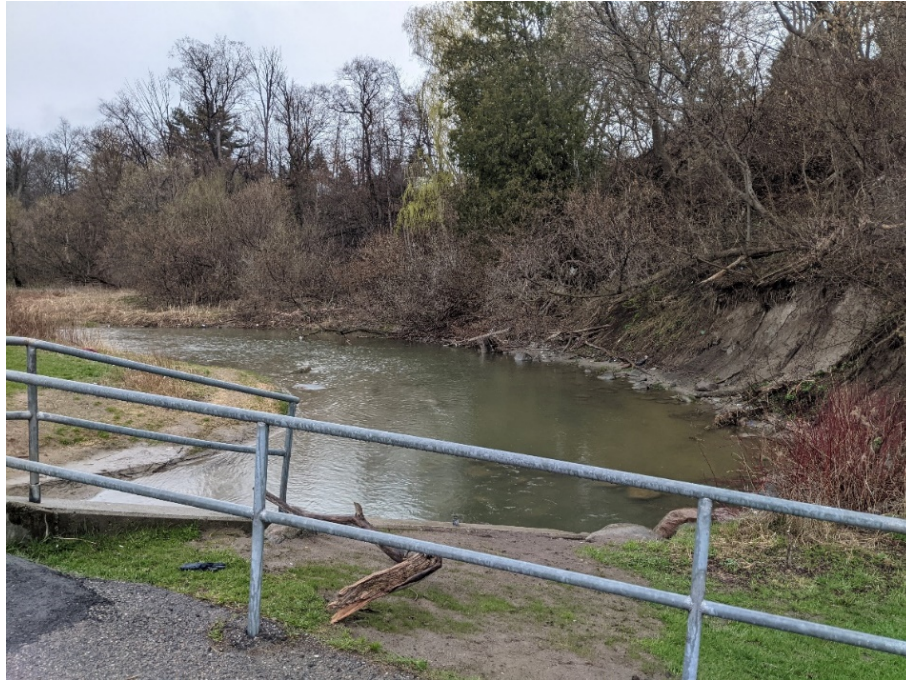
Photo 3. *Valley wall contact along the outer bank of the meander at Site 3. Upstream view.*

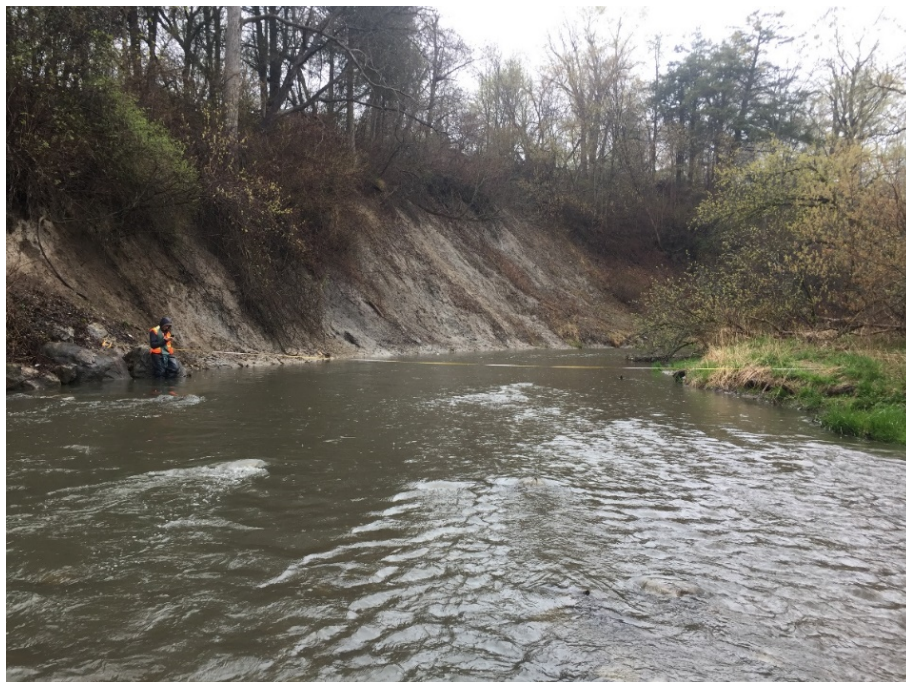
Photo 4. *Valley wall contact along the outer bank of the meander at Site 6. Upstream view. Person for scale.*

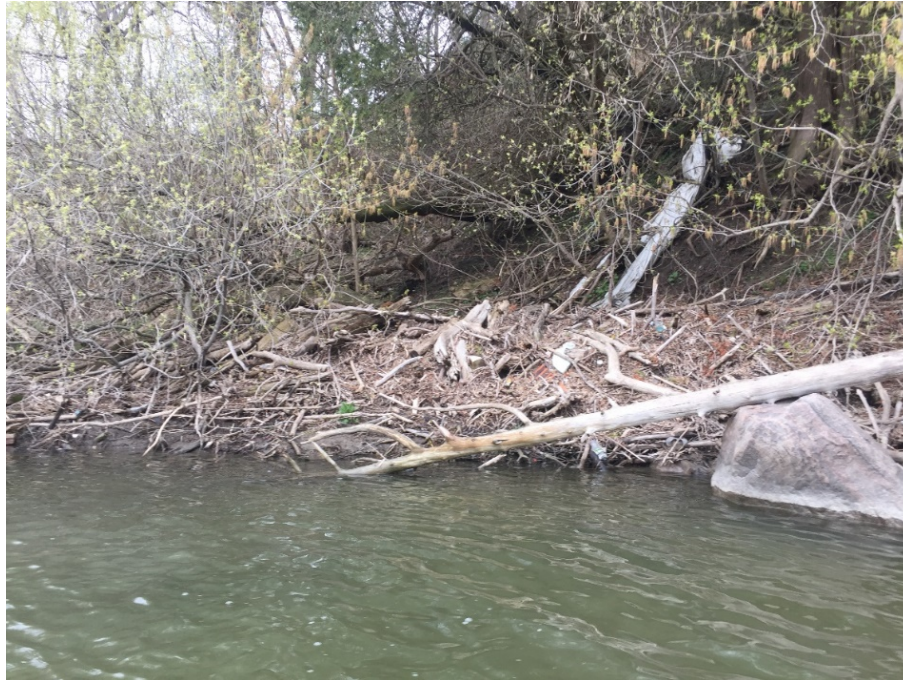
Photo 5. *Woody debris in the channel and overbank deposition of organic debris near Site 3. View of left (east) bank.*

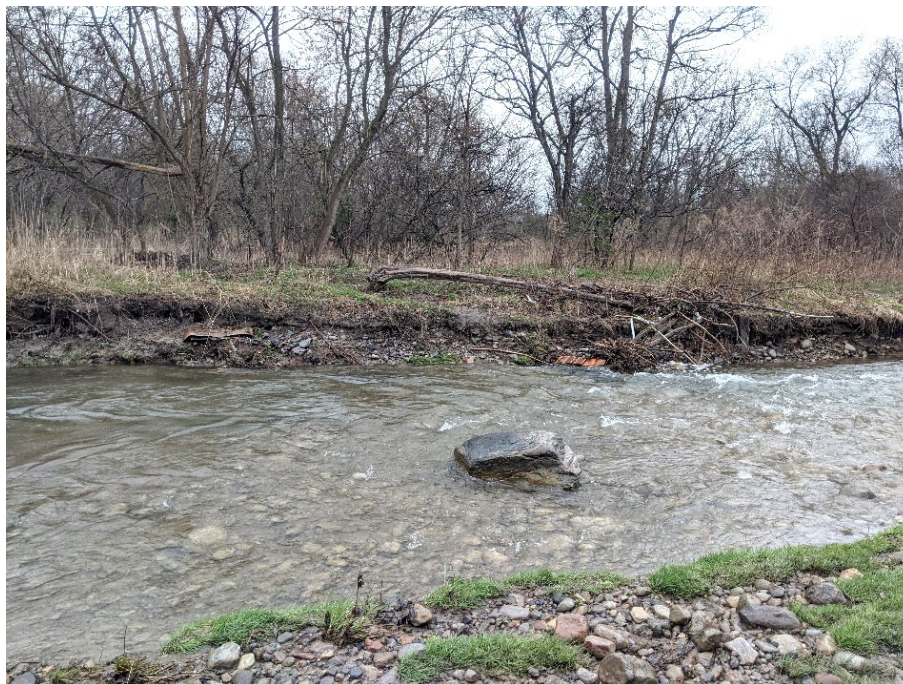
Photo 6. *Low, undercut bank exposing an elevated armoured layer at Site 4. Flow from left to right.*

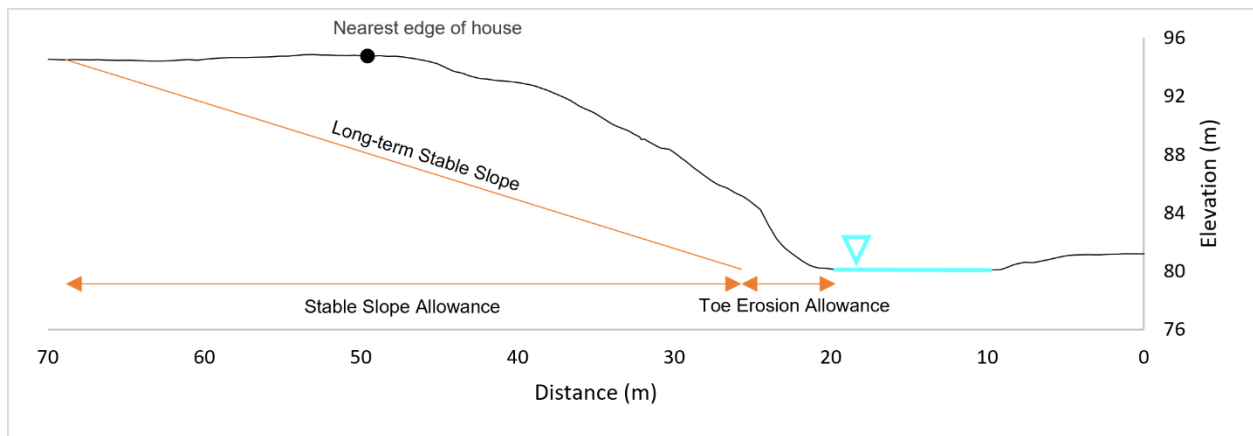
Figure 7. *Downstream view of LiDAR-derived cross-section of east side of valley at Site 3, showing the toe erosion allowance (6 m) and the stable slope allowance (42m) projected into tableland with a private residence.*

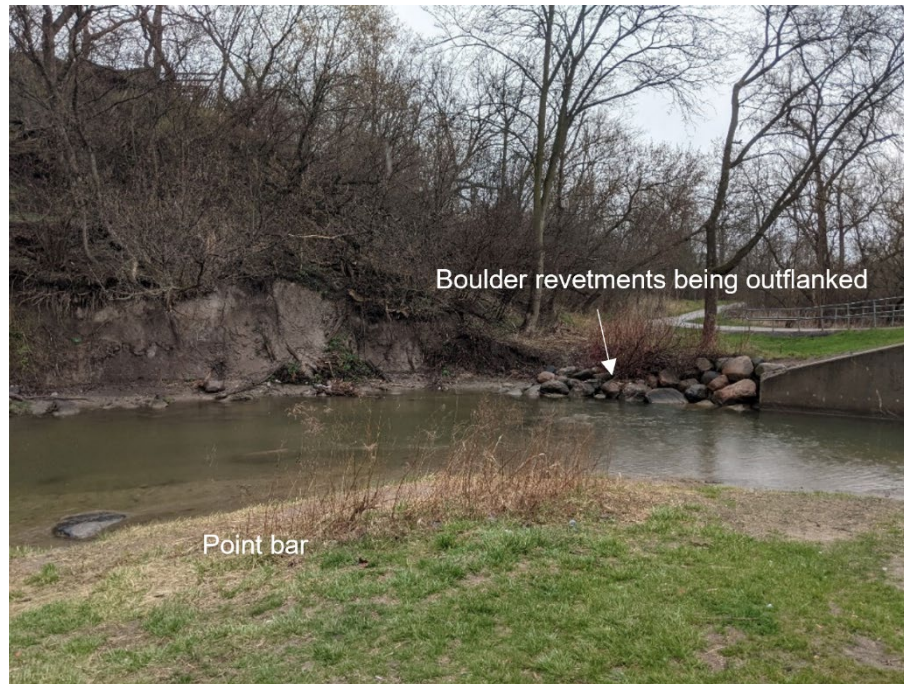
Downstream transfer of energy from the erosion-resistant valley wall has started to outflank and undermine the boulder revetment protecting the bridge abutment (**Figure 1; Photo 7**). The bridge is located immediately downstream of the meander apex, where erosive energy is naturally concentrated, with its left (outer bank) abutment set back much closer to the thalweg than its right (inner bank) abutment. The siting and skew of the bridge abutments exacerbate erosion along the outer bank. The bridge abutment along the outer bank projects into the channel, creating a point of erosion concentration. If bridge abutments were shifted approximately 10 m to the south, erosion risk to the bridge would have been significantly reduced. A deep scour pool has formed along the outside of the meander, exacerbated by a point bar that has formed along the inner bank. The scour pool extends downstream, beneath the pedestrian bridge, the left abutment of which is at risk of being undermined.

Photo 7. *Bank revetment upstream of pedestrian bridge being outflanked at the downstream limit of an erosive scarp, along the Site 3 valley wall contact. Downstream view.*

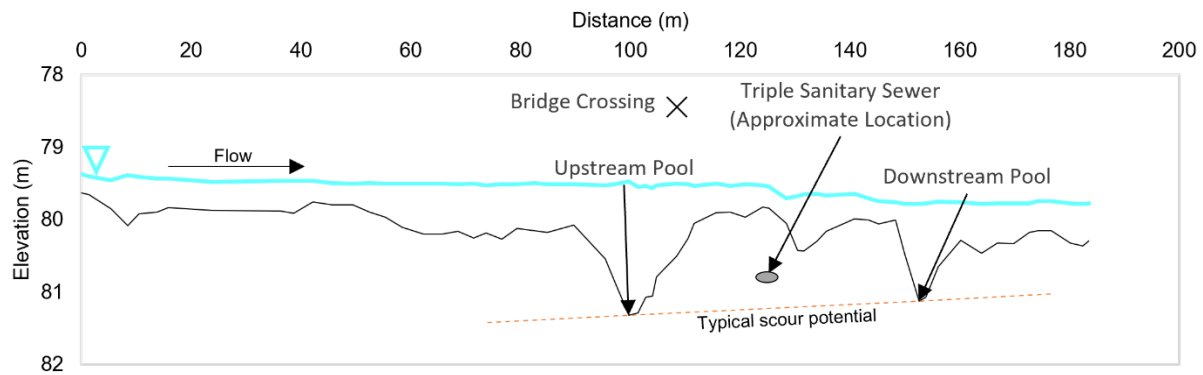
The gradient at Site 4 is 0.62%, notably steeper than at other sites, and the reach-scale average (0.44%). Two deep pools define the upstream (1.66 m deep) and downstream (1.40 m deep) limits of Site 4. A reasonable approximation of typical bed scour potential along this particular section of channel is the grade-line tangent to the bottoms of the deepest pools. Longitudinal adjustments are likely to occur at least within the envelope between the channel bed and this maximum pool depth grade line. The grade-line tangent to the bottoms of the pools is currently 0.16 m below the bottom of the sanitary pipe, such that the sanitary pipe is within the area of scour potential and potentially at risk of exposure and damage (**Figure 8**).

Figure 8. *Longitudinal profile of bed morphology encompassing Site 4, created from local level-rod survey data referenced to 2019 LiDAR-derived elevations. Obvert of sanitary sewer is 0.9 m below the bed and 0.16 m above the grade line, tangential to upstream and downstream pools (representing typical scour potential).*

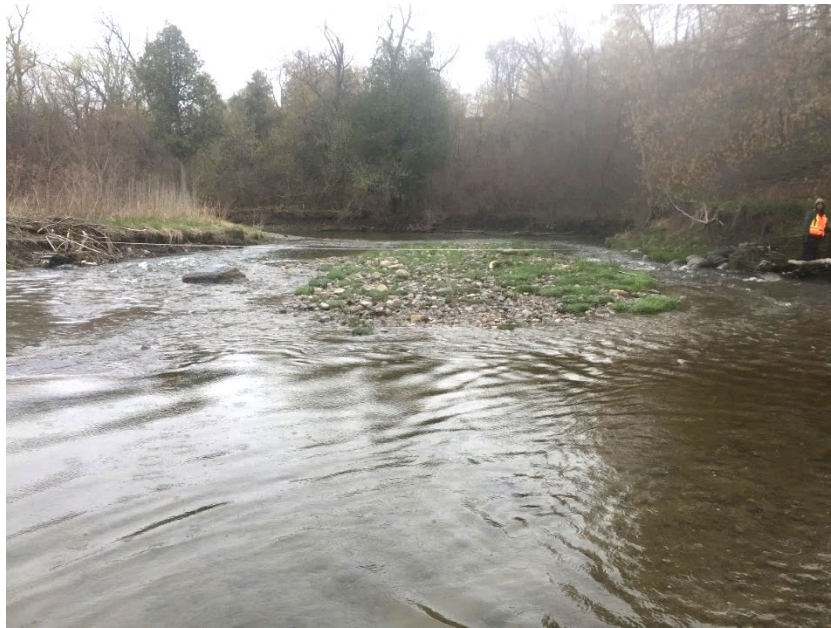
Photo 8. *A medial bar overtop of the sanitary sewer bifurcates flow, concentrating erosion along both banks. Downstream view.*

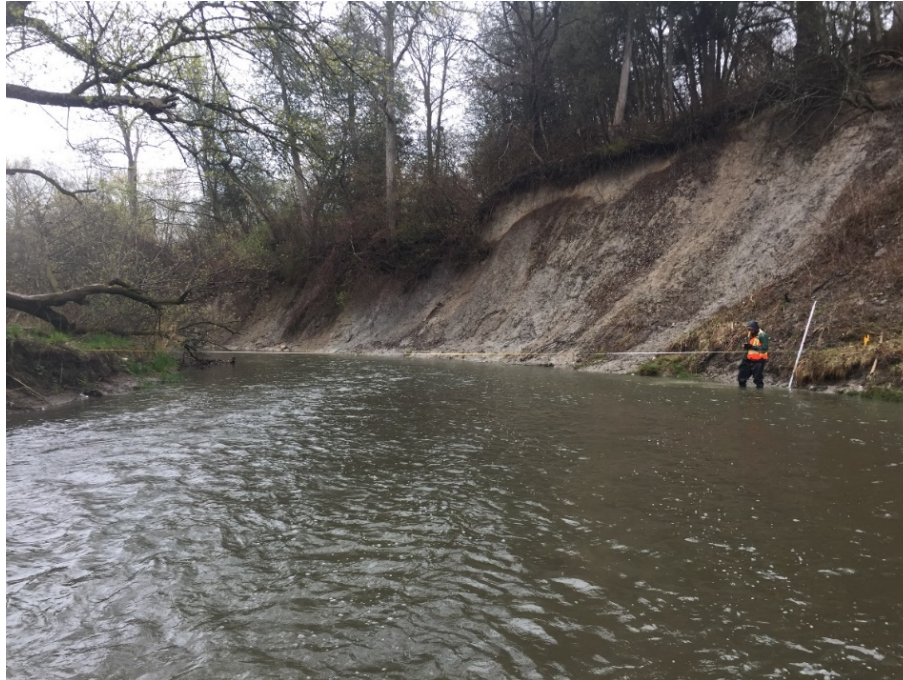
Photo 9. An actively eroding scarp, approximately 100 m long and up to 17 m high, along the western valley wall at Site 6. Downstream view.

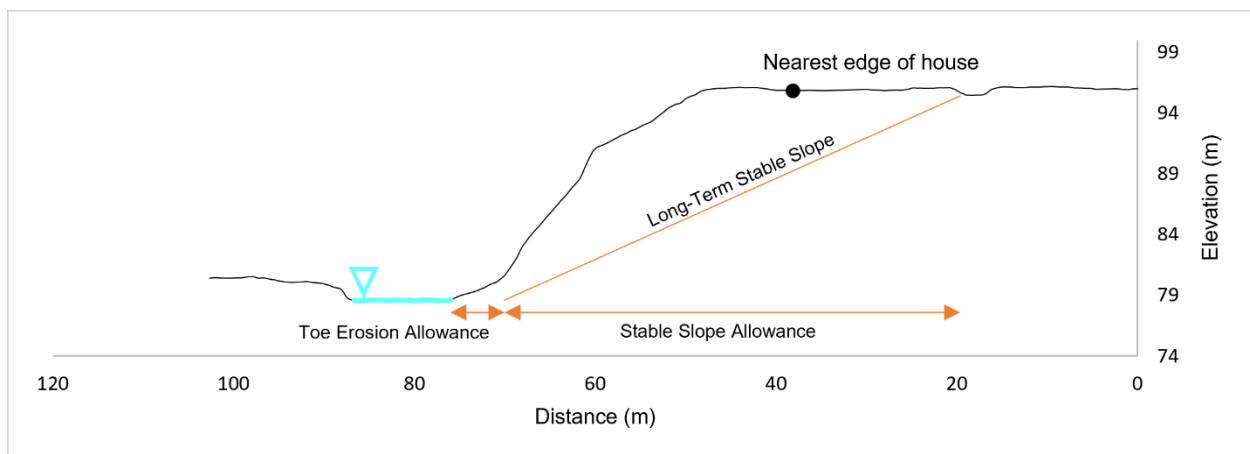
Figure 10. Downstream view of LiDAR-derived cross-section of west side of valley at Site 6, showing the toe erosion allowance (6 m) and the stable slope allowance (51 m) projected into tableland with private residences.

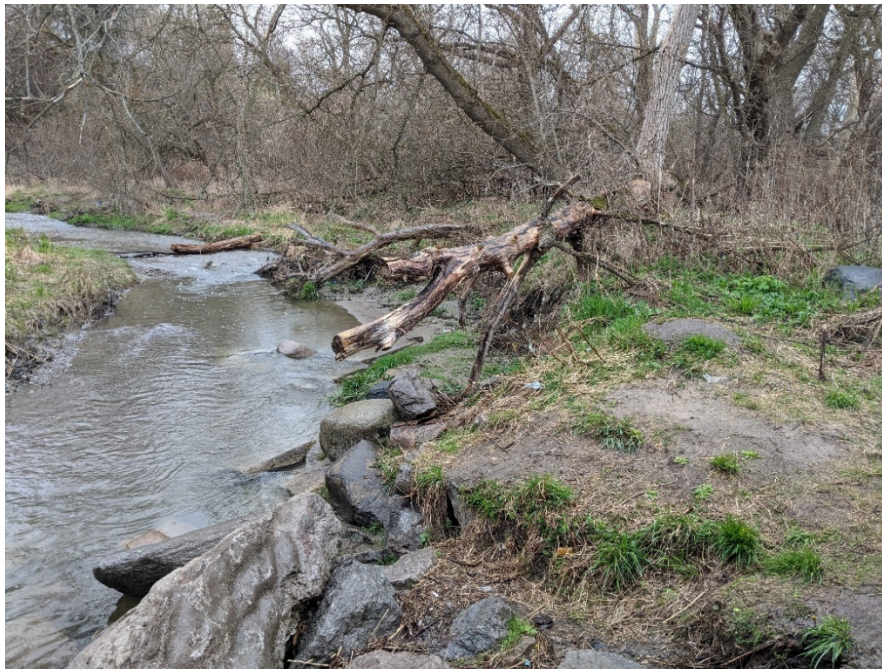
Channel planform adjustment upstream of Thomas Street bridge (Site 8) has started to erode the upstream extent of boulder revetment installed along the left bank to protect the bridge footing and Bike Path (**Photo 10**). Overtopping flood flows have also resulted in the outflanking and winnowing of fines underlying and behind the boulder revetment. Concentrated surface runoff along the Bike Path, from the parking lot, cascades over the boulder revetment into the creek, and acts as a secondary erosion mechanism. Average bankfull width at Site 6 and 8 is 15.9 m, average depth is 0.8 m, and average bankfull discharge is 31.7 m³/s. The critical discharge to mobilize bed materials, averaged across cross-sections, is approximately 67.7% of the bankfull discharge (21.1 m³/s). The energy required to mobilize sediment is concentrated along the banks and/or dispersed into the floodplain when depth is sufficient for channel water to overtop the low bank (**Photo 11**). Higher critical discharge required to move coarser bed material (D₅₀) has resulted in lateral adjustments due to preferential erosion of channel banks.

Photo 10. *Riprap bank revetment at Site 8 that protects the Bike Path and left abutment of the Thomas Street bridge. Upstream view.*

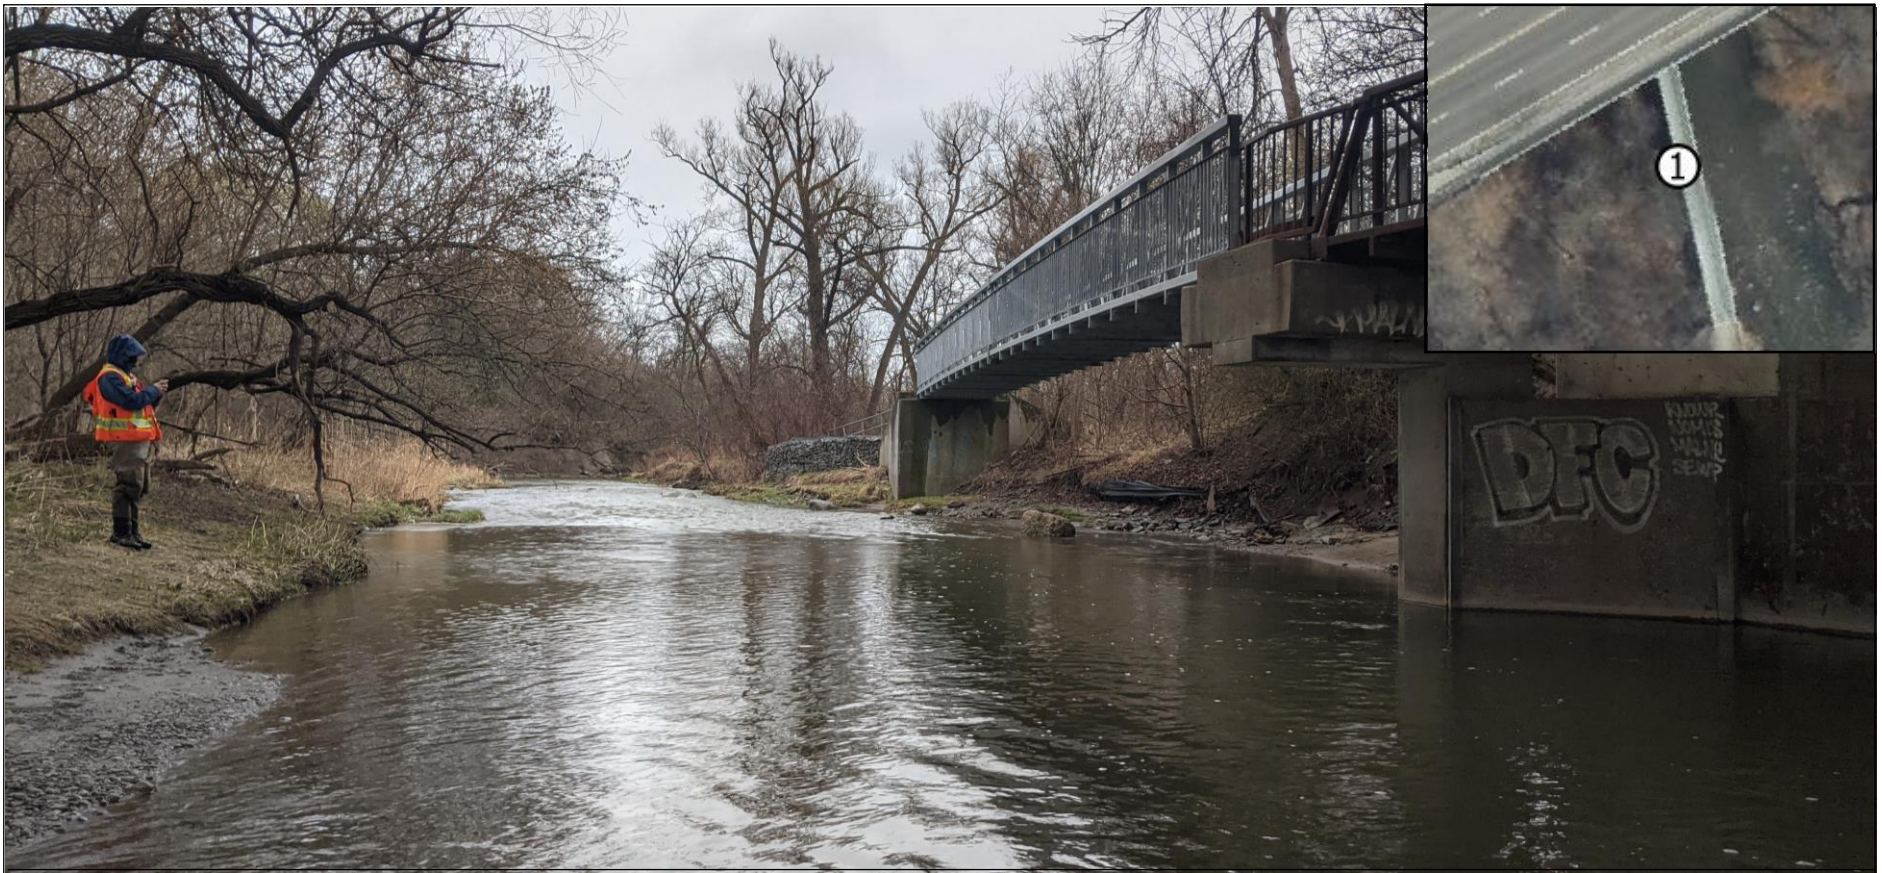
Description:
Erosion along right bank, beneath the elevated section of trail. Flood flows interact with the bridge abutment. Ongoing erosion could eventually cause footings of the pedestrian walkway to be undermined and outflanked. Downstream transfer of energy from smooth concrete bridge abutments may be exacerbating scour. Risk is low, so only ongoing monitoring is recommended. Flow: bottom to top.

Site 1	Feature at Risk:	Distance to Feature	Condition of Bank and/or Existing Erosion Protection:	Mechanism(s) of Failure:	Risk	Recommended Action(s):
	Elevated pedestrian walkway	0 m (contact)	Minor erosion at toe of bank	Undermining and outflanking	Low	Do nothing – continue to monitor.

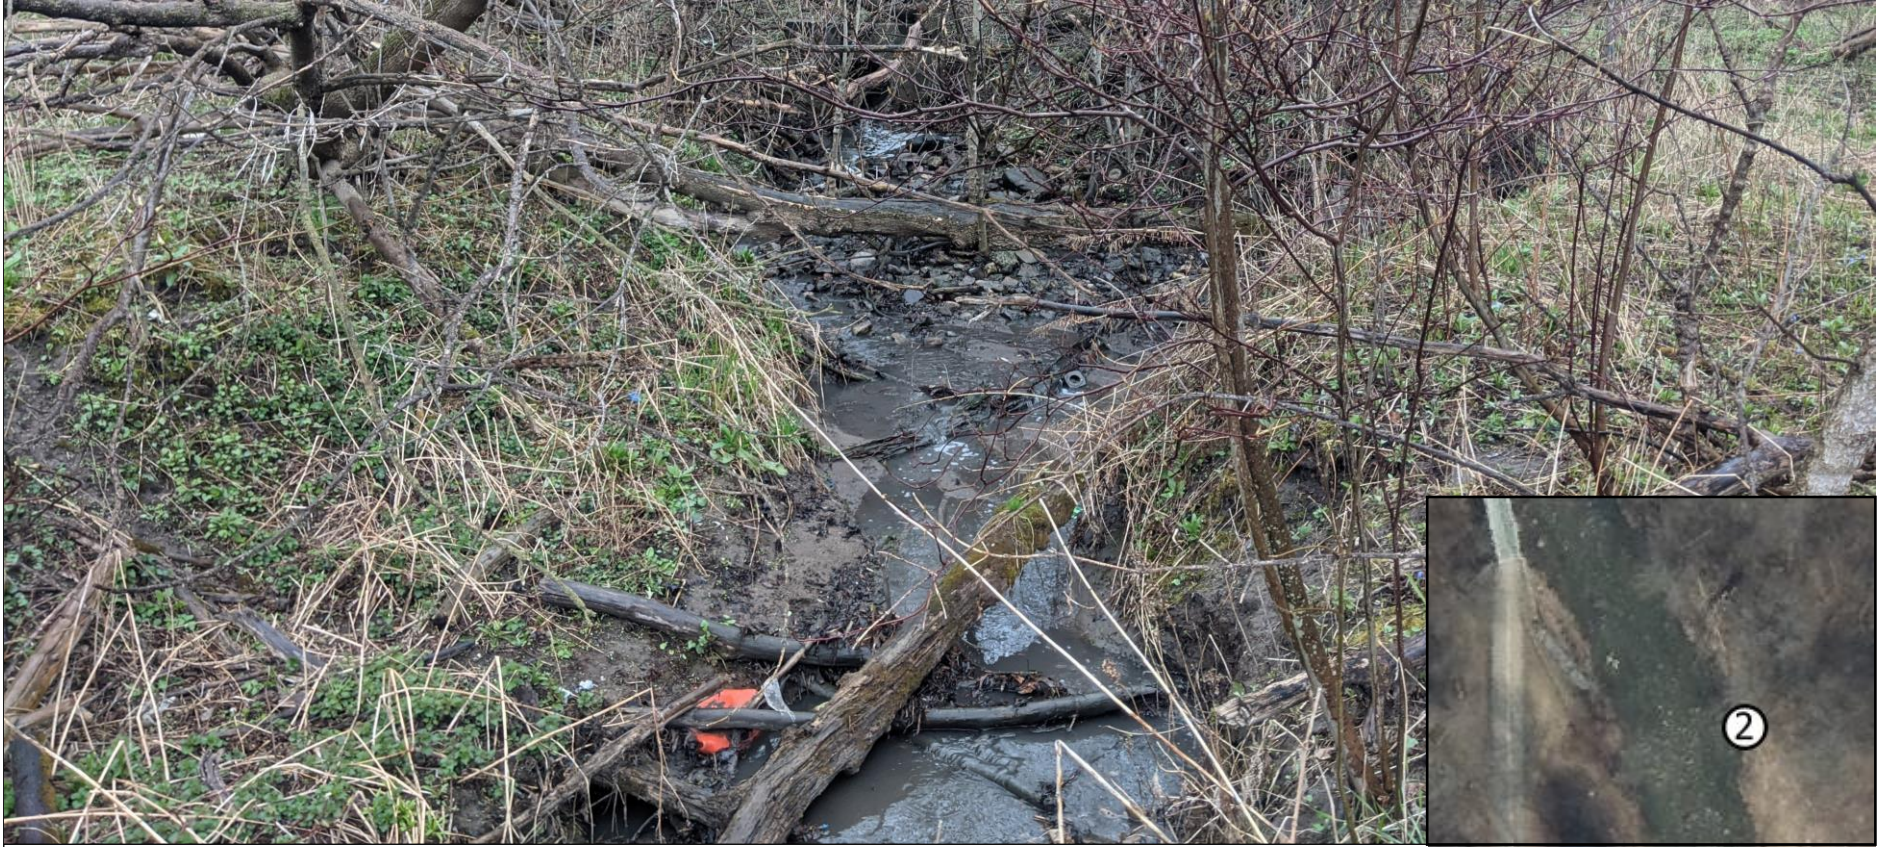
Description:
Stormwater outfall located approximately 5 m from the creek has incised (down-cut) a small outflow channel into the floodplain. The outfall is not at risk from fluvial scour and is sufficiently setback from the watercourse. Grey-coloured, turbid water was discharging from the outfall during both field visits. Water quality may be a concern. Flow: top to bottom.

Site 2	Feature at Risk:	Distance to Feature	Condition of Bank and/or Existing Erosion Protection:	Mechanism(s) of Failure:	Risk	Recommended Action(s):
	Stormwater outfall	5 m	Minor erosion	Undermining	Low	Do nothing - monitor

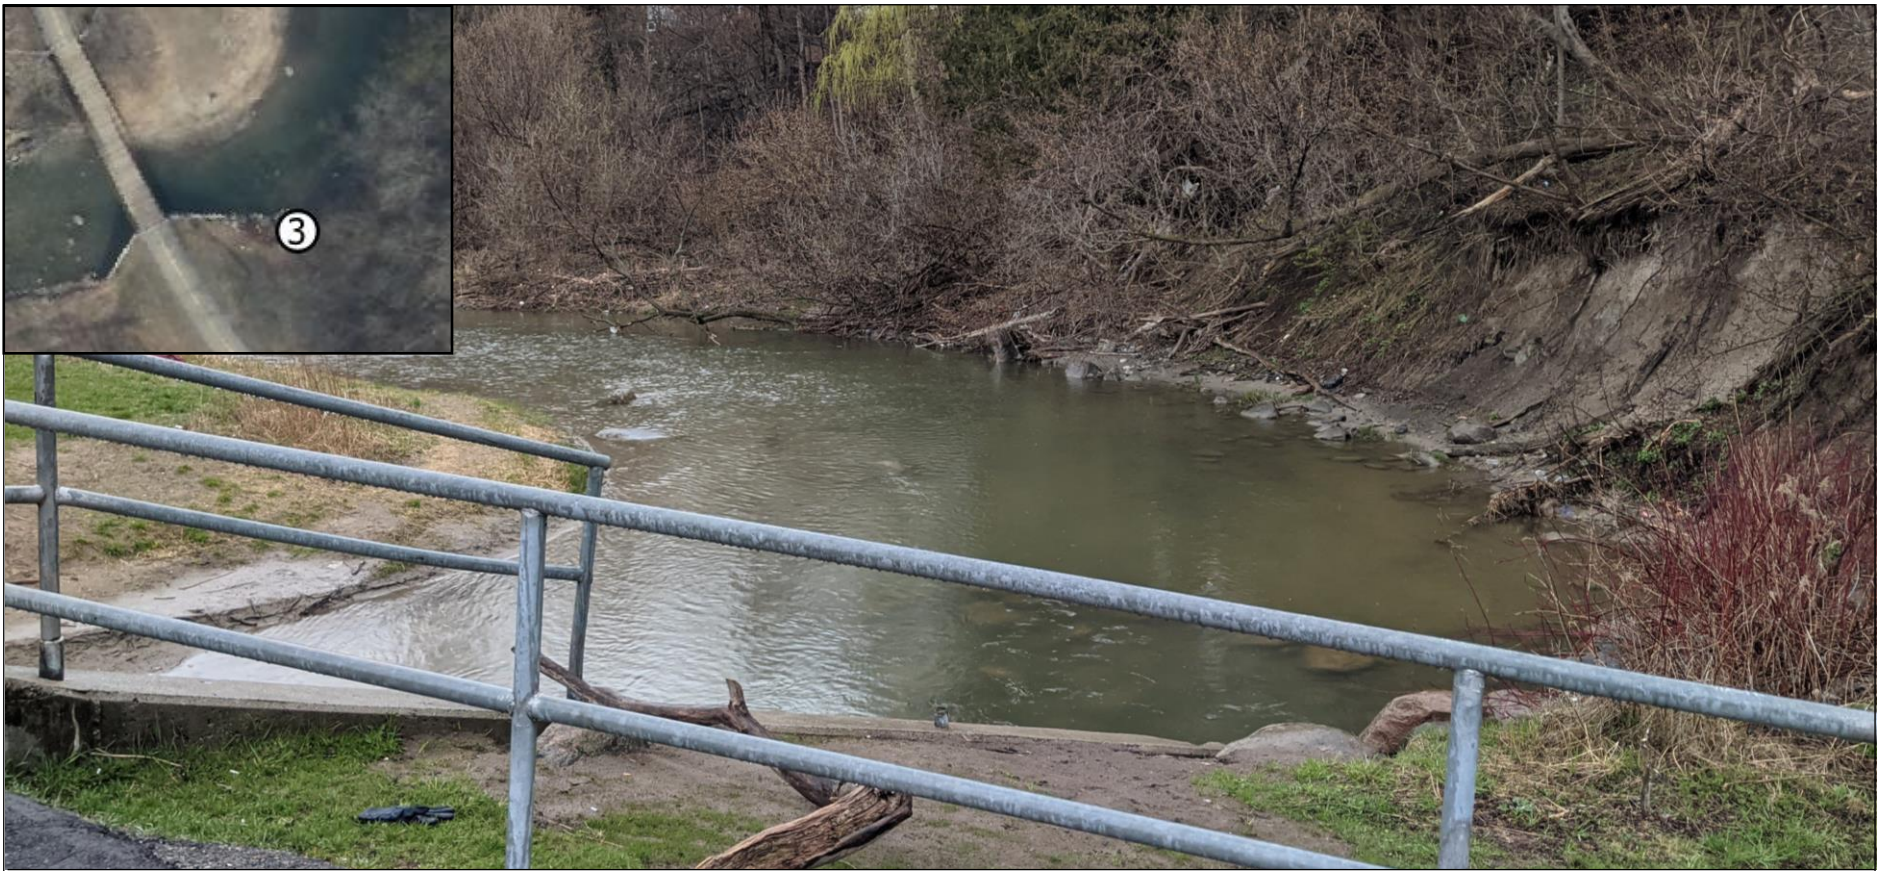
Description:
Straightening of the previously sinuous channel has accelerated flow toward the outer bank of a meander in contact with the eastern valley wall. The upstream portion of the valley wall contact remains vegetated and exhibits no obvious signs of instability, but toe erosion along the downstream portion has forced the construction of a boulder bank revetment to protect a pedestrian bridge immediately downstream. A deep scour pool has formed along this outer bank/revetment. The bridge abutments are now at risk of being outflanked and/or undermined. Flow: top to bottom.

Site 3	Feature at Risk:	Distance to Feature	Condition of Bank and/or Existing Erosion Protection:	Mechanism(s) of Failure:	Risk	Recommended Action(s):
	Pedestrian bridge and private property on valley crest	0 m (contact)	Functional, but deteriorating	Outflanking and/or undermining	High	Design and construct protection for toe of valley wall and bridge

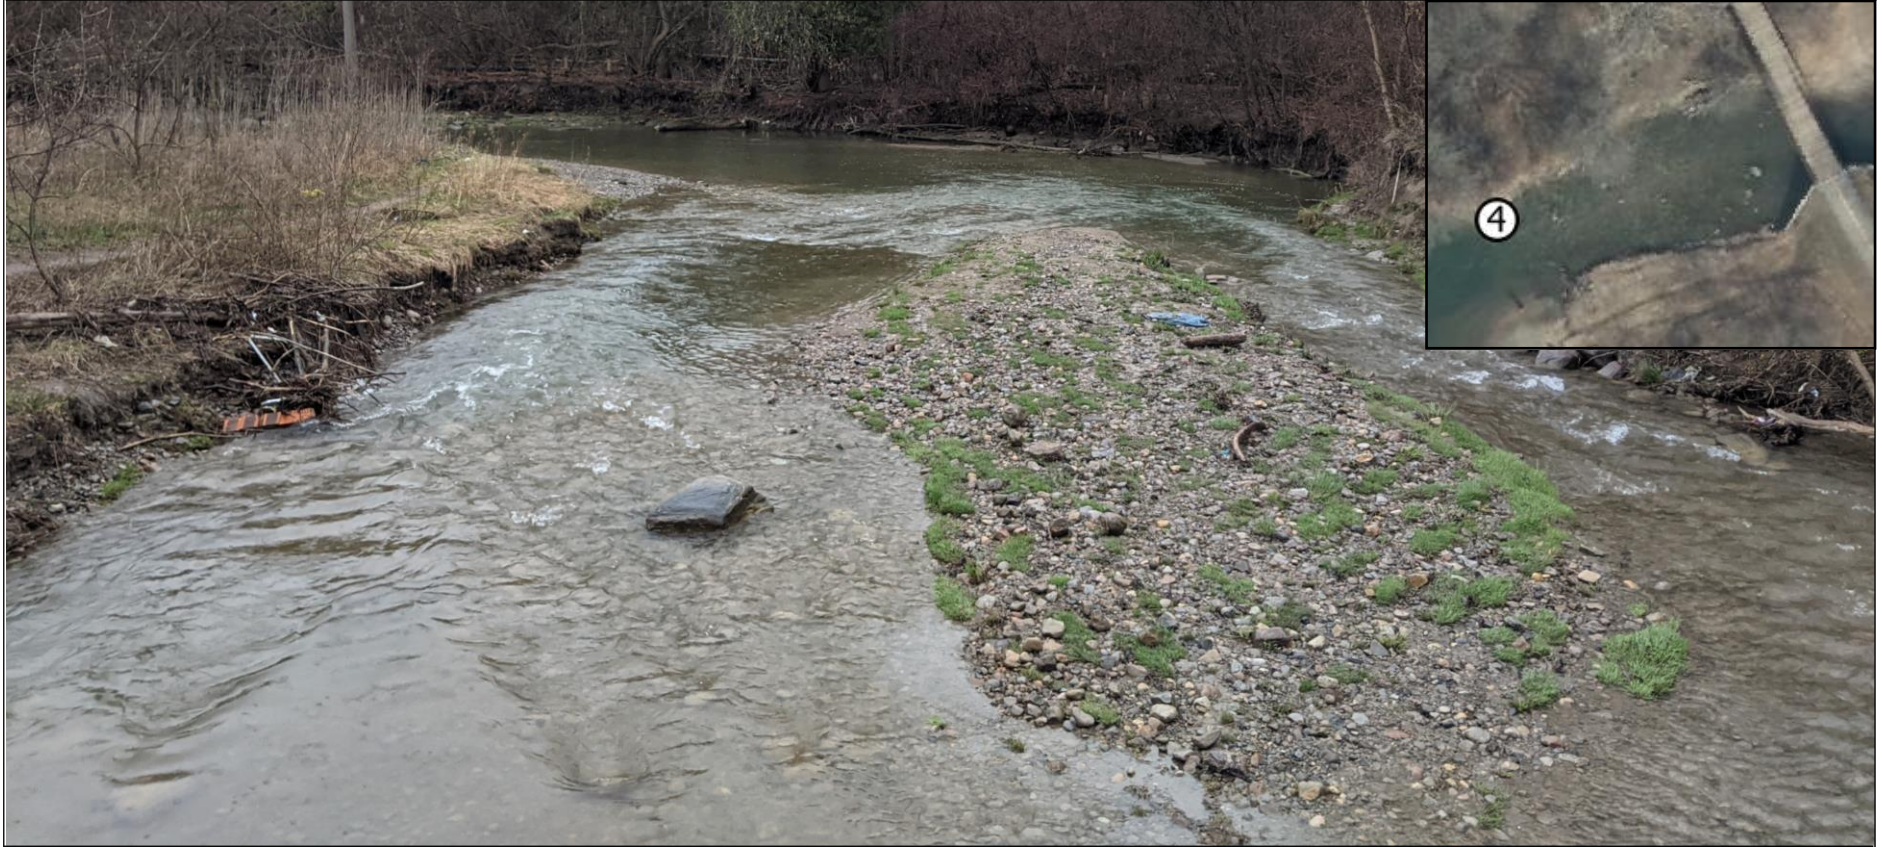
Description:
A sanitary sewer without concrete encasement diagonally crosses the channel at a depth of approximately 0.9 m. A prominent medial bar overtop of the sewer bifurcates flow and has promoted erosion of both banks as well as the beds of the split channels. Additionally, downstream migration of the medial bar could significantly reduce the thickness of cover over the sanitary sewer. Flow: bottom to top.

Site 4	Feature at Risk:	Distance to Feature	Condition of Bank and/or Existing Erosion Protection:	Mechanism(s) of Failure:	Risk	Recommended Action(s):
	Sanitary sewer	0.9 m (depth of cover)	Steep, eroded banks; no protection from continued bed scour	Bed scour and medial bar migration	Moderate	Protect sanitary sewer (based on assumed works to be completed at Site 3)

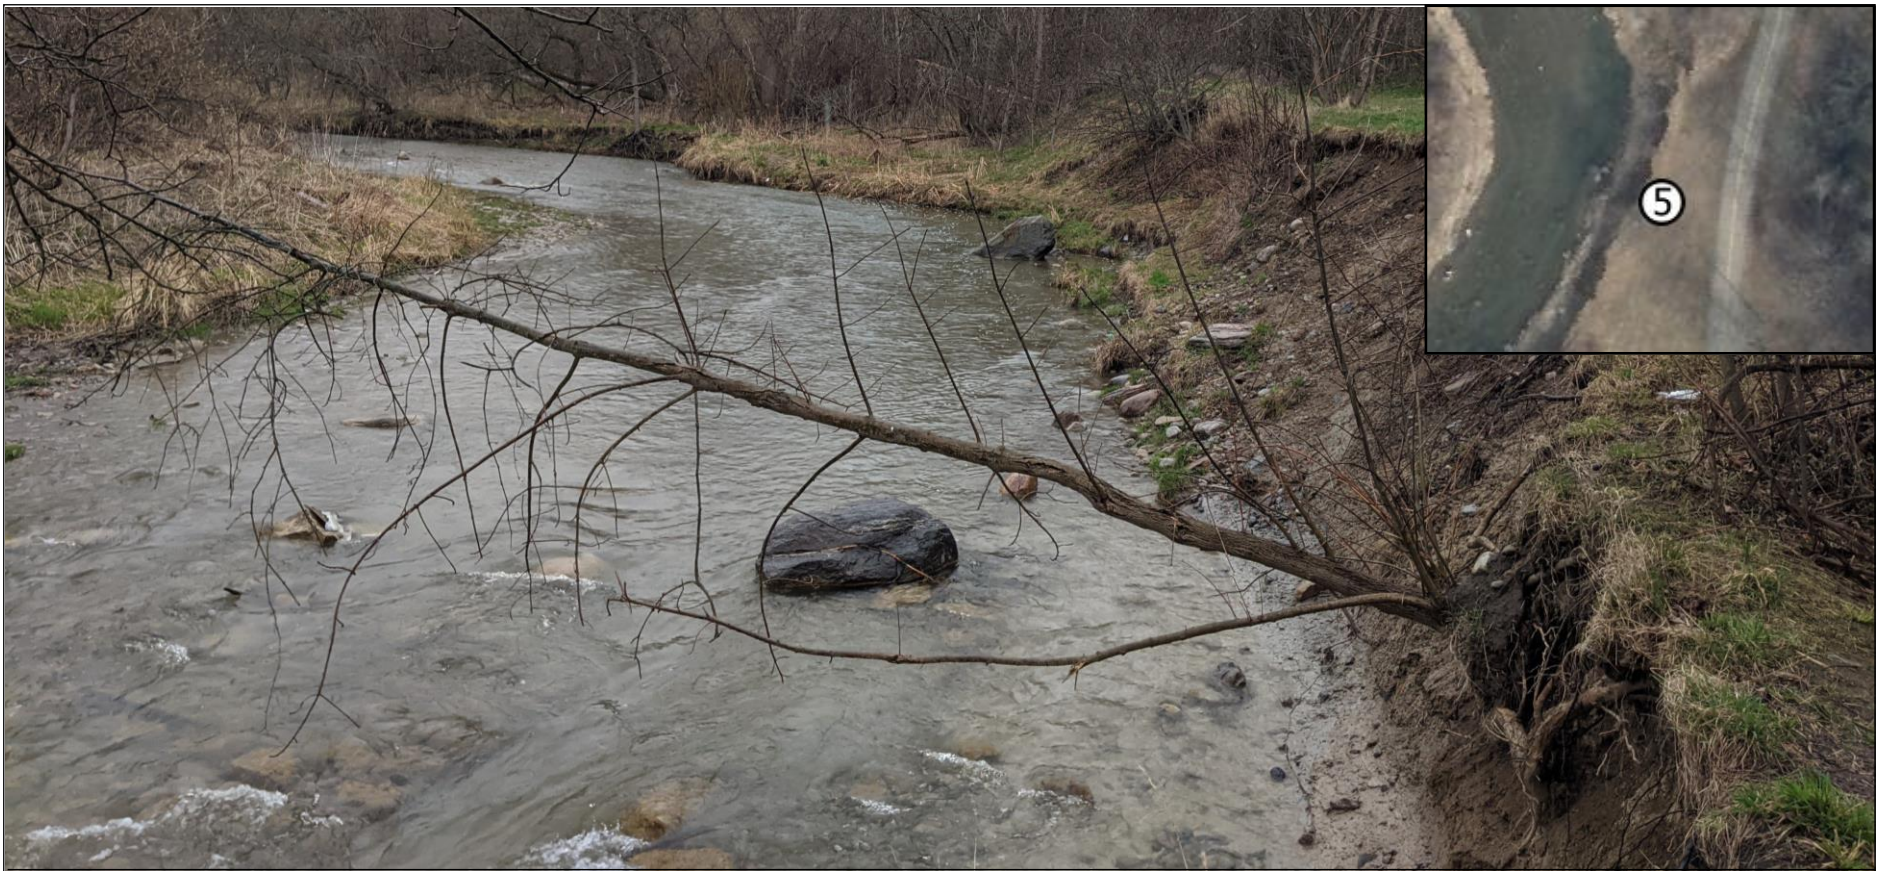
Description:
Erosion along the downstream portion of an outer meander bank has resulted in active down-valley migration roughly parallel to the adjacent Joseph Kolodzie Oshawa Creek Bike Path. Fill has been overlain on alluvium, which has eroded faster than the alluvial toe and created a flood bench. The flat-topped mound of fill has helped slow the rate of bank recession. Sufficient separation (10 m) exists between the eroded bank and trail to accommodate minor recession, although riparian plantings would restore some bank integrity. Flow: top to bottom.

Site 5	Feature at Risk:	Distance to Feature	Condition of Bank and/or Existing Erosion Protection:	Mechanism(s) of Failure:	Risk	Recommended Action(s):
	Joseph Kolodzie Oshawa Creek Bike Path	10 m	Eroded unprotected bank	Undermining	Low	Riparian plantings and continue to monitor

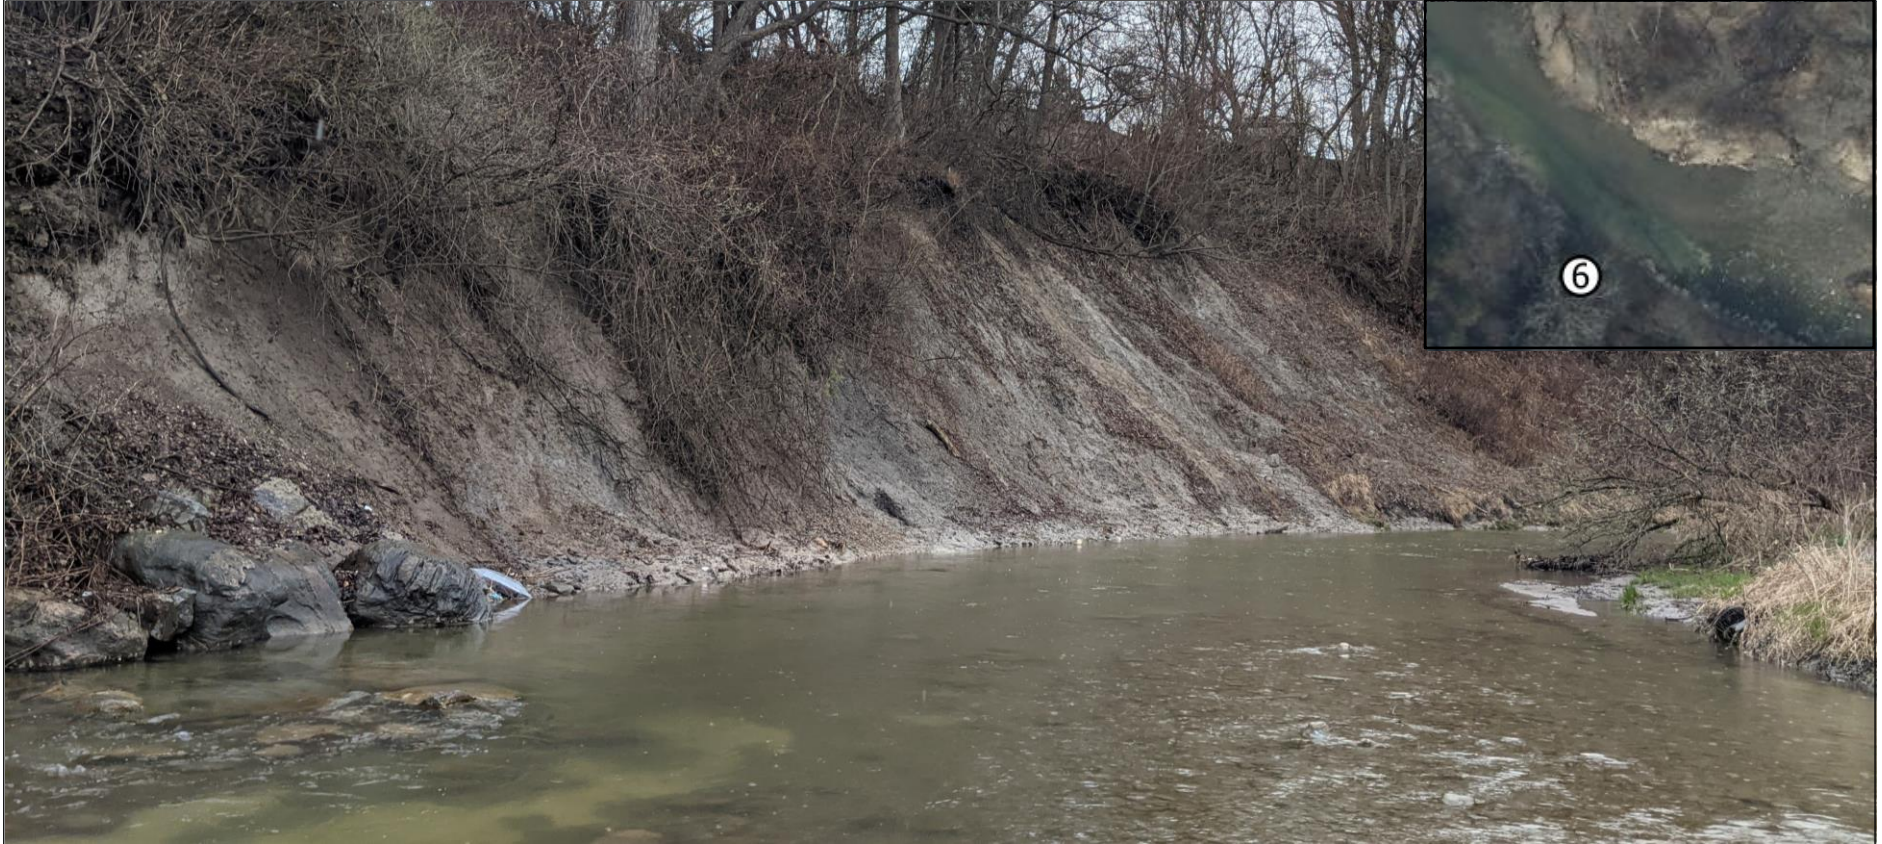
Description:
Erosion along the outer bank of a broad meander in contact with the valley wall has initiated and maintained slope instability. A point bar exhibiting a scroll pattern has developed along the inner bank, a testament to the history of lateral and down-valley migration of the meander apex. Private property is approximately coincident with the crest of the valley wall, which comprises till locally capped by glaciolacustrine sand. A dwelling and outbuilding is set 10 m back from the crest of the valley wall and is at risk if recession of the valley wall were to continue. Flow: top to bottom.

Site 6	Feature at Risk:	Distance to Feature	Condition of Bank and/or Existing Erosion Protection:	Mechanism(s) of Failure:	Risk	Recommended Action(s):
	Property at edge of adjacent tableland	10 m	Approximately 18 m high, 150 m long erosion scar along lower valley wall	Repeated fluvial scour and mass movements	High	Design and implement measures to protect valley wall from continued fluvial interaction

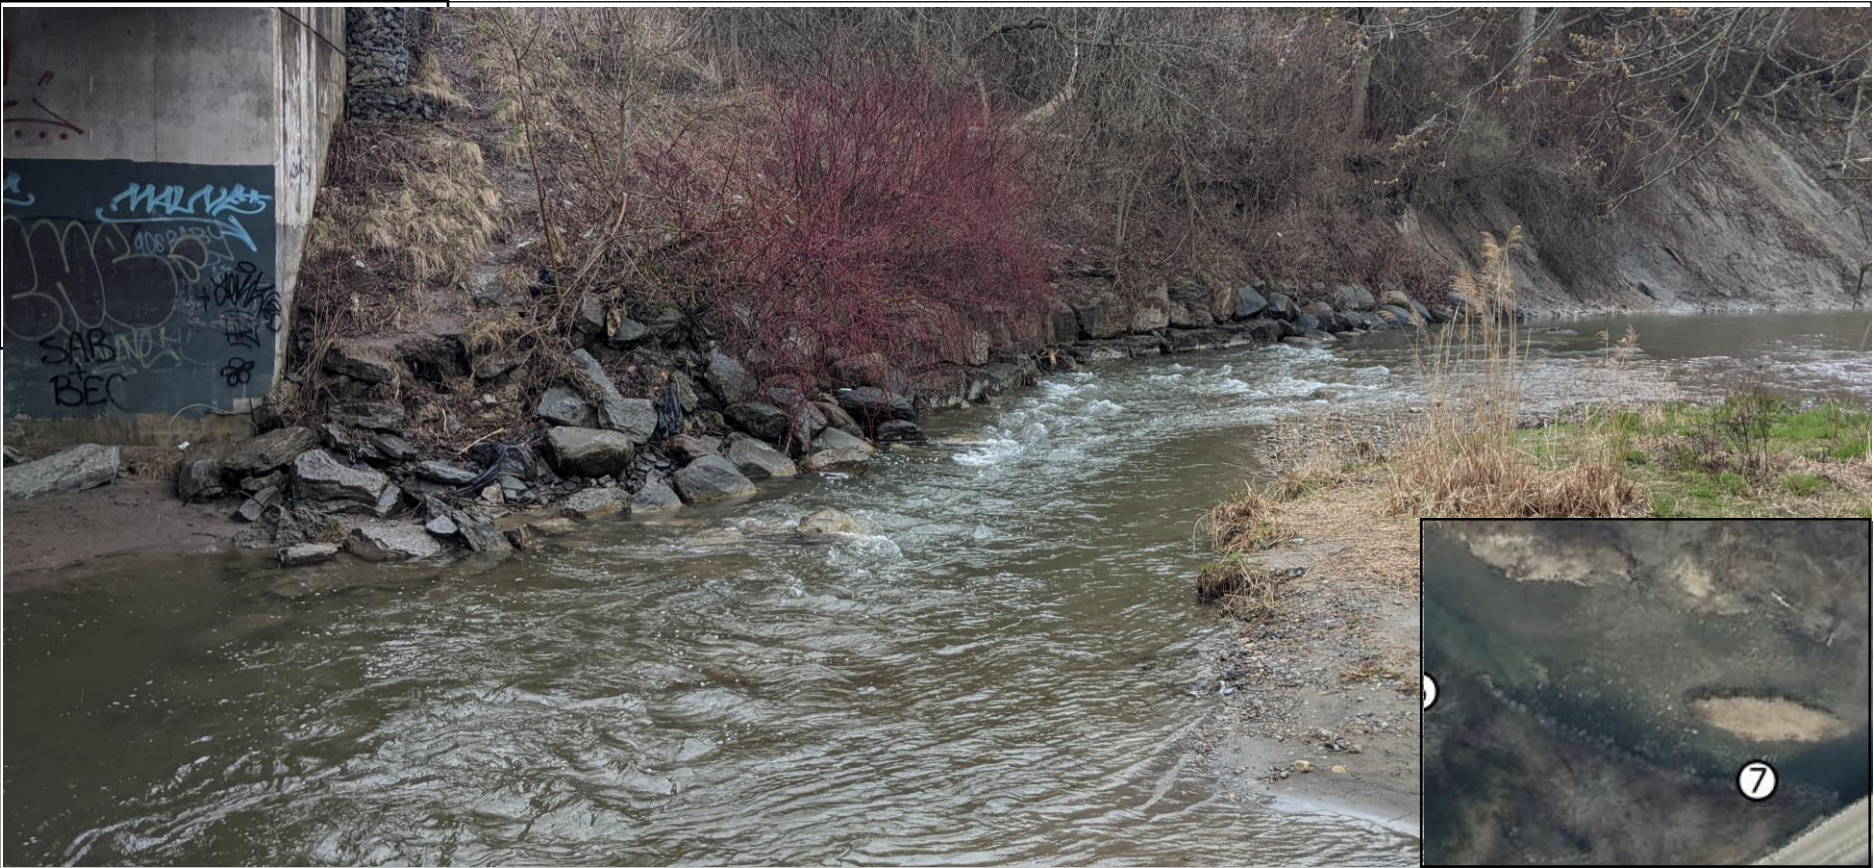
Description:
Boulder riprap and armourstone revetments installed along the right bank immediately upstream of the Thomas Street bridge protect the bridge footings. A medial bar locally concentrates flow along the right bank, which could eventually undermine or outflank the revetments and pose a risk to the bridge footings. Given the relative stability of the channel planform and the bank revetments in past years to decades, risk is currently considered low. Flow: right to left.

Site 7	Feature at Risk:	Distance to Feature	Condition of Bank and/or Existing Erosion Protection:	Mechanism(s) of Failure:	Risk	Recommended Action(s):
	Western bridge footing	0 m (contact)	Functional	Outflanking and/or undermining	Low	Do Nothing – continue to monitor
