Fluvial Geomorphological Assessment of Oshawa Creek and Evaluation of Erosion Mitigation Strategies at Prioritized Sites

Thomas Street to Wentworth Street West

City of Oshawa

October 8, 2021

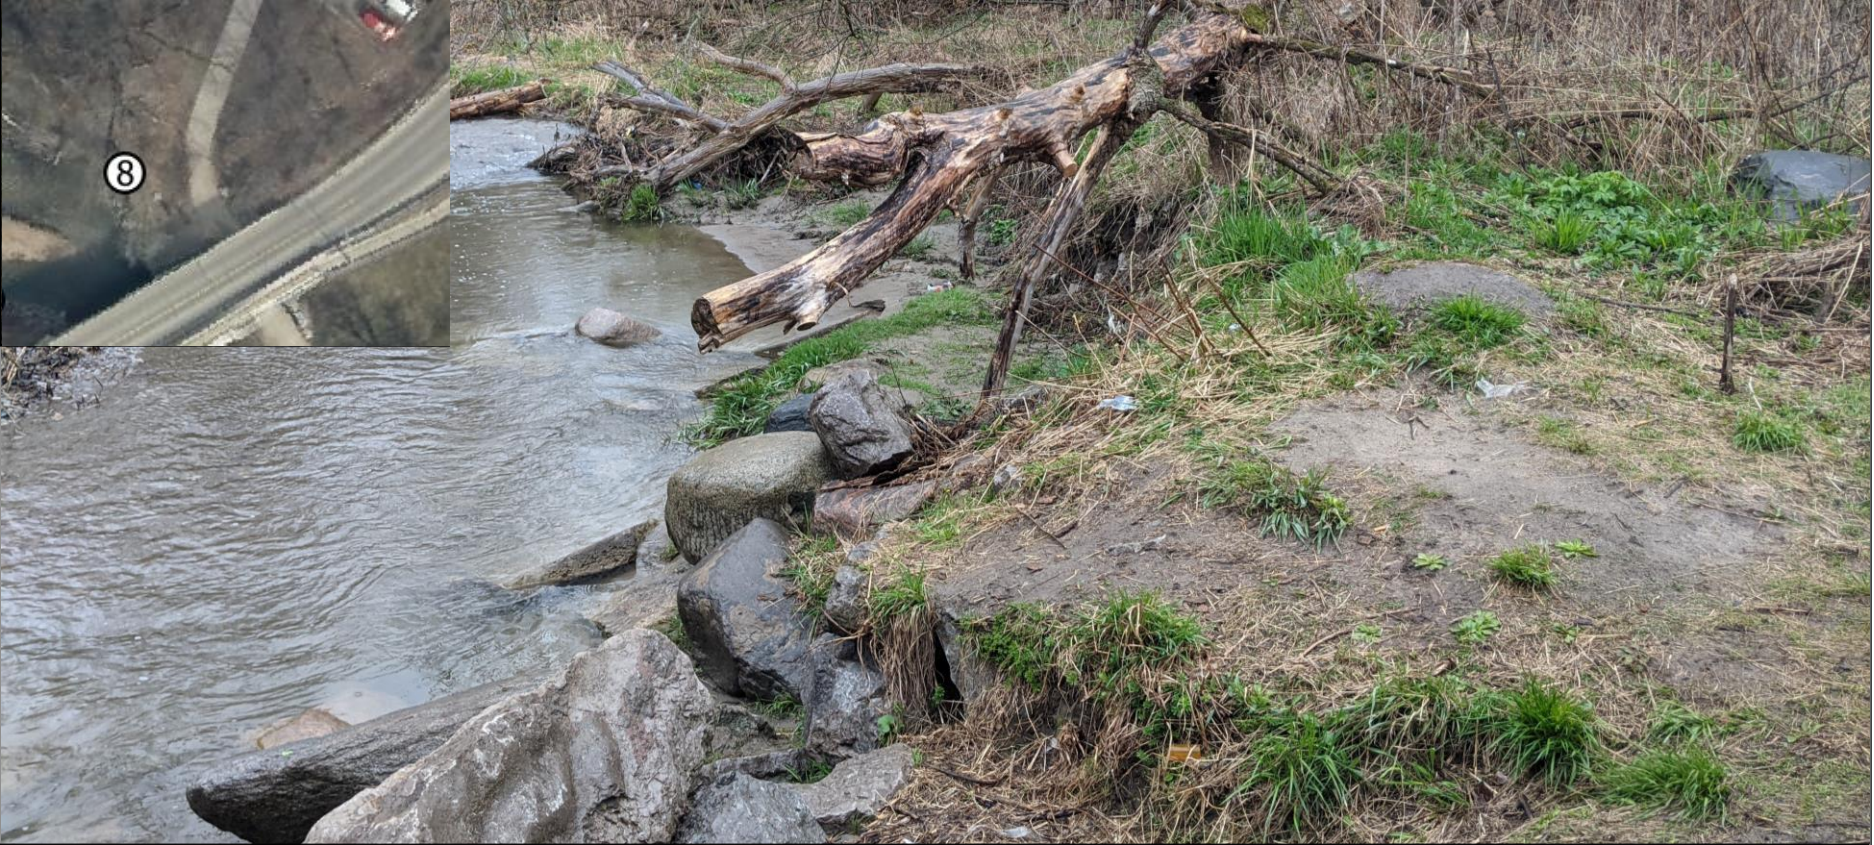
Description:
Boulder riprap revetments installed along the left bank immediately upstream of the Thomas Street bridge protect the bridge footings. A medial bar locally concentrates flow along the left bank, which could eventually undermine or outflank the revetment and pose a risk to the adjacent Joseph Kolodzie Oshawa Creek Bike Path and eastern bridge footing. Additionally, concentration of surface runoff from the parking lot northwest of the creek winnows fine material from behind the revetments and forms small collapse areas. Flow: top to bottom.

Site 8	Feature at Risk:	Distance to Feature	Condition of Bank and/or Existing Erosion Protection:	Mechanism(s) of Failure:	Risk	Recommended Action(s):
	Joseph Kolodzie Bike Path and bridge footing	0 m (contact)	Functional	Outflanking and/or undermining	Moderate	Design and implement measures to protect trail and bridge abutment (based on assumed works to be completed at Site 6)
