# Preliminary Design and Municipal Class Environmental Assessment Schedule B Report

## Harmony Creek Sites 2 & 3

Palmer Project # 1510208

**Prepared For** City of Oshawa

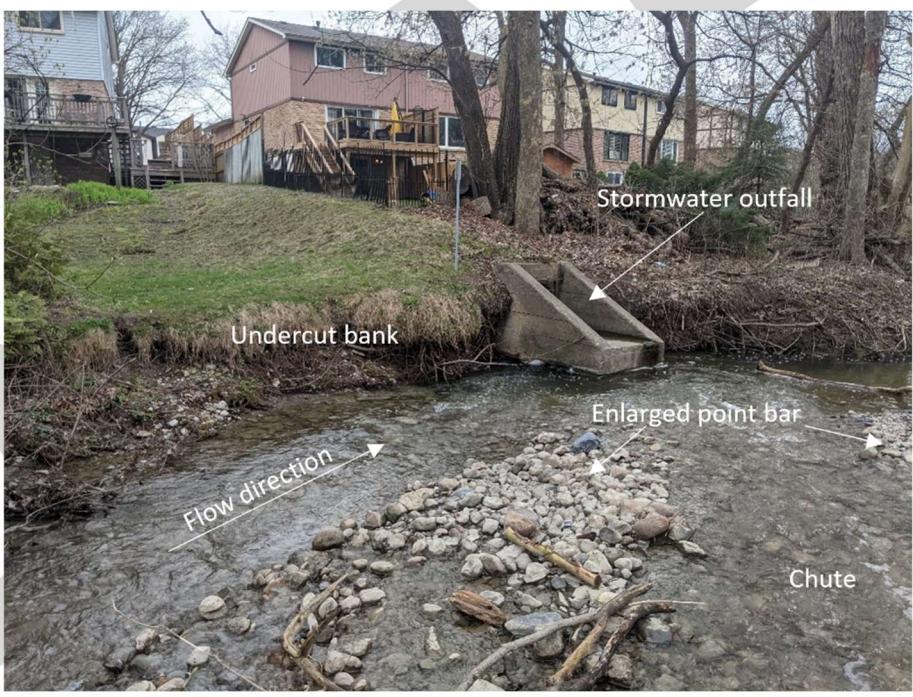
Photo 1. Undercutting and collapse of the outer (east) bank of a meander is beginning to outflank the stormwater outfall adjacent to private property (608 and 612 Camelot Drive) at Site 2. Note large bar in foreground. Flow: left to right.

Site 2 encompasses the unprotected outer bank of a slight channel bend that is adjacent to private property and interrupted by a stormwater outfall. Site 2 is located 100 m downstream of the confluence of Harmony Creek and the upstream tributary (**Figure 1**). An oversized point bar exists along the western (inner) bank just upstream of the outfall, likely formed as a result of a large flood event between 2012 and 2013. Although some water flows through a chute that has formed within the point bar, most is deflected towards the eastern (outer) bank at the outfall (**Figure 5**). The modification to channel hydraulics as a result of this bar form promotes erosion of the eastern bank at Site 2. This erosion is observed in the undercutting and bank collapse occurring just upstream of the stormwater outfall (**Photo 1**). The crest of the outer bank is on municipal land adjacent to private property (608 and 612 Camelot Drive) along the entire bend. Continued undercutting of the eastern bank is eventually expected to erode private property. Outer bank erosion (occurring at a rate of approximately 0.16 m per year since 2012, just before the formation of the point bar) has begun to outflank the stormwater outfall (**Photo 1**, **Photo 3**). A deep scour pool has also formed at the stormwater outfall, resulting in pronounced cross sectional asymmetry (**Figure 6**). The outfall now projects approximately 1.5 m into the thalweg and is at risk of being undermined.

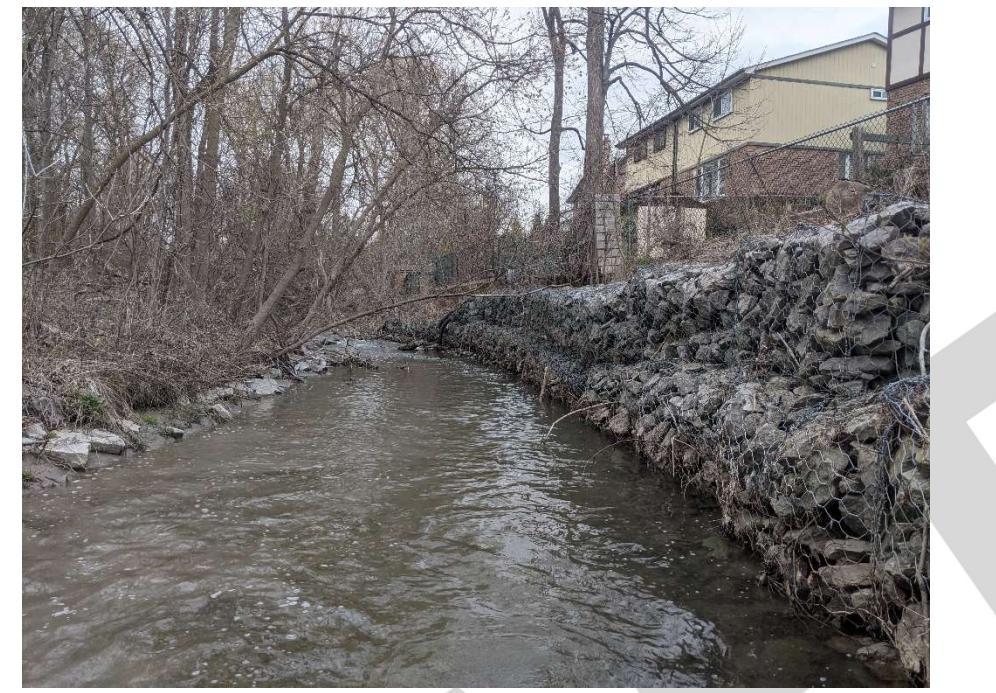
Photo 2. A meander coincident with the toe of the gentle eastern valley wall adjacent to private property (596 to 590 Camelot Drive) at Site 3. Upstream view.

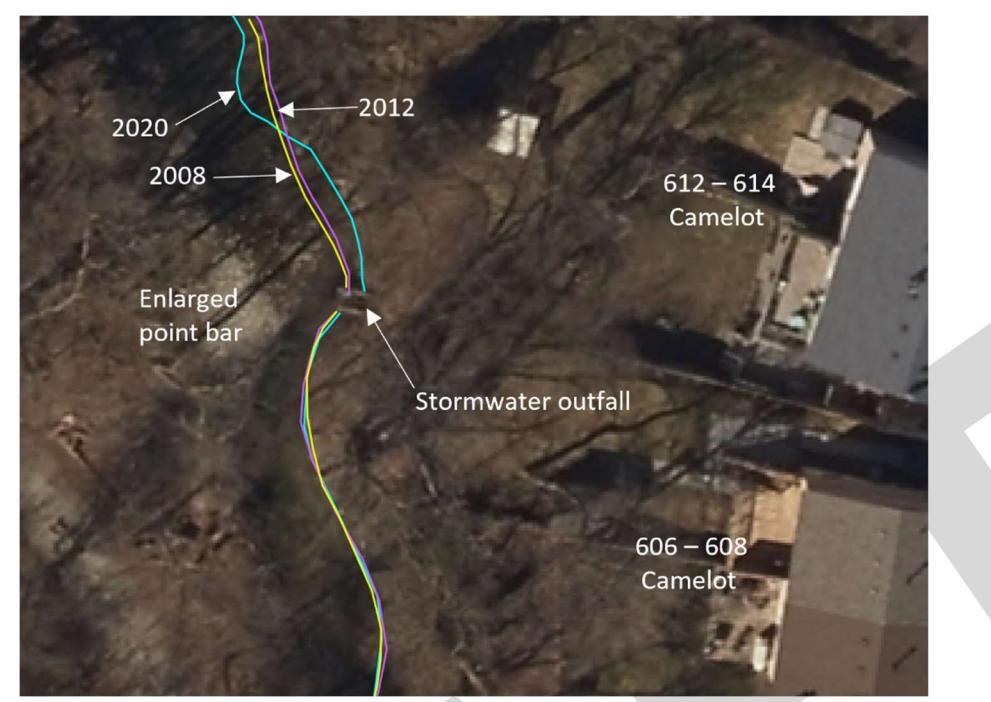
Photo 3. Photo highlights the position of the left bank around Site 2 in 2008, 2012, and 2020. A large flood event between 2012 and 2013 appears to have formed an enlarged point bar upstream of the stormwater outfall, which concentrates erosive energy along the eastern bank and has initiated outflanking of the stormwater outfall. Flow: top to bottom. Photo location not shown in Figure 3.

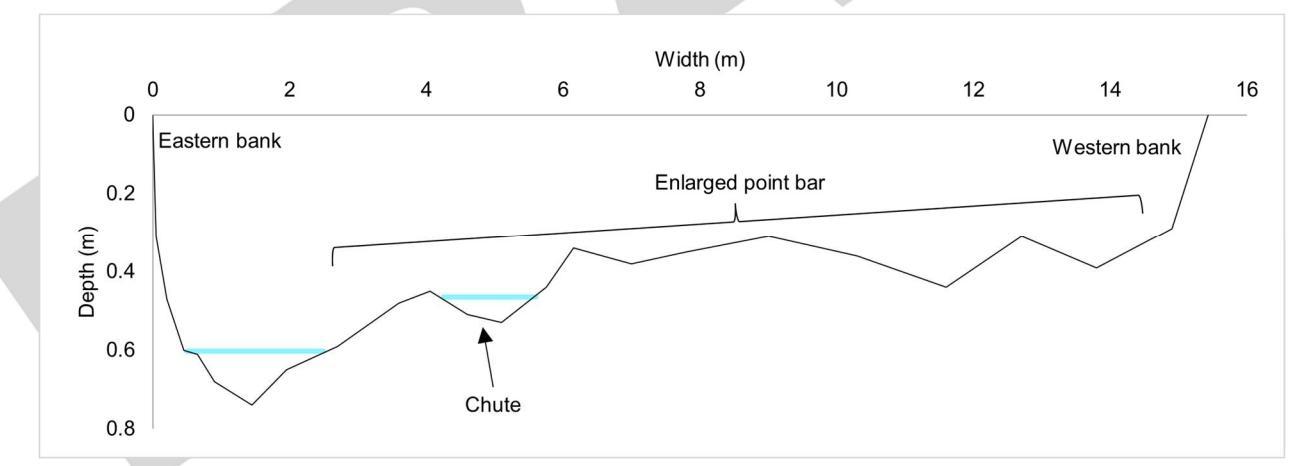
*Figure 5.* An enlarged point bar just upstream of the stormwater outfall concentrates flow along the left (eastern) bank. Downstream view.

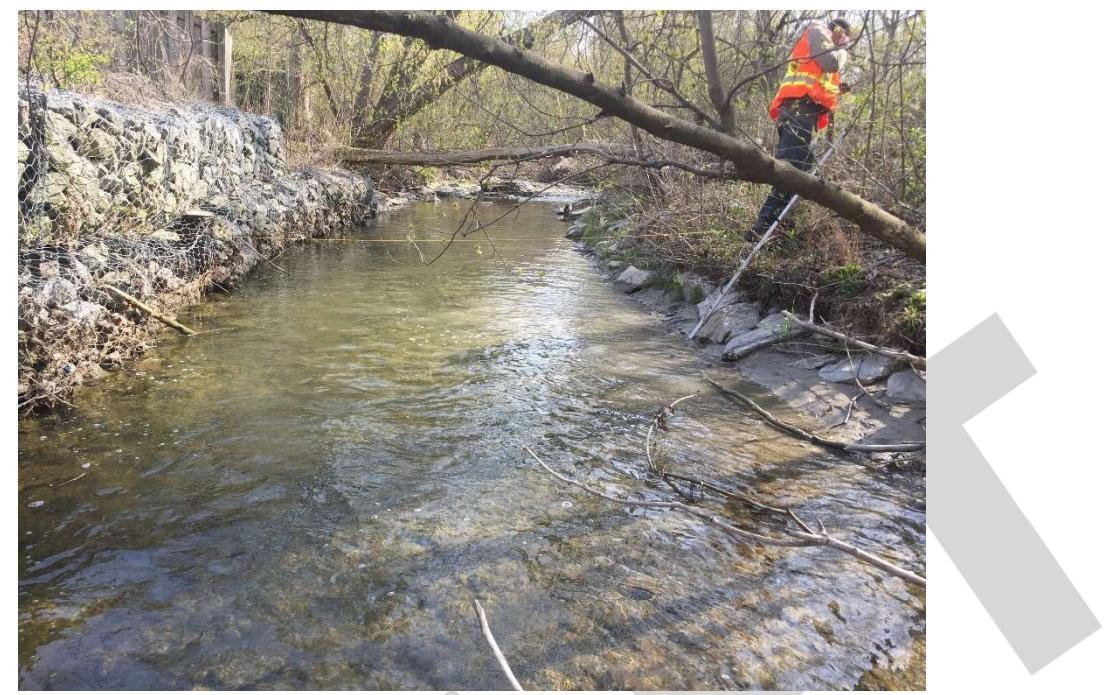
Site 3 starts approximately 75 m downstream of Site 2 and encompasses the eastern (outer) bank of a 30 m-long, broad meander reinforced by a two-tiered gabion wall (**Photo 4**). Private property limits are coincident with the eastern bank. The meander geometry along this section maintains the position of the thalweg along the eastern bank, concentrating erosion along the gabion wall (**Figure 7**). The smooth and hardened bank also concentrates erosive energy along the bed, promoting scour and undermining of the gabion wall. The stone has dropped out of some of the constituent gabion baskets with deteriorated wire cages and limited underlying support (**Photo 5**). Though the gabion wall has historically maintained channel planform, private property adjacent to the outer bank is at risk if failure of the gabion wall continues.

Photo 4. Meander geometry at Site 3 concentrates erosive energy along the left (eastern) bank, along the base of the two-tiered gabion wall. Downstream view.

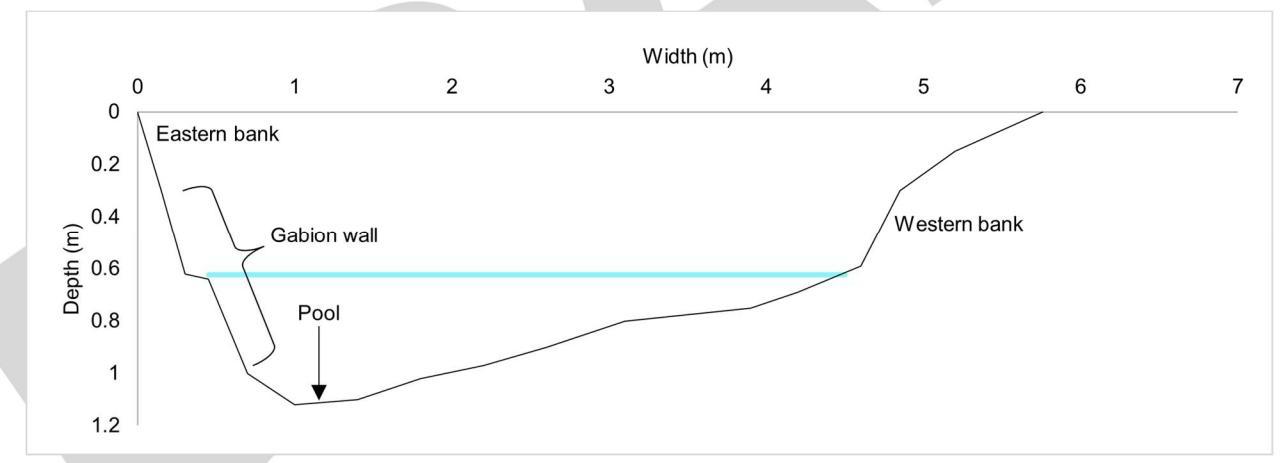
*Figure 7.* Cross section 3-1. Concentration of erosive energy along the gabion-protected left (eastern) bank has scoured a relatively deep pool. The gabion wall has begun to fail and is at risk of being undermined and collapsing into the channel. Downstream view.

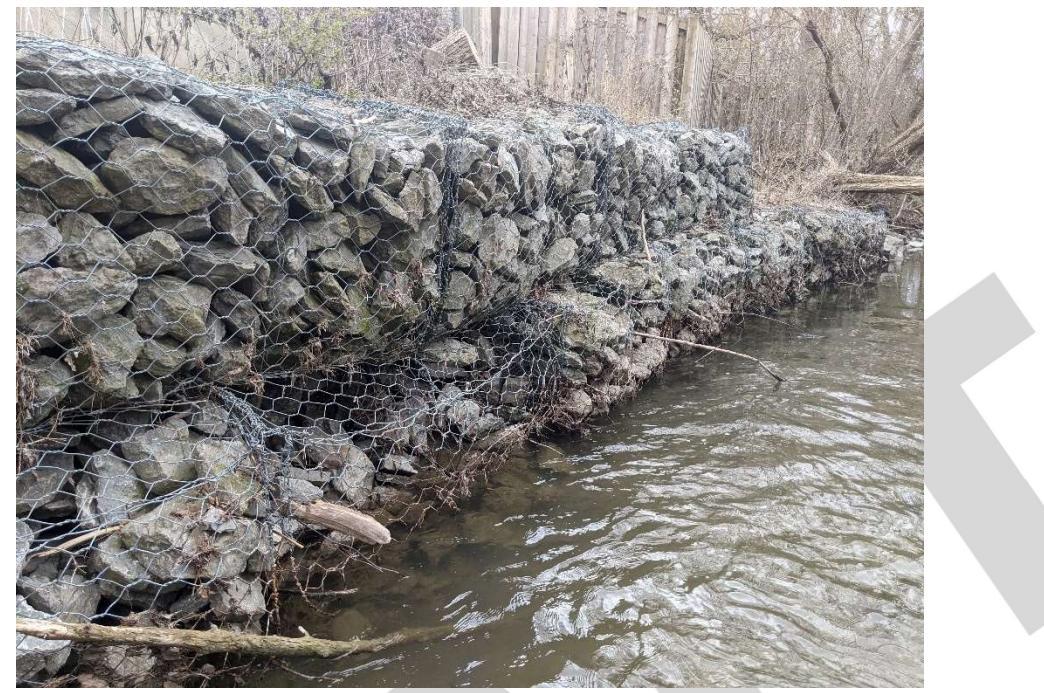
*Photo 5.* Concentration of erosive energy along the bed and subsequent channel deepening have undermined the gabion basket wall at 594 Camelot Drive, causing stone to drop out of those with deteriorated wire cages. Downstream view.

Without intervention, a 30 m-long section of private properties along Camelot Drive (addresses 596, 594 and 590) is at risk from erosion if an existing gabion basket wall continues to deteriorate and fail. A number of baskets have already released stone along the bottom tier. The upper tier has started to sag and lean into the channel. If the wall were to fall into the channel, flow would outflank the structure and scour unprotected banks, posing a risk to retaining walls and fences situated behind the gabions. The wall, although deteriorated along its entire length, still provides adequate erosion protection.

This concept involves the construction of a vegetated boulder revetment to replace the existing, deteriorated gabion basket wall protecting private properties along Camelot Drive (addresses 596 to 590). The revetment would be approximately 60 m long and extend further upstream and downstream of the existing gabion basket wall to minimize risk of outflanking. The revetment would be founded below the channel bed to accommodate anticipated scour. A grade control riffle would be constructed at the downstream extent to tie-in with existing channel and prevent upstream knickpoint migration. The failed gabion basket would be removed. A compensatory inner bank cut would offset the projection of the regraded bank into the channel. The proposed cut would result in a wider cross section to reduce shear stresses along the outer bank.

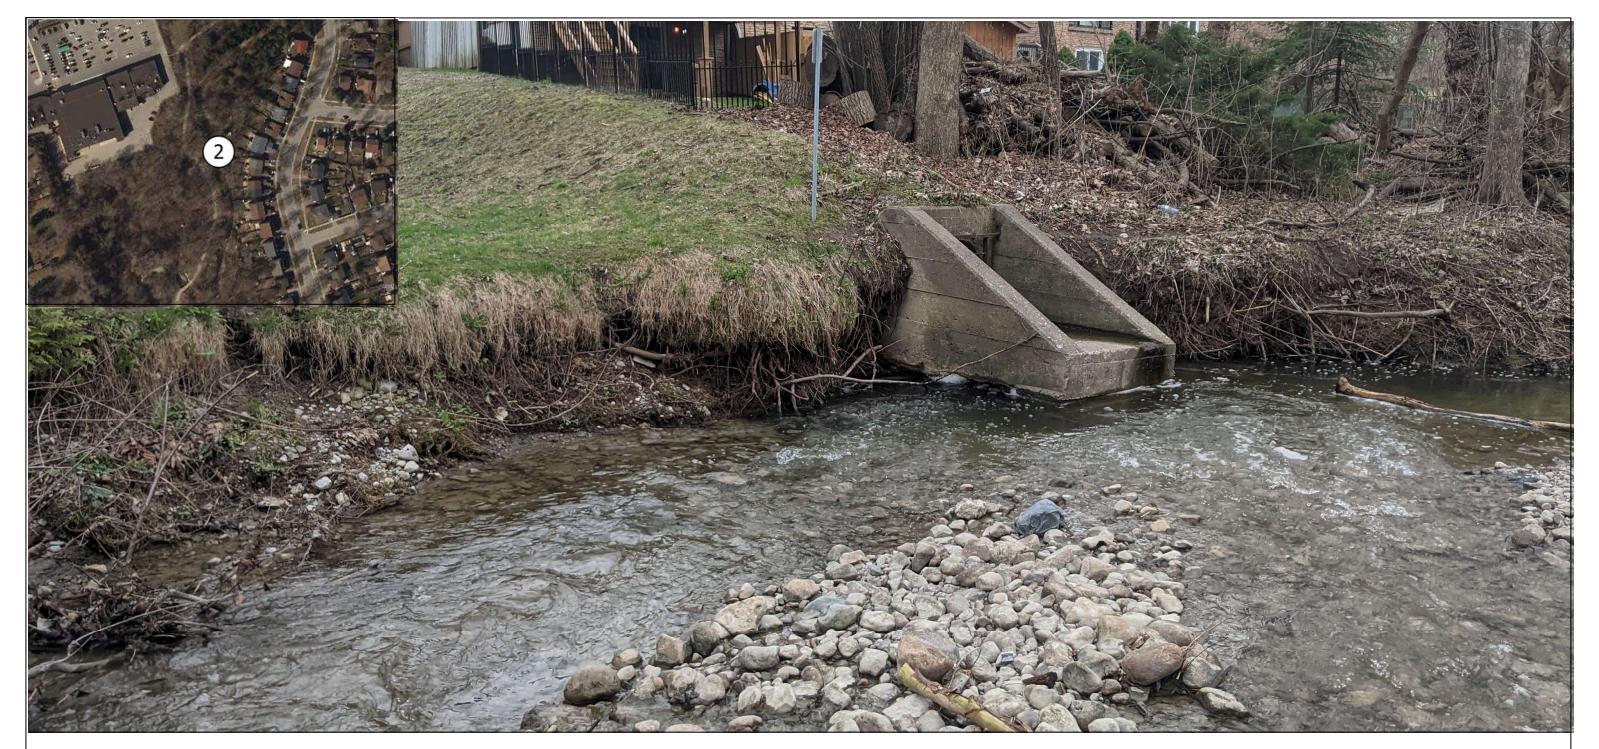
**Description:** Development of a large cobble point bar has deflected flow toward the stormwater outfall and exacerbating erosion along the outer bank. The outfall has begun being outflanked, at a rate of approximately 0.2 m per year since 2012, and now projects into the channel where it further disrupts flow. A deep pool has also formed at the stormwater outfall such that the outfall is perched above the bed. Flow: left to right.

Feature at Risk:	Distance to Feature	Condition of Bank and/or Existing Erosion Protection:	Mechanism(s) of Failure:	Risk	Recommended Action(s):
Site 2	Private property and stormwater outfall	0 m (contact)	Eroded, unprotected bank, outflanked stormwater outfall	Outflanking, undermining	High	Design and implement erosion mitigation measures to mitigate risk to outfall
			A La X			
		SA
