Preliminary Design and Municipal Class Environmental Assessment Schedule A+ Report

Oshawa Creek Site 6 & 8

Palmer Project # 1510207

June 15, 2022

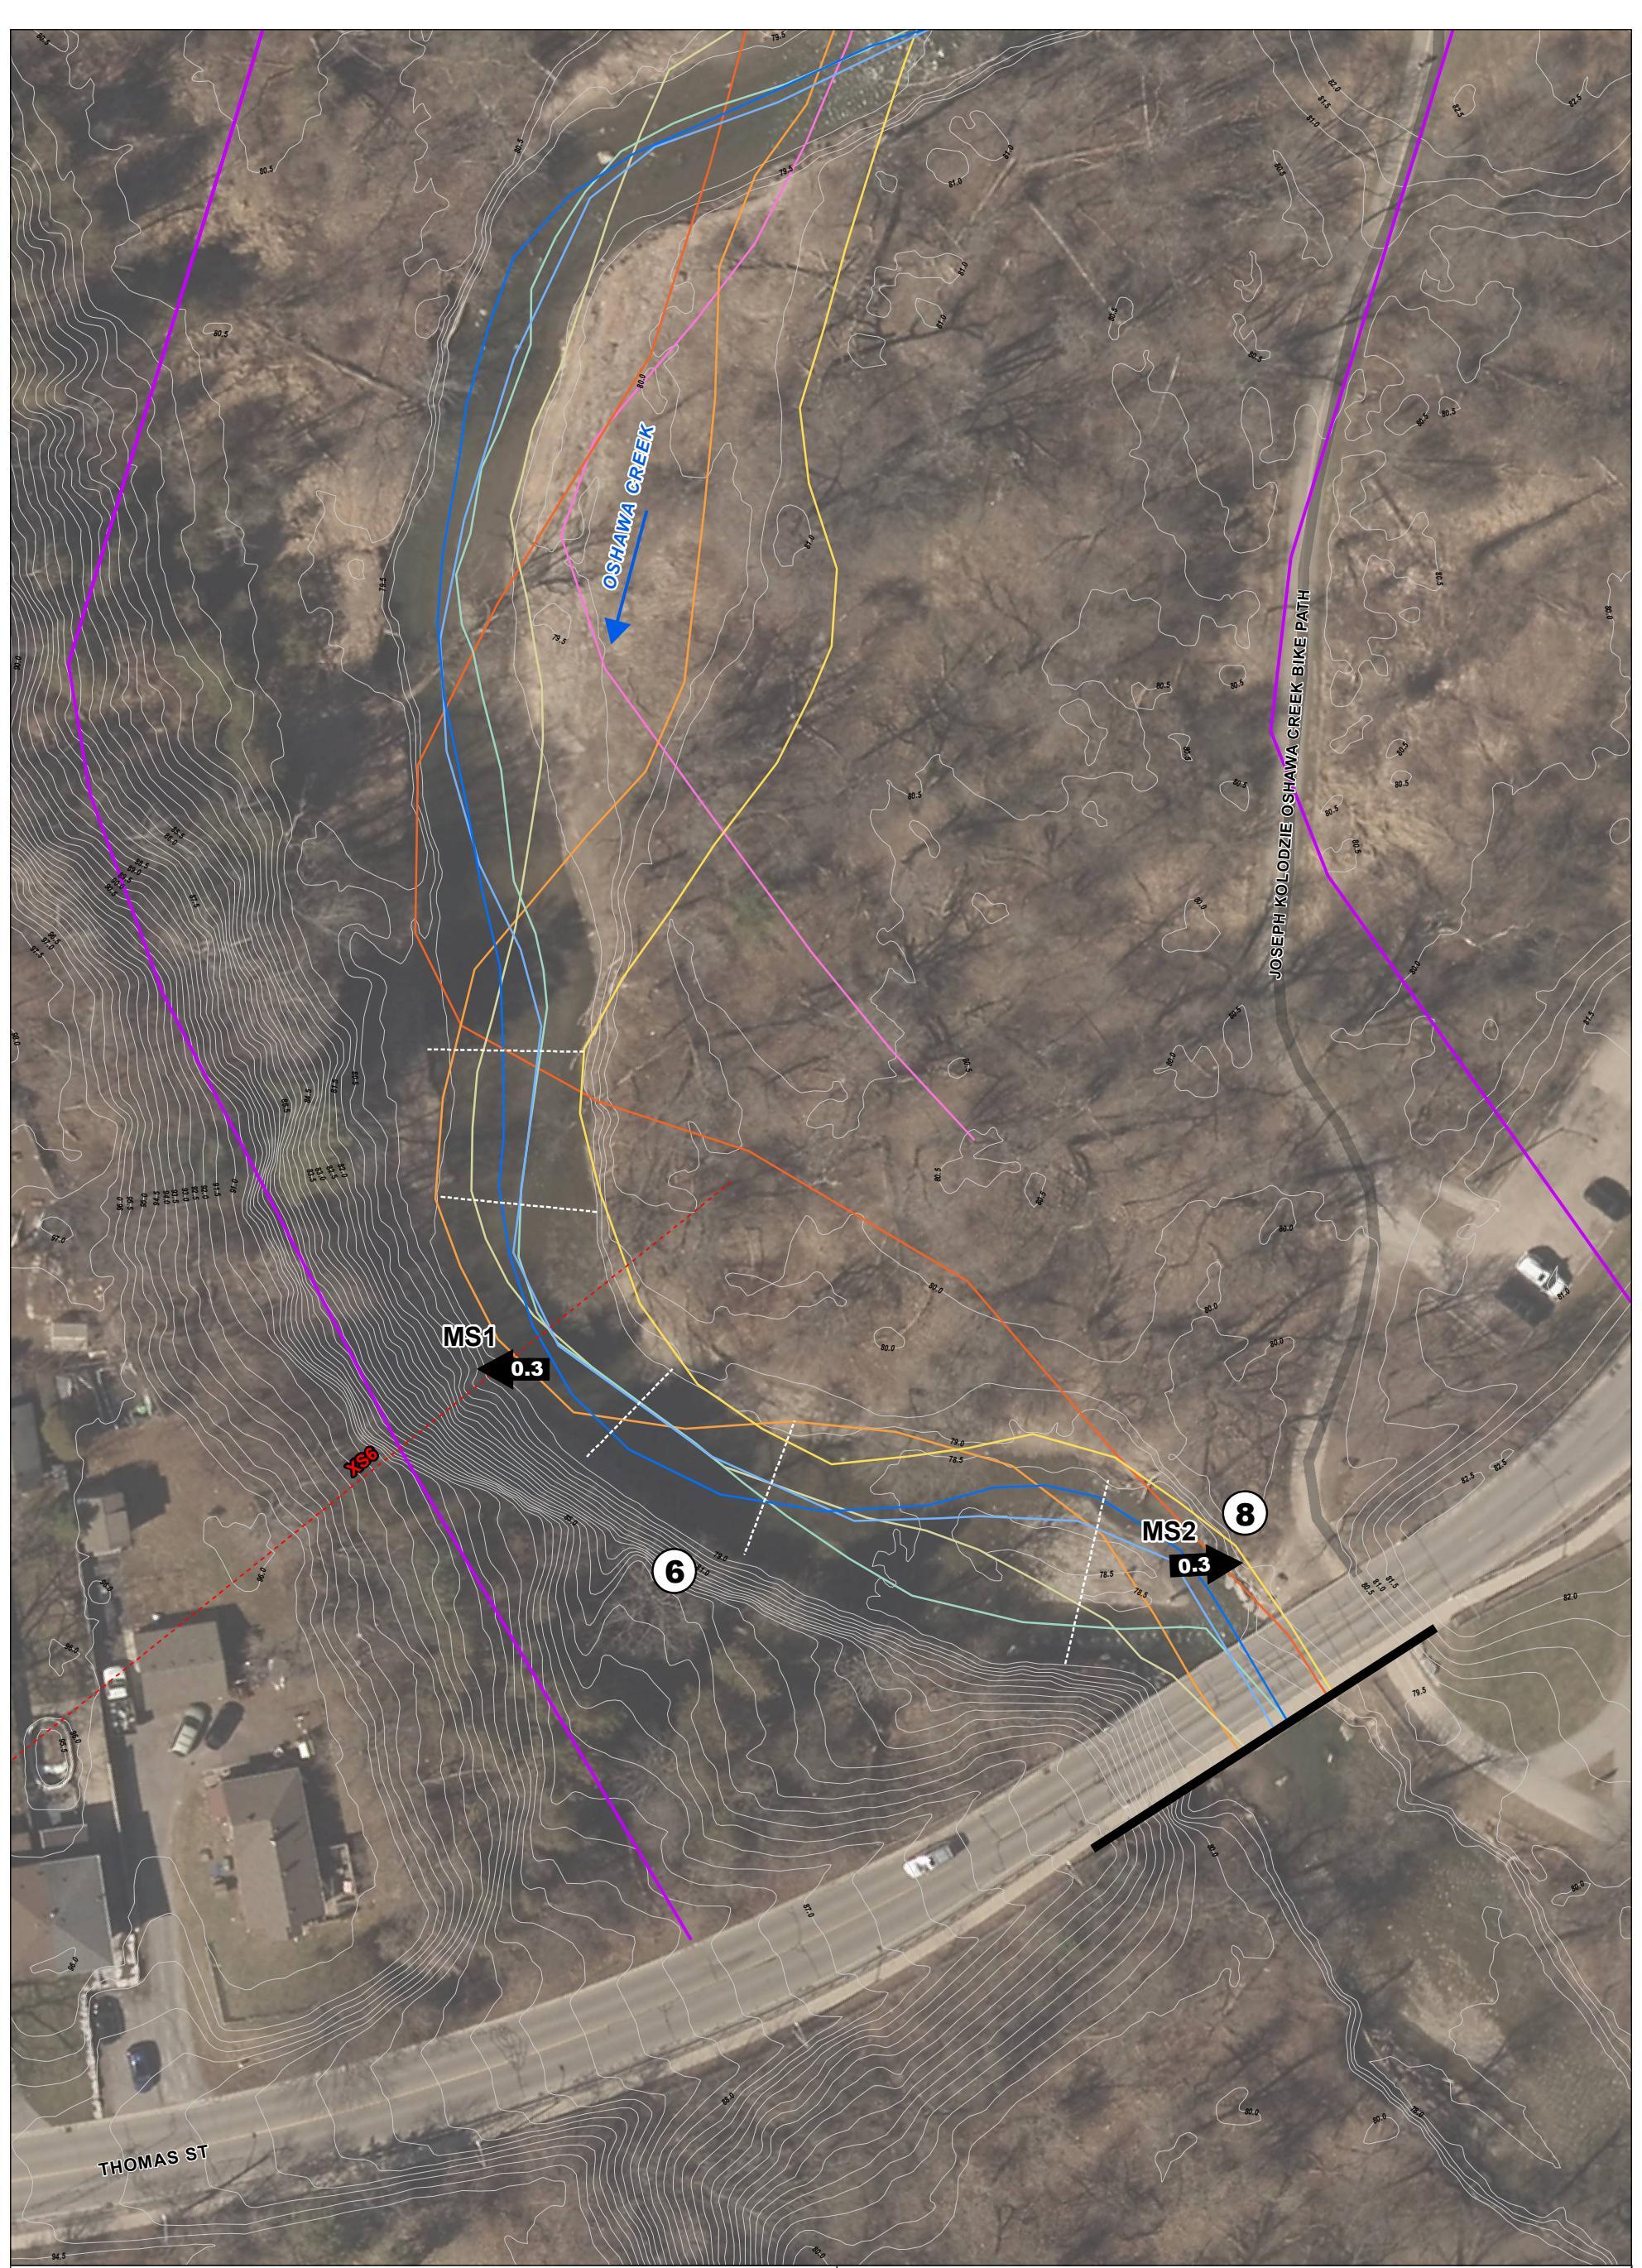
Historic Changes and Meander Belt

Between 2005 and 2010, the outer bank of Oshawa Creek, just upstream of the Thomas Street crossing and pedestrian crossing, was reinforced with boulder and armourstone revetments to prevent lateral erosion and subsequent outflanking of bridge footings.

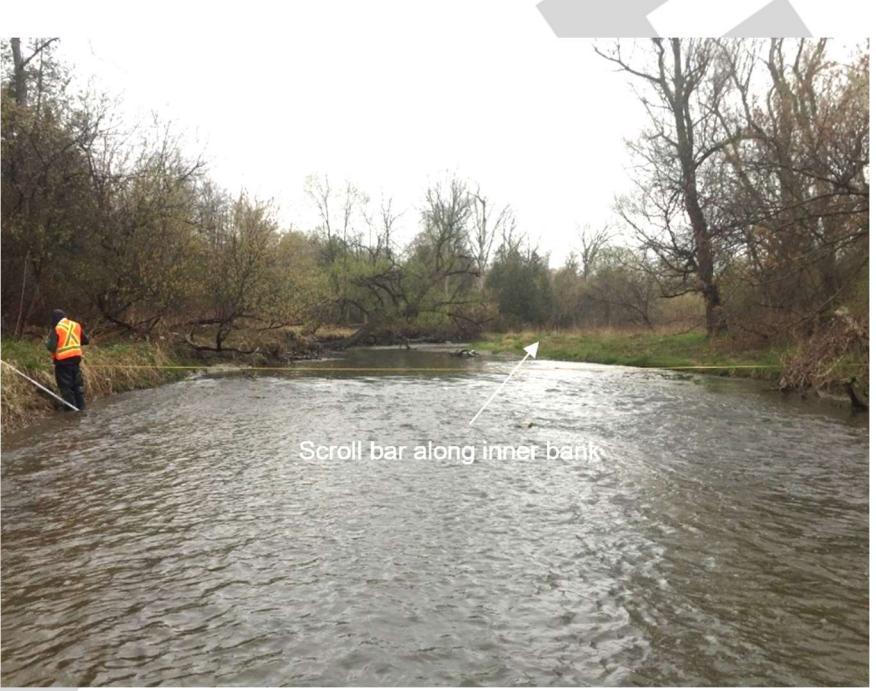
Photo 1.

Upstream view of channel approaching Site 6. A low, gentle eastern bank maintains good floodplain connectivity and helps attenuate flood energy.

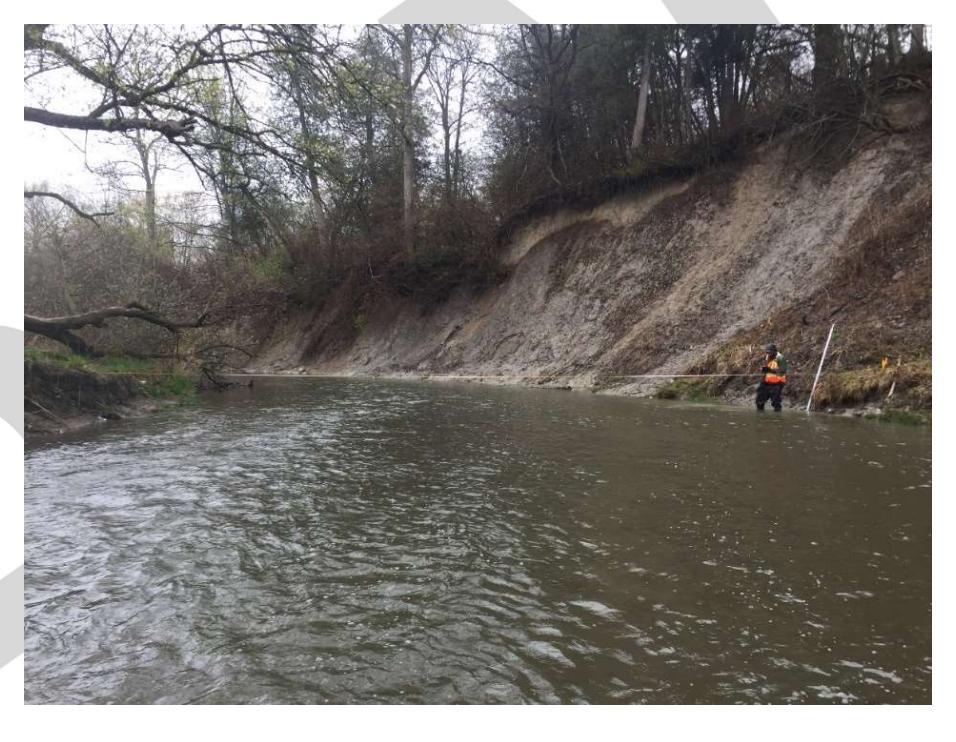
Site 6 is located along the outer bank of a meander in contact with the western valley wall of Oshawa Creek (Figure 1). Channel contact with the valley wall has lengthened from about 75 m to 150 m between 1927 and 2020. The base of the valley wall has receded at a rate of approximately 0.3 m/year through an ongoing cycle of fluvial scour, oversteepening, and repeated mass movements (Photo 2). The valley wall has been unable to self-stabilize due to the repeated entrainment of sloughed material that temporarily accumulates along its toe during floods. Valley wall erosion at Site 6 was noted as a "high priority" for "erosion control or bank stabilization works" in the City's Oshawa Creek Watershed Master Drainage (Totten Sims Hubicki Associates, 1995) (Figure 5). LiDAR data acquired in 2019 indicates the eroded valley wall is approximately 39° steep along its unvegetated, eroded face, although only 23° steep along its forested upper slope (Figure 6). Groundwater seepage, emerging part way down the erosion scar, may also be contributing to instability. The crest of the valley wall is approximately coincident with the edge of private property, with a dwelling and outbuildings setback approximately 10 m on adjacent tableland. Private property is located within the stable slope allowance (3H:1V, as defined by MNR, 2002) plus the toe erosion allowance (6 m, based on dense till exposed along the slope toe and MNR (2002). Continued slope recession and subsequent oversteepening of the valley wall may encroach into the tableland, toward 204 Thomas Street, until toe erosion is mitigated, or a stable slope is achieved. An overview of the erosion hazards and associated risks at Site 6 are provided in Appendix A.

Photo 2. An actively eroding scarp, approximately 100 m long and up to 17 m high, along the western valley wall at Site 6. Downstream view.

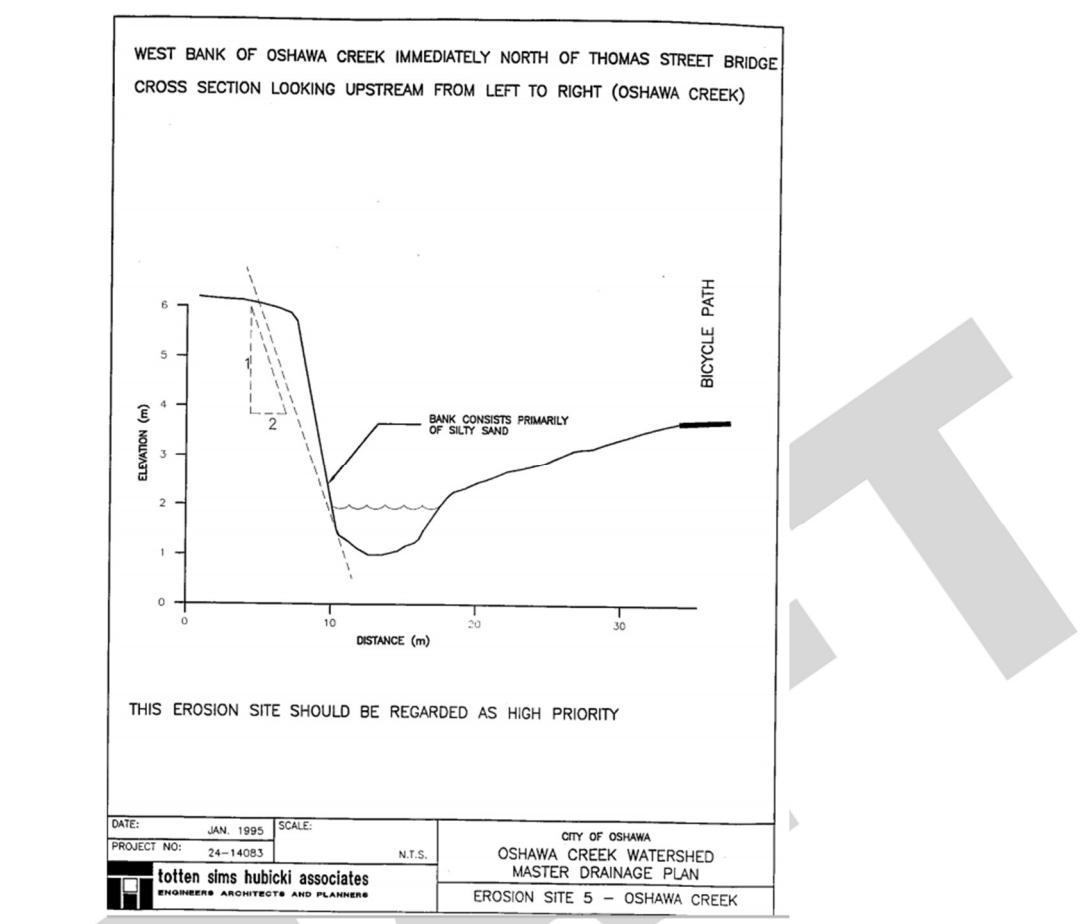
Figure 5. Upstream view of cross-section used by Totten Sims Hubicki Associates to identify the erosion hazard at Site 6 in 1995.

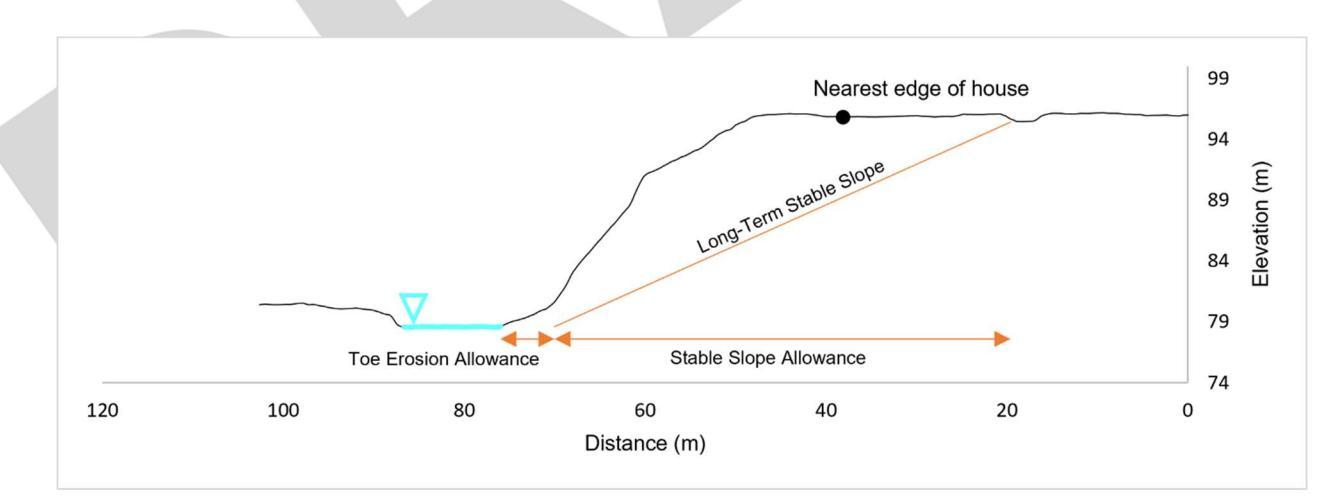
Figure 6. Downstream view of LiDAR-derived cross-section of west side of valley at Site 6, showing the toe erosion allowance (6 m) and the stable slope allowance (51 m) projected into tableland with private residences.

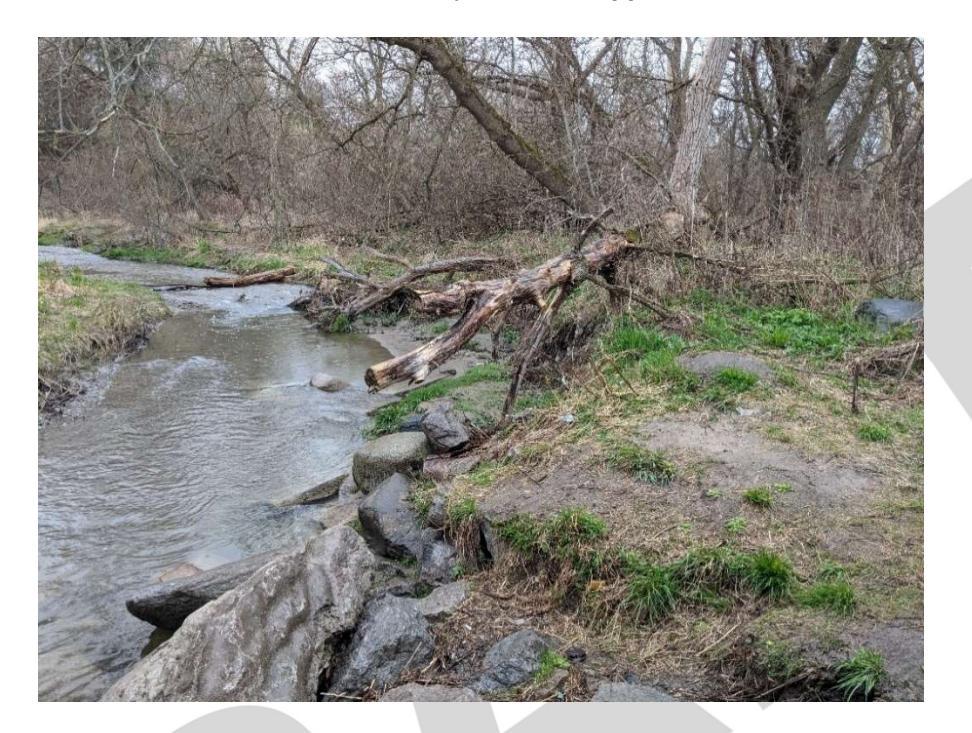
Channel planform adjustment upstream of Thomas Street bridge (Site 8) has started to erode the upstream extent of the left bank boulder revetment protecting the bridge footing and Bike Path (**Photo 3**).

Overtopping flood flows have also resulted in the outflanking and winnowing of fines underlying and behind the boulder revetment. Surface runoff along the Bike Path, from the parking lot, cascades over the boulder revetment into the creek, and acts as a secondary erosion mechanism. An overview of the erosion hazards and associated risks at Site 8 are provided in **Appendix A**.

Photo 3. Riprap bank revetment at Site 8 that protects the Bike Path and left abutment of the Thomas Street bridge. Upstream view.

scour. A vegetated boulder revetment is proposed to replace an existing and deteriorated boulder revetment that extends approximately 20 m from the eastern footing of the Thomas Street bridge. Existing boulders would be reused in the new structure. Secondary erosion from concentrated surface runoff from the adjacent trailhead parking lot and paved Bike Path would be intercepted by a slope drain integrated with the proposed boulder revetment.
