Heritage Research Report:

# 76 Elgin Street East City of Oshawa

Prepared for Heritage Oshawa

Melissa Cole, Heritage Consultant  
2/1/2013

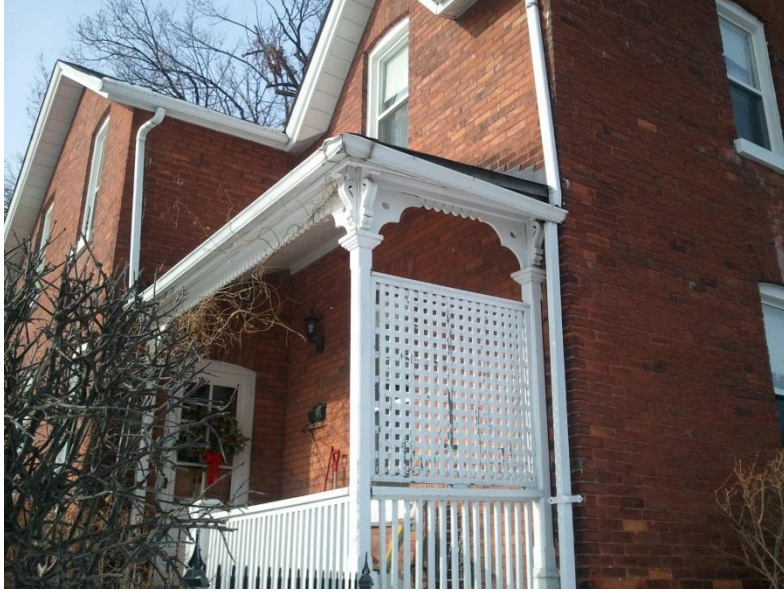
Porch, South Façade, 76 Elgin Street East, January 2013

The main doorcase features a single leaf wooden storm door with a six-paned fixed window opening and arched overhead. A door opening of similar style is located in the north side of dwelling facing east onto Mary Street. The wooden interior door that is covered by the storm door is original to the home and features a beautiful stain glass window pane and the original door bell.

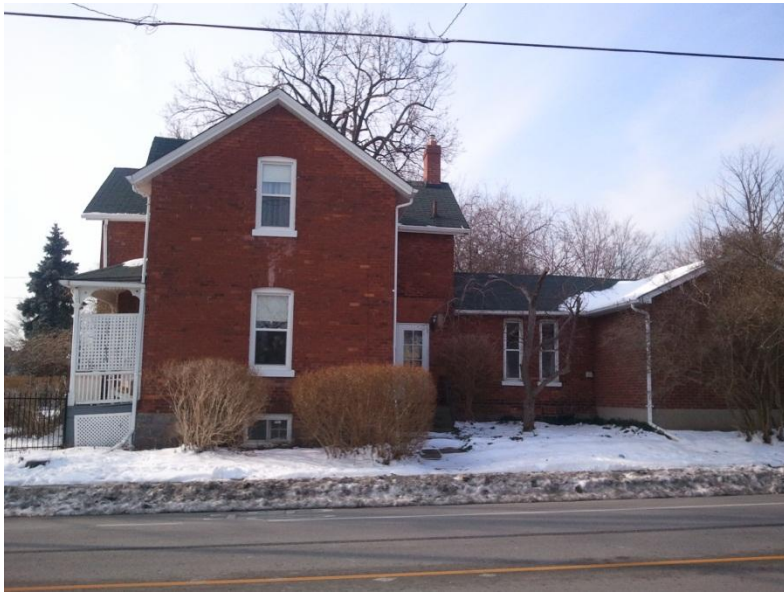
East Façade showing additions on the north facade, 76 Elgin Street East, January 2013

There are two additions that have been added onto the north façade of the original dwelling. The first addition was added shortly after the house was built as it appears on the 1911 fire insurance map. This is a one storey addition that currently contains the kitchen. Once inside you can see what used to be the exterior brick wall is now the south wall in the current kitchen. What was once a window opening on the north façade of the home is now a built in shelf. One- storey extensions or tails to main dwellings were usually standard as kitchen wings.

The second addition was added by the current owners, it is a one-storey addition with a cement foundation that has a full basement. The addition was added in the 1970's. The cladding on the additions is sympathetic in design by keeping with the original use of red brick.
