## Research Report

2651 Harmony Road North  
Oshawa, ON

Prepared for Heritage Oshawa  
Melissa Cole, Local Heritage Consultant  
August 2018

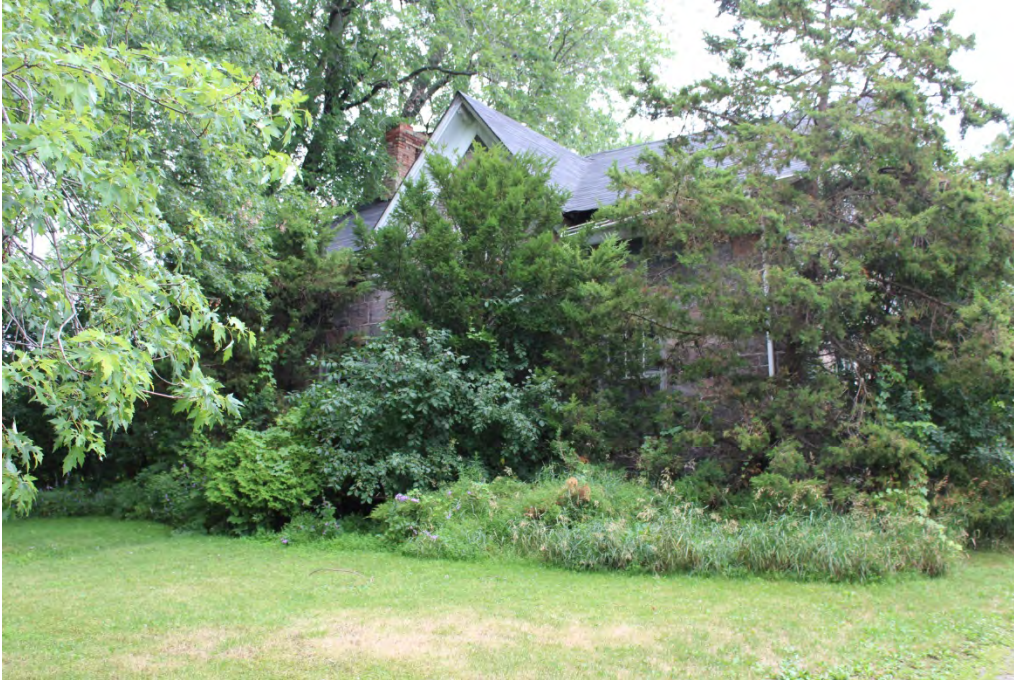
1. 2651 Harmony Road North, Front Façade, West/South Elevation. See historical photographs for an image of the front façade without the vegetation.

This is a 1½ storey, stone dwelling with a steep roof pierced by a 1 chimneystack. This dwelling has a small centre-gable and simple verge boarding (barge boarding). There is an extension on the east façade and north façade. Unfortunately due to the overgrown vegetation surrounding the home, the extensions were difficult to view up close and do not appear in pictures.

The window openings are flat, simple sash windows with stone heads. The frames and lugsills appear to be made of wood. The existing sash has 6x6 panes. The windows are symmetrically placed on the ground level with segmented stone heads over the windows reflecting the vernacular style of the era. The west façade features a 6x6 pane window in the small centre-gable. The north and south façade feature 6x6 sash windows on the upper and lower storey. It appears that the windows and a few of the glass panes are original.

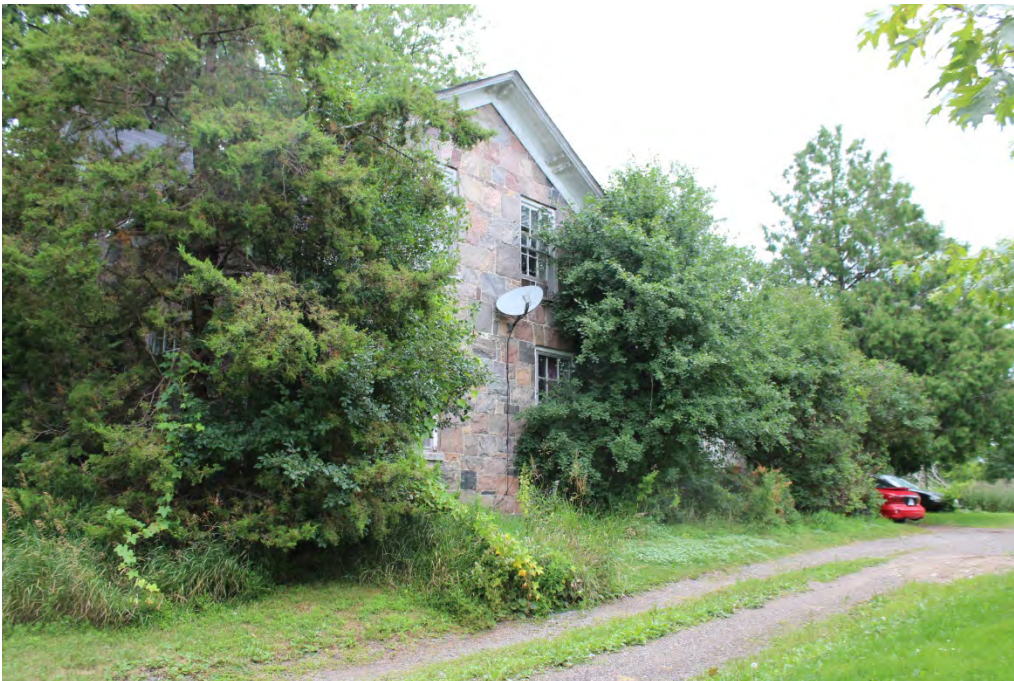
2. 2651 Harmony Road North, South Elevation

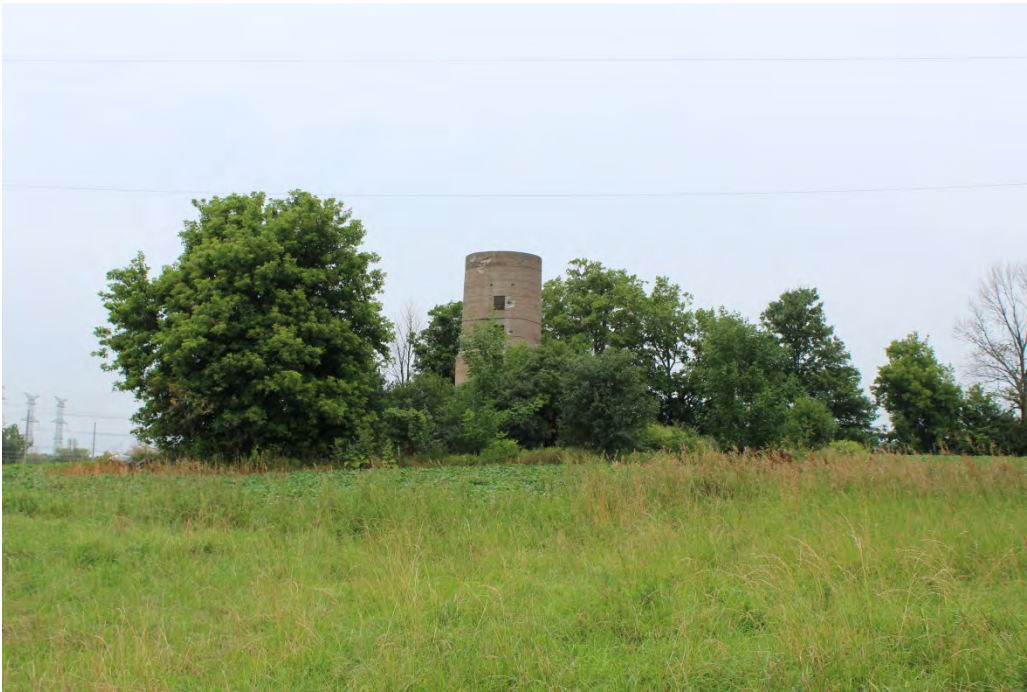
3. Silo on property, located north of the home.

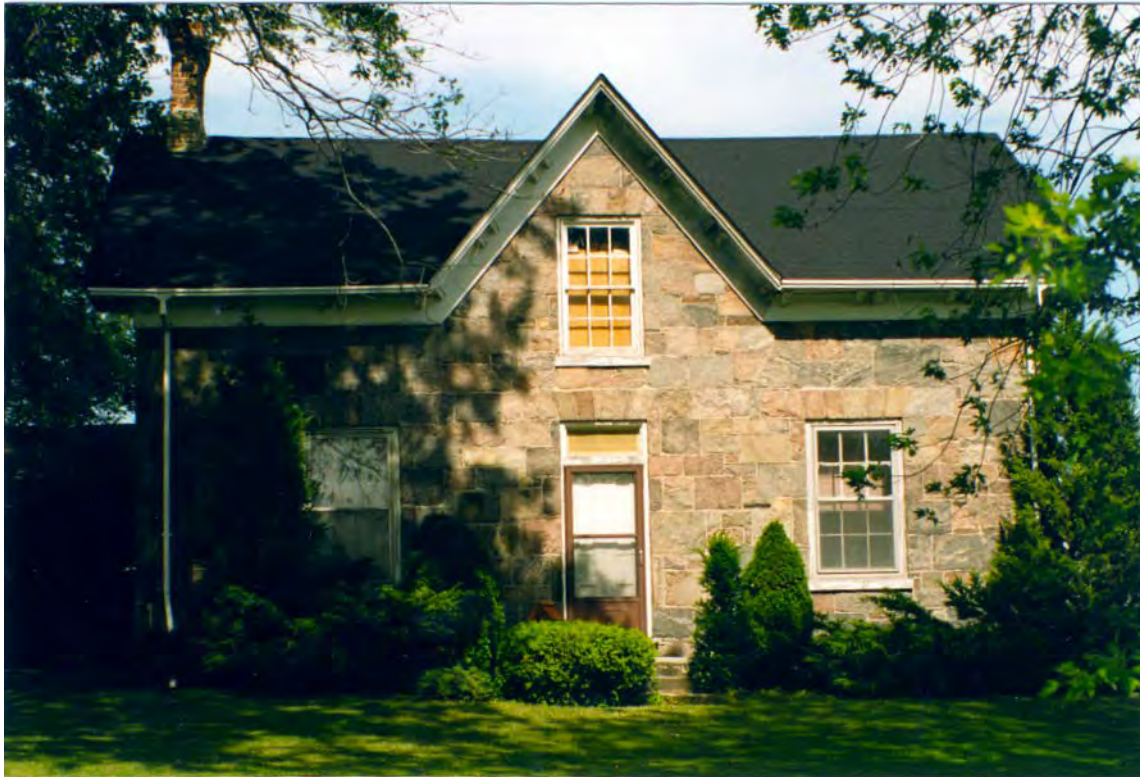
1. 2651 Harmony Road North, West Façade, *Heritage Oshawa Collection, Oshawa Museum. May 1998.*
