Research Report

Biltmore Theatre
39 King Street East
City Of Oshawa

Prepared by:
M. Cole, Local Heritage Consultant

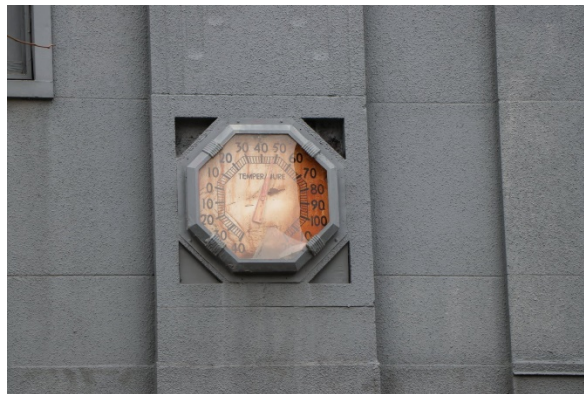
Figure 4 – Biltmore Theatre, Exterior Thermometer, Photo Robert T. Bell, April 2021.

Designed by Toronto Architects Wilbur Ralph Webb, Alex Blythe, and Wallace C. Sproule, the Biltmore Theatre was a model of modernity and sophistication when it opened in 1940. This classic Art Deco theatre was solidly built, with a steel frame, the exterior clad in brick that has been painted, the main street facing upper façade featured a smooth cut stone finish and brick on the other facades. Within the upper façade are recessed narrow windows featuring black metal linear horizontal decorations. A thermometer, located on the exterior of the building, is original and still in place. Originally there was a clock parapet that was located above the thermometer at the roofline.

The exterior treatment of the lower portion of the front facade has been altered several times, but some original features remain buried under the current treatment¹. Recently, the lower portion of the front facade was painted. The upper portion of the front facade has many of its original details. The original façade still exists, although it is currently covered in stucco and is being restored by the current owner.

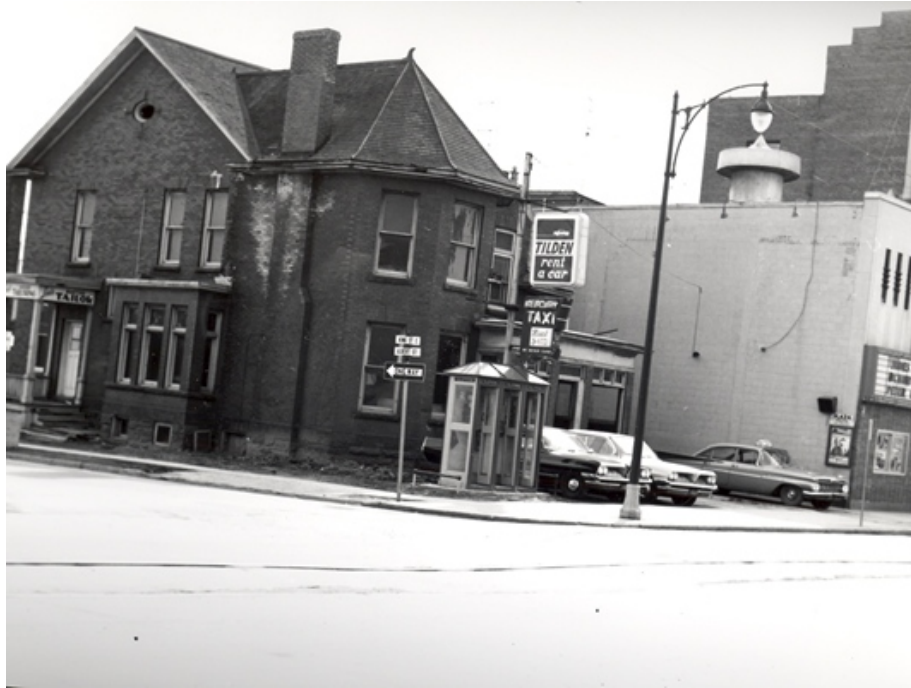
Figure 9 - Biltmore Theatre, Northeast Facade, Corner of King Street East, and Albert Street. circa 1950

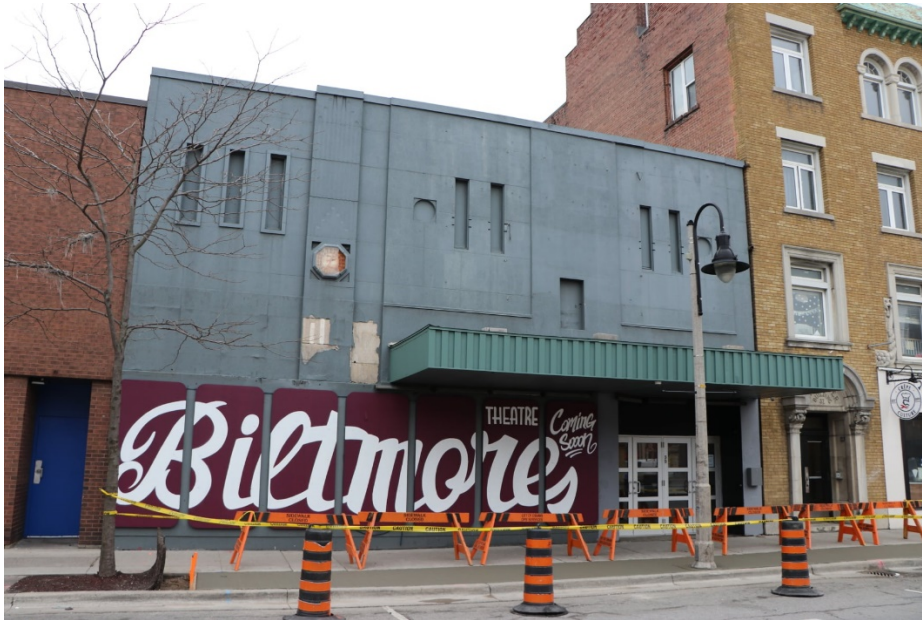
Figure 12 - 39 King Street East, Test Spot on Stucco by owner. April 2021, Photo Courtesy Robert T. Bell

The owner intends to strip the layers of paint and stucco on the exterior facade back to the original natural and man-made stone finish and trusts that will meet Heritage Oshawa approval and support.
