Research Report

McLaughlin House
195 Simcoe Street North
Oshawa, ON

Prepared for Heritage Oshawa
Melissa Cole, Local Heritage Consultant
November 2017

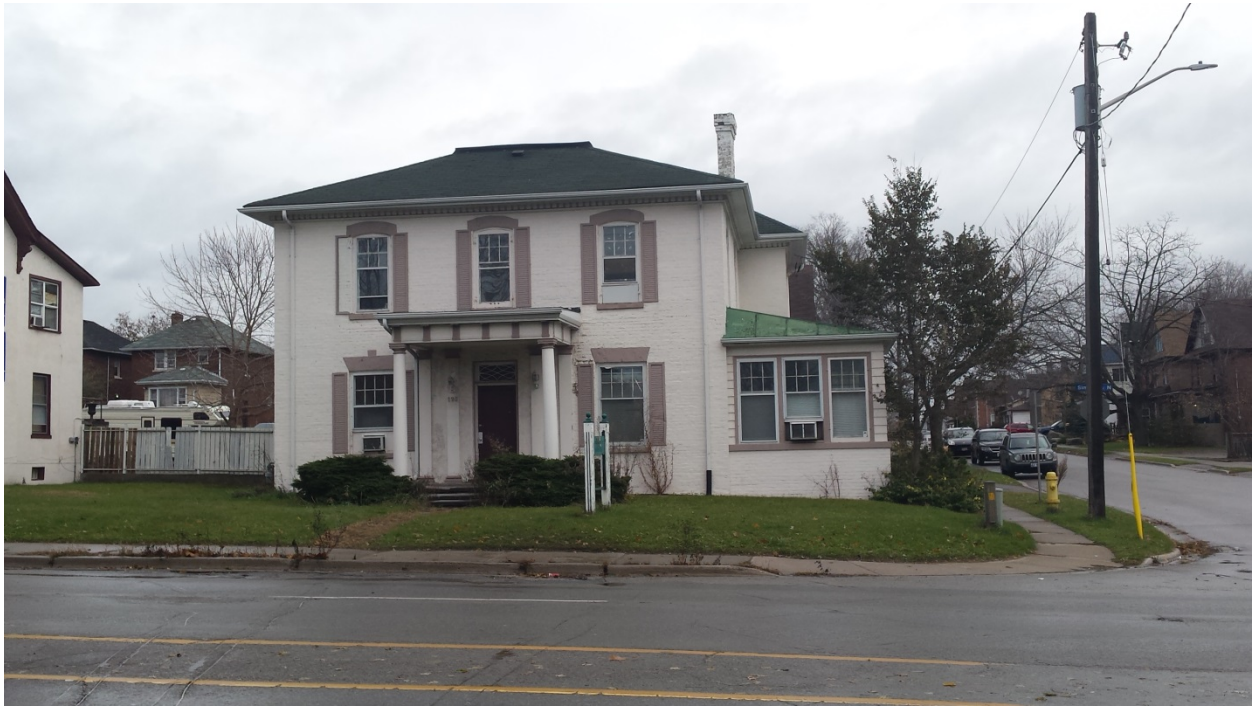
West Façade facing west onto Simcoe Street North

This home is Classical Revival in style featuring, full two storey, 3-bay front façade (centre door, flanking windows), a T-shaped plan, hipped roof, quoining on the corners (currently covered in white paint), with three chimneys, one is located on the south side and two are located the east side of the building. The wide soffits are panelled and connected to the frieze by a decorative dental cornice.

The fenestration (window placement) is balanced on the prominent (west) facade but irregular on the remaining sides. The windows on the prominent west façade feature three large multi panes over single panel double hung sash windows topped by brick lintels and set on cement lug sills. Multi-paned sashes are seen on other period examples but most of these sashes are believed to be replacements. Some are double hung, others are fixed. Most of the upper sashes still contain 6 panes and the lower sashes would most likely have contained 9 panes based on the longer length of the lower sashes. Today they are single panes.

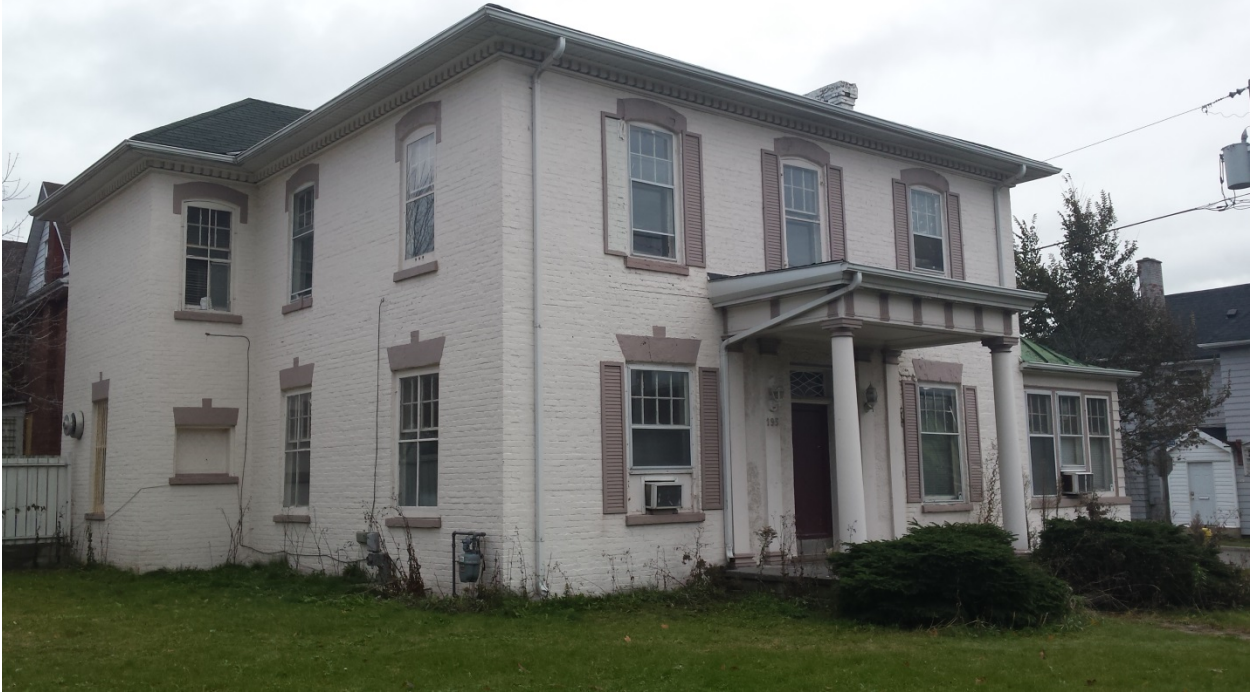
West and North façade

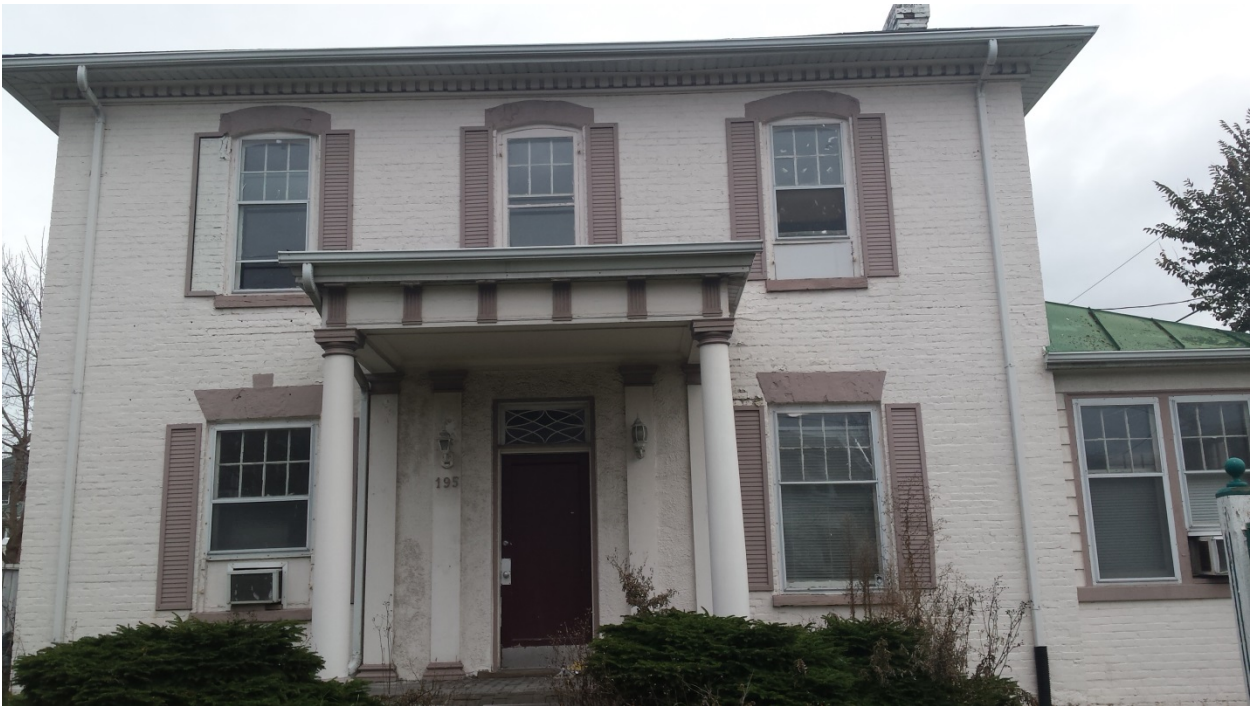
West Façade

The main door case features a portico that contains a single leaf (replacement) door with transom. The portico has a set of columns at the front, set on a stepped square plinth with simple square capitals at the top. The home once featured a Regency Style verandah but many don't survive because they were made from wood which is less durable than products such as stone. A south entry is located within the same area of where an original south entry was located. Some renovations have occurred on the south façade where the sunroom is located today. There is a third door opening on the rear (east façade) that may be a renovation.

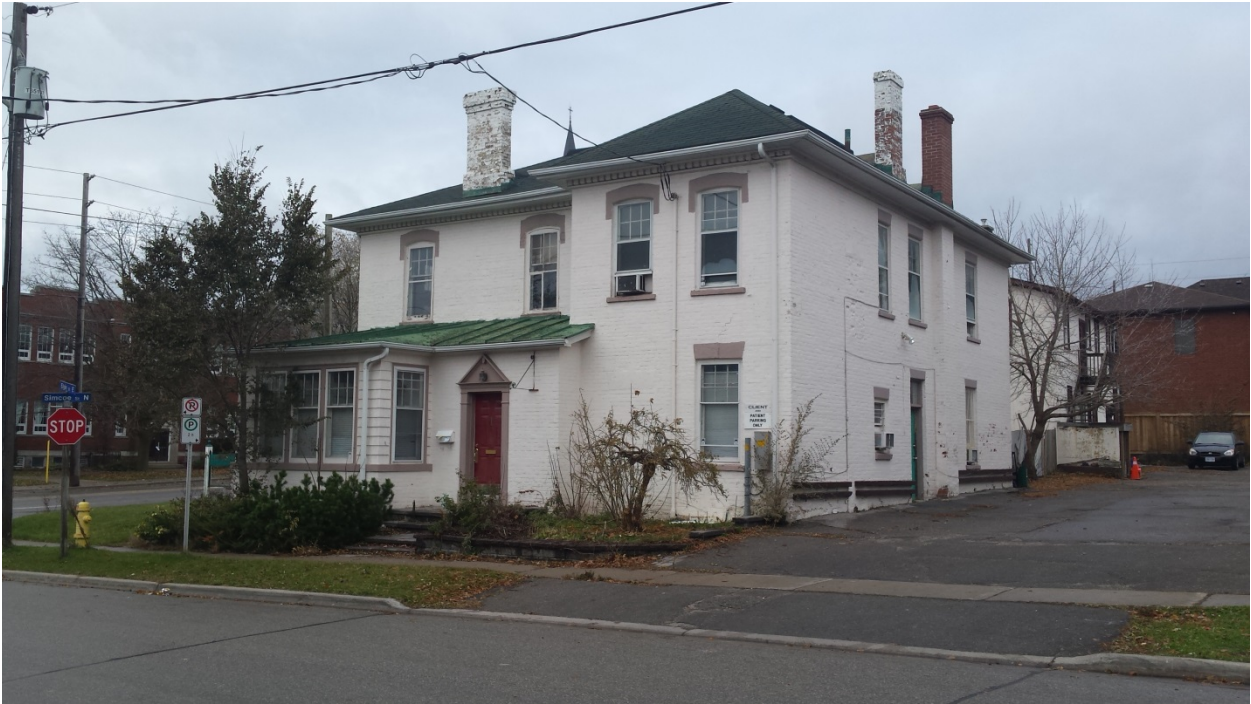
South and East Façades

The south and west façades feature window openings that have been covered over by brick. The brick lintels are still evidenced through the white paint.

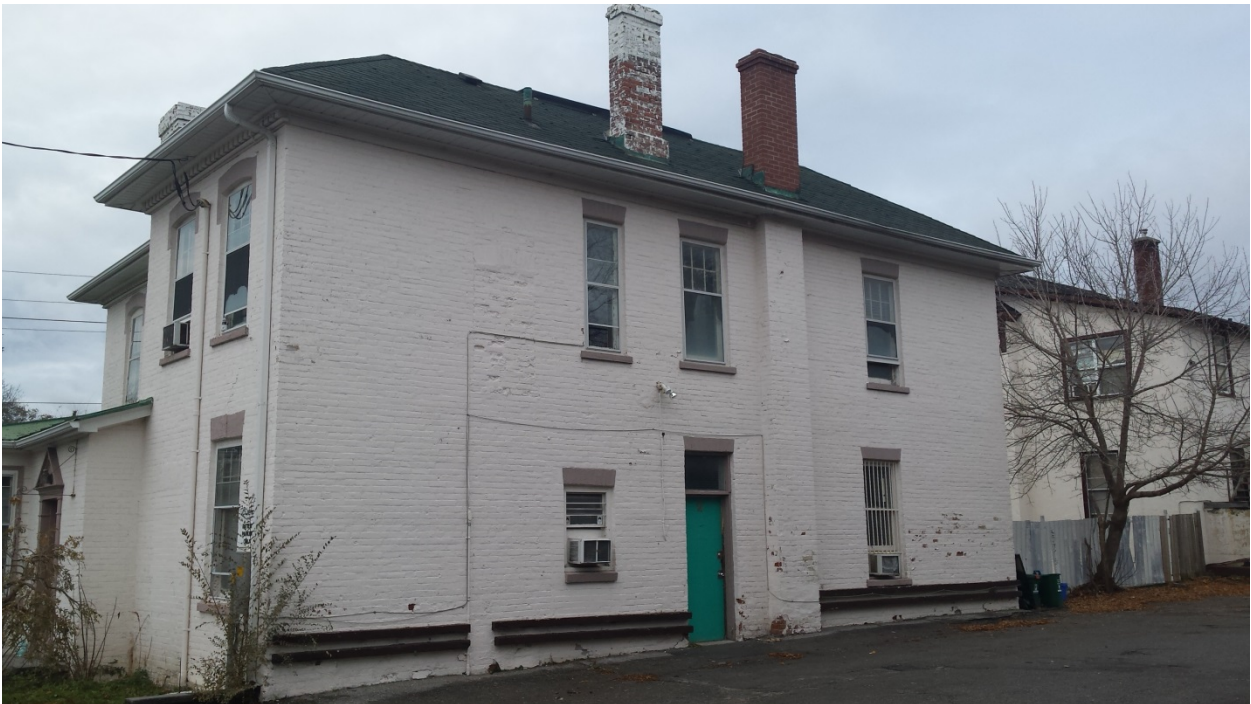
East Façade, Rear of the Building

Typical of the Classical Revival style, the hipped roof features a large overhang that is ornamented with dentil blocks along the cornice. The roof cladding is asphalt shingles. The one-storey side “sunroom” features a copper roof. There are two brick chimney stacks rising from the roof at the rear (east side) and another brick chimney rising from the roof on the south façade.

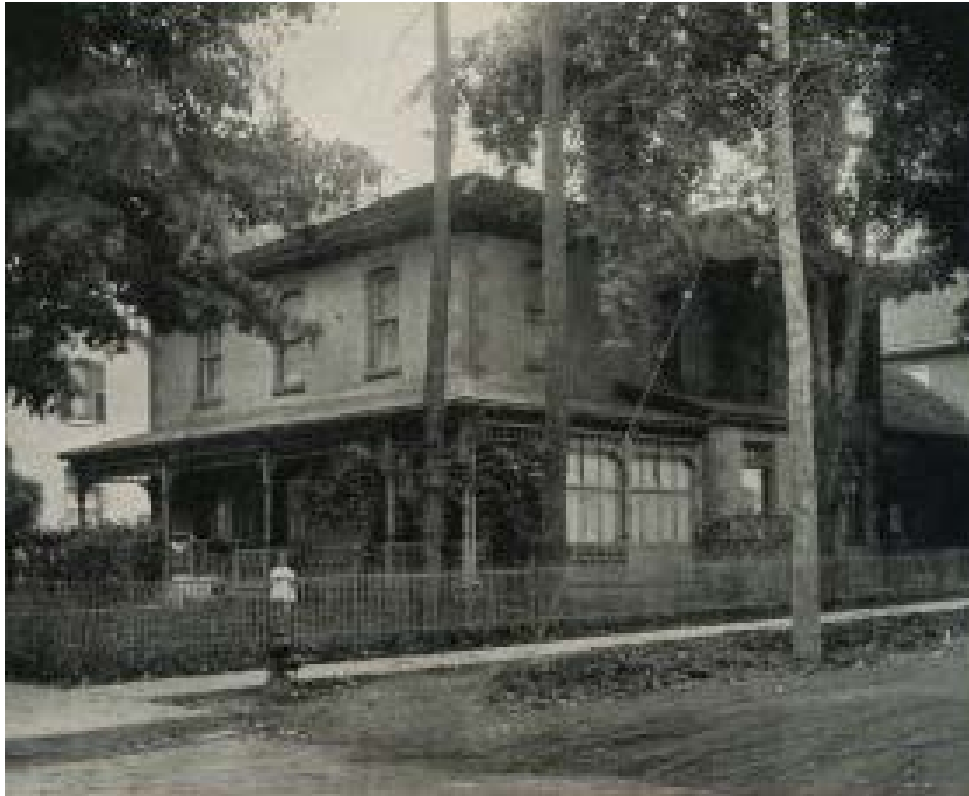
Robert McLaughlin House, Oshawa Archives Collection
West and South Façades

The house is a fine example of early brick construction in Oshawa. Typical of the Classical Revival style, the structure has a symmetrical 3-bay Georgian plan but with more refined, delicate features. The yellow brick has been covered in white paint. Quoins were present, on the corners of the home according to an image of the home from the collection of the Oshawa Archives. They have since been painted over.
