TO: Laura Moebs, Principal Planner, City of Oshawa
FROM: James Neilson and Katherine Hull, ASI
RE: Integrated Columbus Part II Planning Act and Municipal Class Environmental Assessment Act Study - 121 Columbus Road West, City of Oshawa

ASI File: 18CH-056

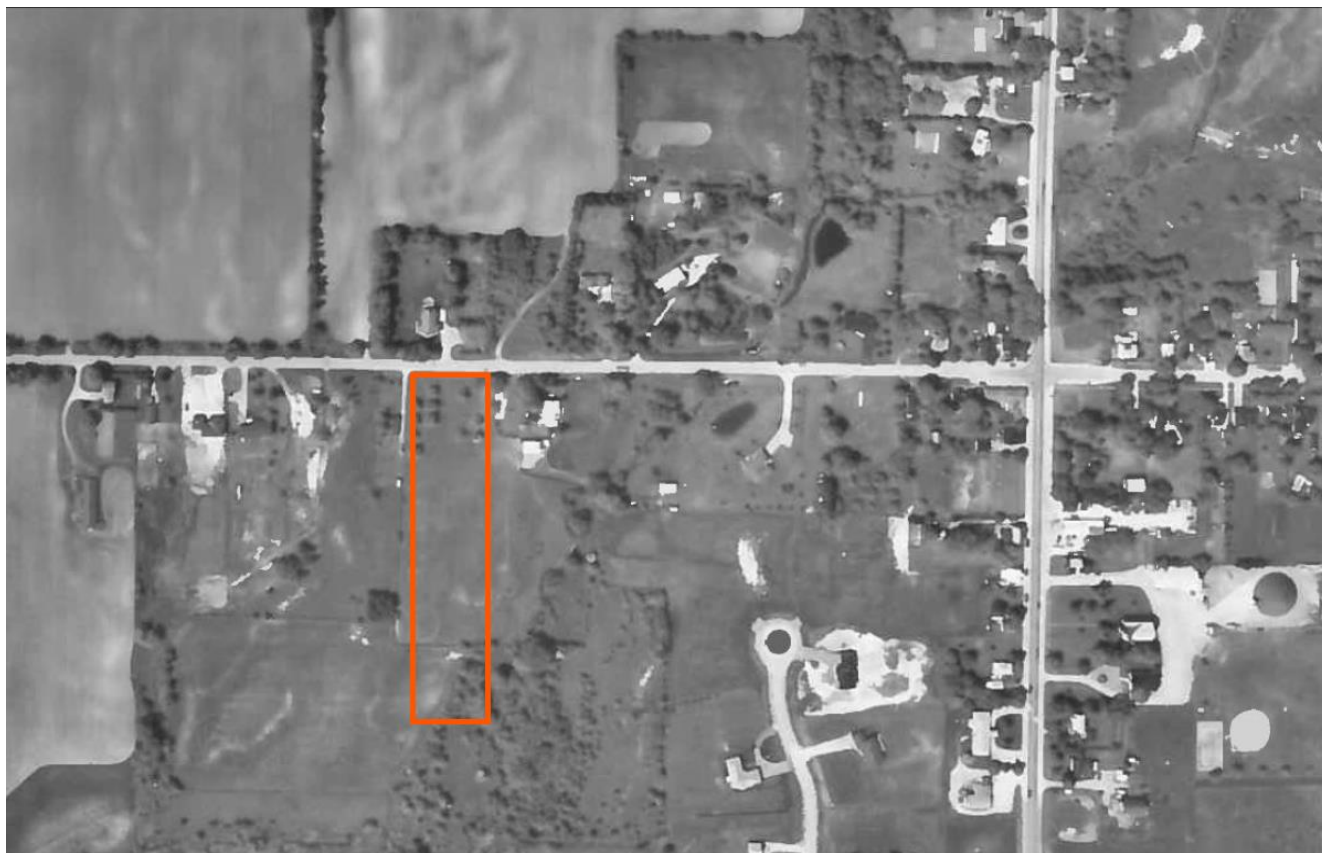
Attachment B – 1988 Aerial Photo of 121 Columbus Road West

However, as seen in Attachments B and C, an aerial photograph from 1988 confirms that the building did not exist prior to 1988. Heritage Oshawa was also able to confirm a 1994 construction date. It appears that the property was built to mimic a nineteenth-century heritage Gothic Revival farmhouse and was done so in a convincing fashion from the public right-of-way. Based on this information, we agree with Heritage Oshawa's assessment of the property and that the property should not be considered a potential cultural heritage resource.
