**TO:** Laura Moebis, Principal Planner, City of Oshawa  
**FROM:** James Neilson and Katherine Hull, ASI  
**RE:** Integrated Columbus Part II Planning Act and Municipal Class Environmental Assessment Act Study - 121 Columbus Road West, City of Oshawa

ASI File: 18CH-056

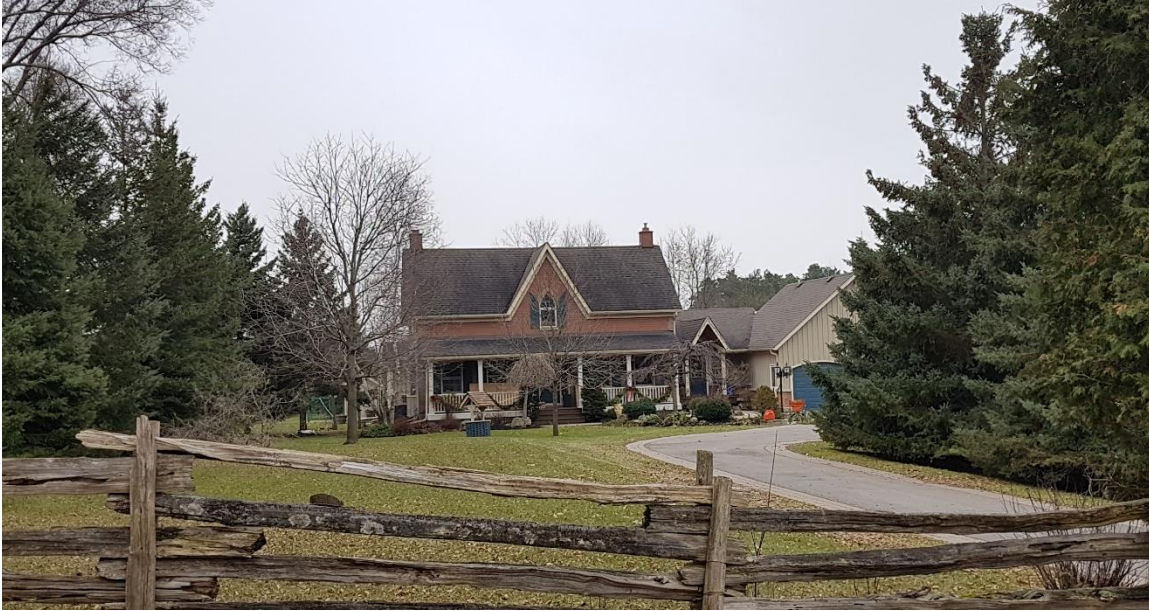
**Attachment A – November 2018 photo of 121 Columbus Road West**

In January 2020, Heritage Oshawa alerted City of Oshawa staff that they had determined that 121 Columbus Road West was built in 1994 and as such, should not have been identified as a potential cultural heritage resource in the CHRA. The inclusion of this property in the CHRA was based on two key indicators: the presence of a building on or near the site of the existing building on a map from 1877; and a field review from the public right-of-way which showed the presence of a “Gothic Revival” style residential building with a brick

exterior, gable roof with centre gable, and gothic arched windows. This architectural style would have been common in 1877, and as such, it was determined that the residence merited identification as a potential cultural heritage resource.

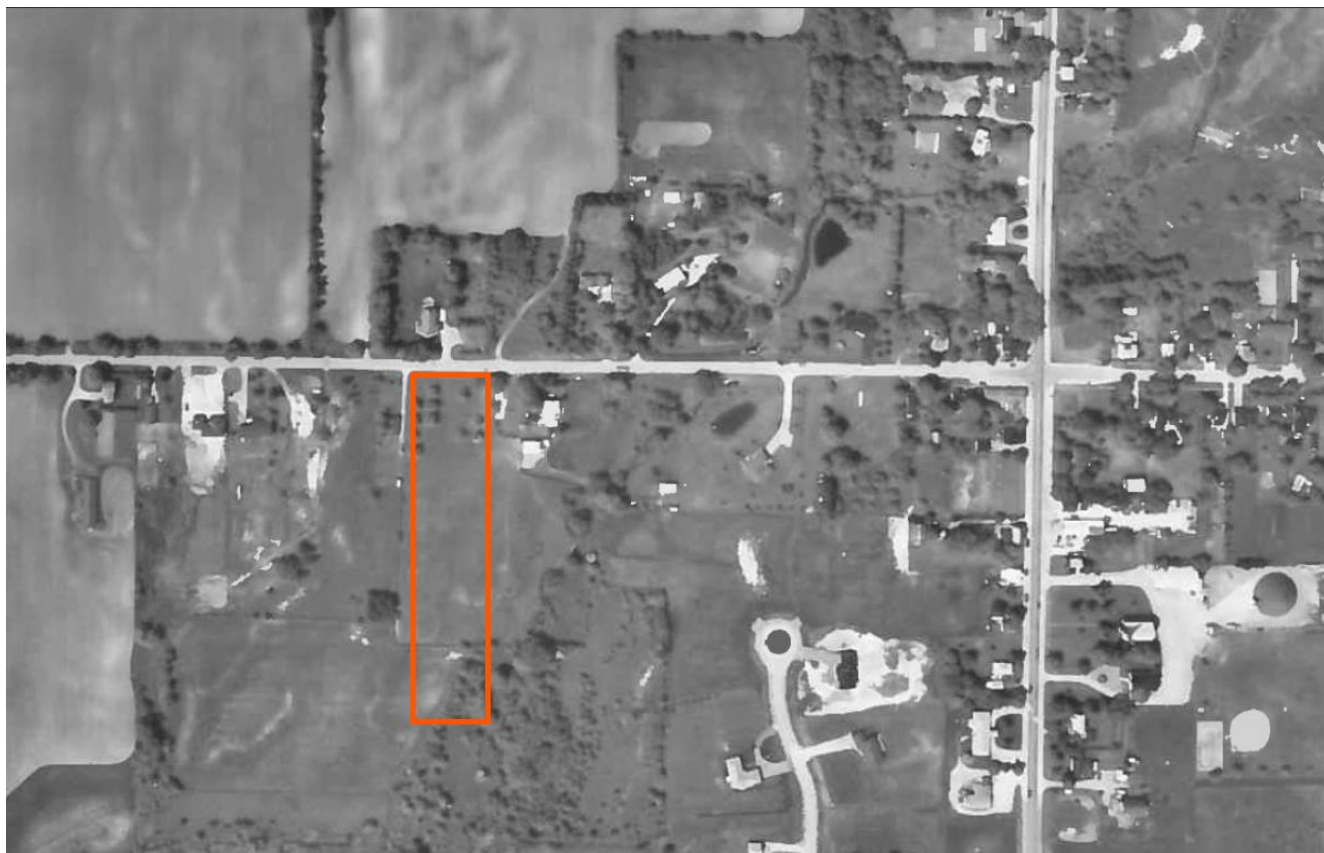
**Attachment B – 1988 Aerial Photo of 121 Columbus Road West**

However, as seen in Attachments B and C, an aerial photograph from 1988 confirms that the building did not exist prior to 1988. Heritage Oshawa was also able to confirm a 1994 construction date. It appears that the property was built to mimic a nineteenth-century heritage Gothic Revival farmhouse and was done so in a convincing fashion from the public right-of-way. Based on this information, we agree with Heritage Oshawa's assessment of the property and that the property should not be considered a potential cultural heritage resource.

Based on the findings outlined in this memorandum, the property at 121 Columbus Road West should not be considered a potential cultural heritage resource. As such, there are now a total of 61 recognized and potential cultural heritage resources within the study area of the Integrated Columbus Part II Planning Act and Municipal Class Environmental Assessment Act Study, of which 29 have been identified as potential cultural heritage resources.
