**Integrated Columbus Part II Planning Act  
and Municipal Class Environmental Assessment Act Study**

**Cultural Heritage Resource Assessment Study  
Existing Conditions Report**

**City of Oshawa, Ontario**

February 2019 (Revised April 2019)

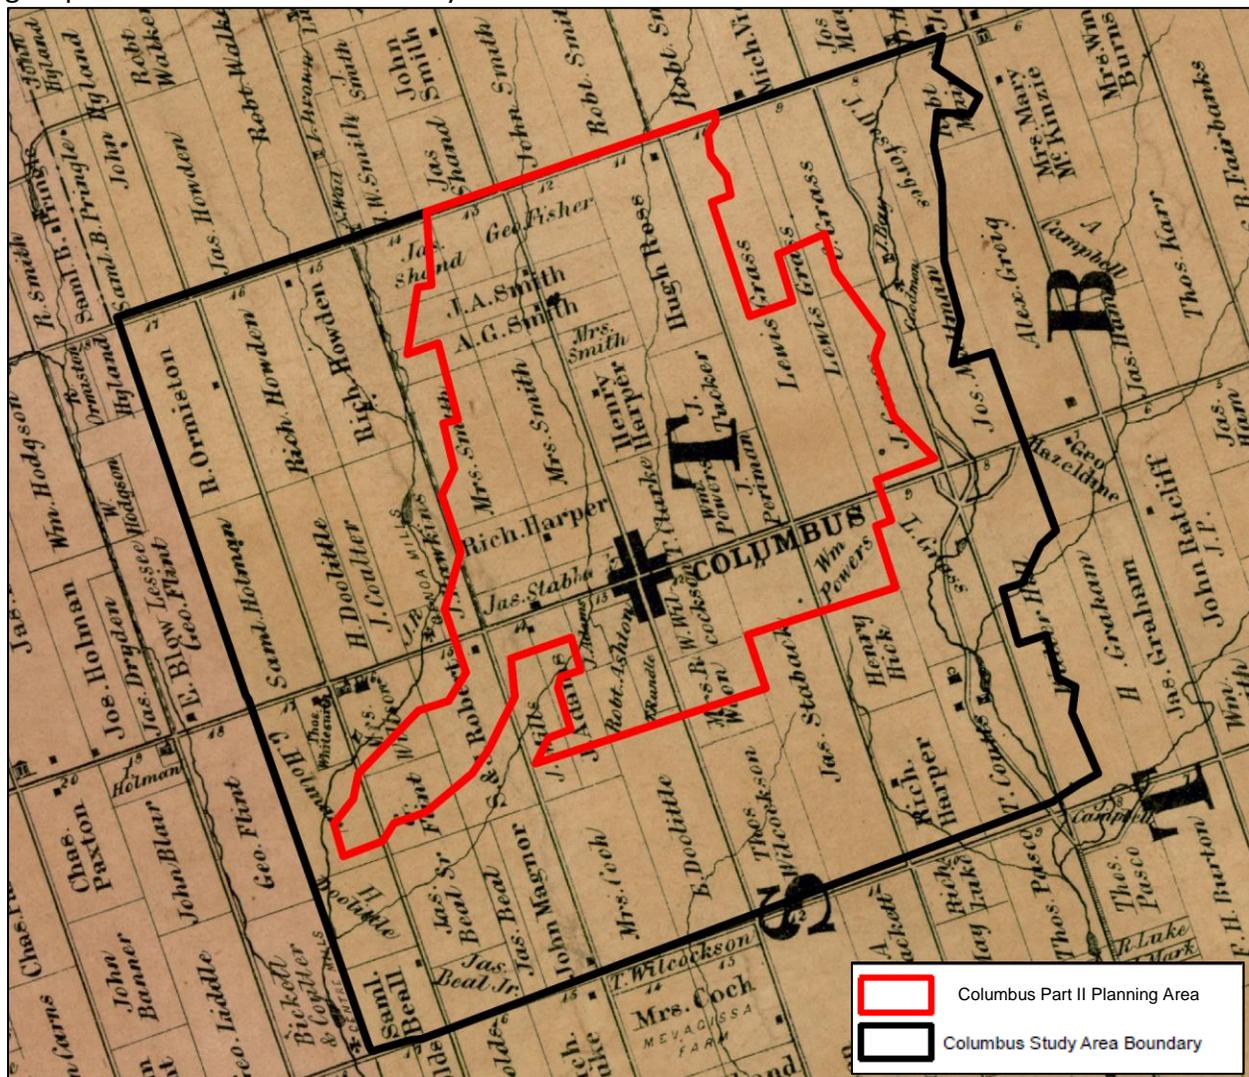
Figure 9: 1860 *Tremaine's Map of the County of Ontario* (Tremaine 1860)

The 1860 *Tremaine's Map of the County of Ontario* (Figure 8) provides information about land ownership and the presence of farmhouses on various properties in the study area along with the location of the historic Hamlet of Columbus. The owner of each property is noted along with the alignments of Columbus Road, Thornton Road, Ritson Road, Winchester Road, Howden Road and Bridle Road North. Twenty-two buildings are noted in the study area along with a group of structures not individually identified in the historic Hamlet of Columbus.

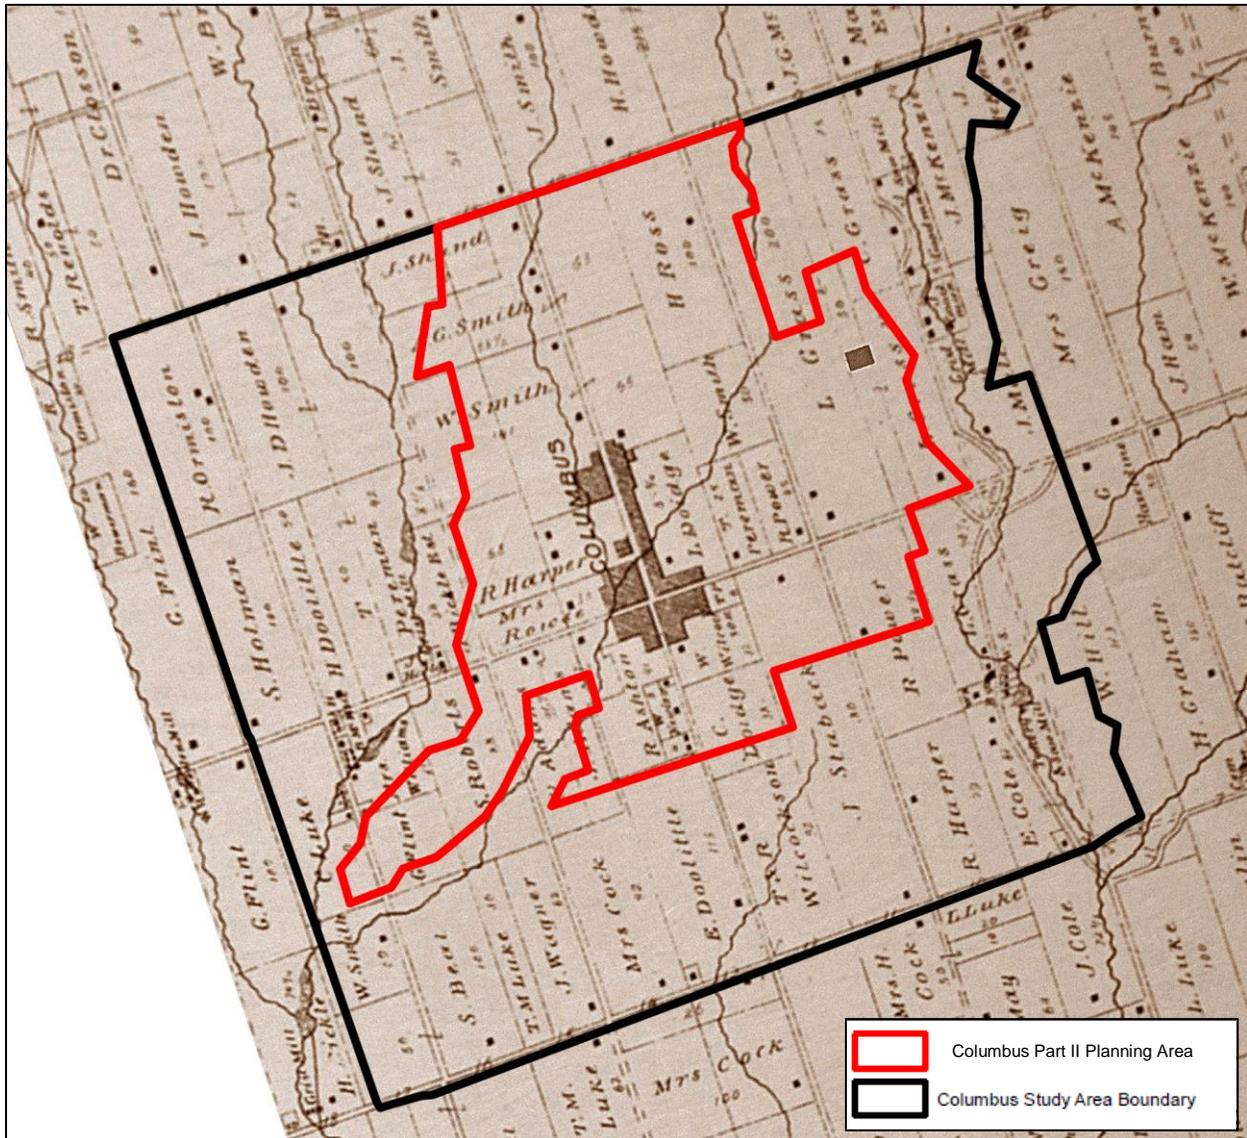
Figure 10: 1877 *Illustrated Historical Atlas of the County of Ontario* (J.H. Beers & Co., 1877)

The 1877 *Illustrated Historical Atlas of the County of Ontario* (Figure 9) map provides additional information about the study area, depicting land ownership, the location of houses and more detail about the growth of the historic Hamlet of Columbus. When compared to the 1860 *Tremaine* Map it is notable that several properties have changed hands over the years. Many additional farmsteads have been constructed since 1860 and the map contains approximately 75 buildings along with the group of structures not individually identified in the historic Hamlet of Columbus.

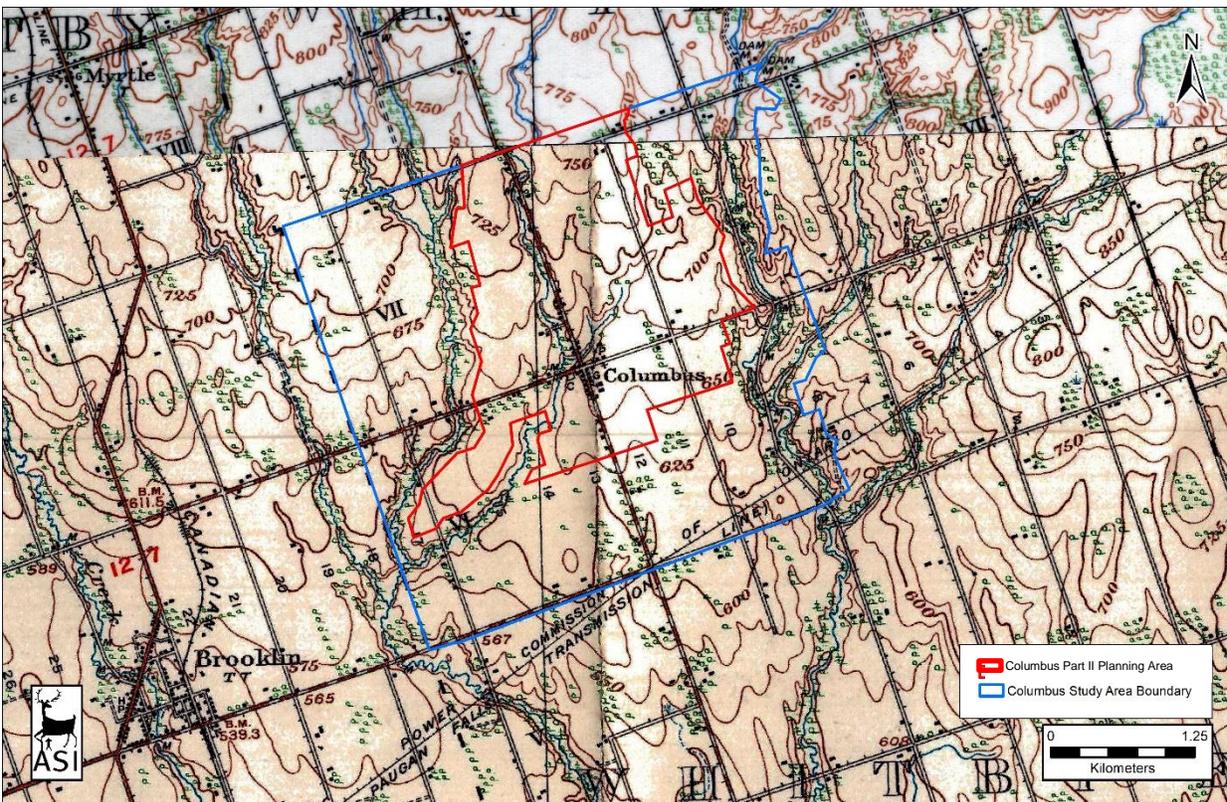
Figure 11: 1930 N.T.S. Map, Oshawa Sheet No. 108 and Scugog Sheet No. 109 (Department of Militia and Defence 1930)

The 1930 N.T.S. map displays the rural character of the study area (Figure 11). Approximately one hundred buildings are noted within the study area with the largest concentration centred around Simcoe Street North and Columbus Road. The area contains seven mills, two churches, two cemeteries, a post office and a garage. The area appears to be used primarily for agricultural purposes with three creek tributaries depicted along with associated vegetation.

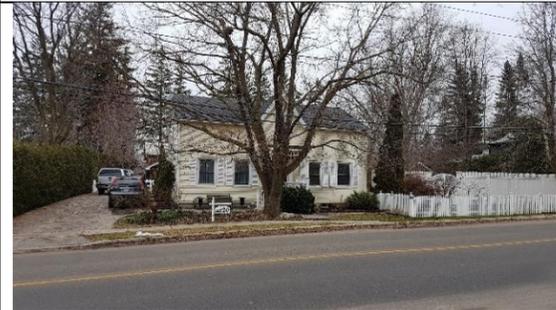
CHR2	27 Columbus Road East	Class A	Residence	<p>Design: Two-storey Italianate farmhouse with a front porch, buff brick accents, paired windows with segmental arches and paired brackets beneath the eaves.</p> <p>History: According to the Heritage Oshawa Inventory of City of Oshawa Heritage Properties, the residence was built in 1860.</p> <p>Context: The building is situated at the centre of the historic Hamlet of Columbus near the community’s main intersection. It is the closest building to the intersection of Columbus Road and Simcoe St North on the southeastern corner of the intersection.</p>

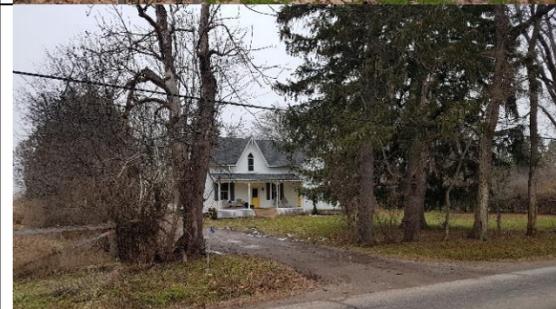
CHR8	255 Columbus Road East	Identified during field review	Residence	<p>Design: A one-and-a-half storey residential building with a gable roof with centre gable, aluminum siding, stone foundation and an enclosed front porch.</p> <p>History: According to mapping from 1877, the property was owned by J. Stabeck.</p> <p>Context: The property is situated on the south side of Columbus Road East within a group of residential buildings centred around the intersection of Columbus Road East and Grass Grove Lane. The surrounding area consists of agricultural lands.</p>

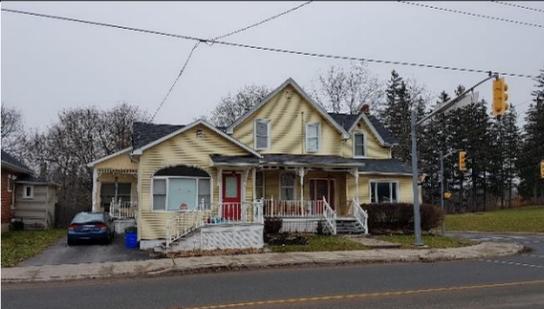
Feature ID	Address	Heritage Status	Resource Type	Description/Comments	Photograph(s)
CHR12	6 Columbus Road West	Class B	Residence	<p>Design: A one-and-a-half storey residential building with multiple additions. The building has a cross-gable roof, brick internal chimney, front porch with wooden decorative trim and has been clad in vinyl siding.</p> <p>History: According to the Heritage Oshawa Inventory of City of Oshawa Heritage Properties, the residence was built in 1900.</p> <p>Context: The building is situated at the centre of the historic Hamlet of Columbus on the northwest corner of the community's main intersection at Columbus Road and Simcoe St North.</p>

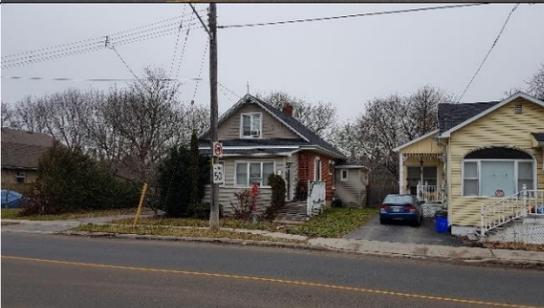
CHR13	12 Columbus Road West	Identified during field review	Residence	<p>Design: A one-and-a-half storey brick residential building with an enclosed porch, gable roof, decorative wooden finial above the peak of the gable and wooden trim beneath the gable.</p> <p>History: According to mapping from 1877, the property is situated within the developed area of the historic Hamlet of Columbus.</p> <p>Context: The building is situated at the centre of the historic Hamlet of Columbus near the community's main intersection of Columbus Road and Simcoe St North.</p>

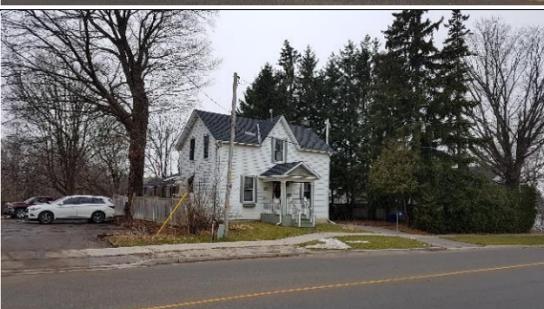
CHR14	19 Columbus Road West	Identified during field review	Residence	<p>Design: A one-and-a-half storey Gothic Revival residential building with a T-shaped plan, gable roof, centre gable, front porch and clad in aluminum siding.</p> <p>History: According to mapping from 1877, the property is situated within the developed area of the historic Hamlet of Columbus.</p> <p>Context: The building is situated at the centre of the historic Hamlet of Columbus near the community's main intersection of Columbus Road and Simcoe St North.</p>

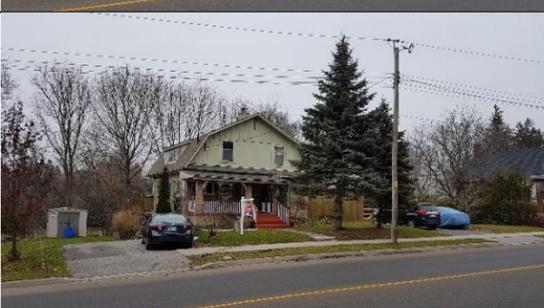
CHR15	20 Columbus Road West	Identified during field review	Residence	<p>Design: A one-and-a-half storey residential building with a gambrel roof with shed dormers, front porch, a mix of cladding materials including board and batten, vinyl and brick.</p> <p>History: According to mapping from 1877, the property is situated within the developed area of the historic Hamlet of Columbus. Mapping from 1930 suggests that the residential building may be one of four buildings depicted on the north side of Columbus Road.</p> <p>Context: The building is situated at the centre of the historic Hamlet of Columbus near the community's main intersection of Columbus Road and Simcoe St North.</p>

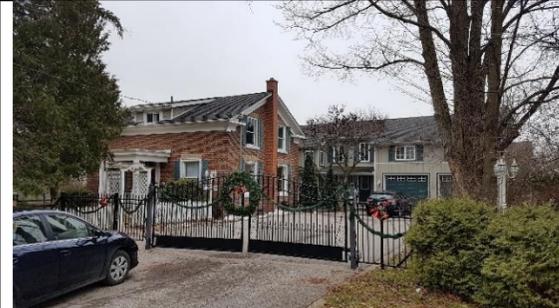
CHR19	121 Columbus Road West	Identified during field review	Residence	<p>Design: A one-and-a-half storey brick Gothic Revival residence with a gable roof with centre gable, gothic arched windows, a wooden front porch and side and rear additions.</p> <p>History: Mapping from 1877 depicts a farmhouse near this location owned by J. Adams.</p> <p>Context: The property is located on the south side of Columbus Road West, to the west of the centre of the historic Hamlet of Columbus amongst a cluster of buildings that are situated on Columbus Road.</p>

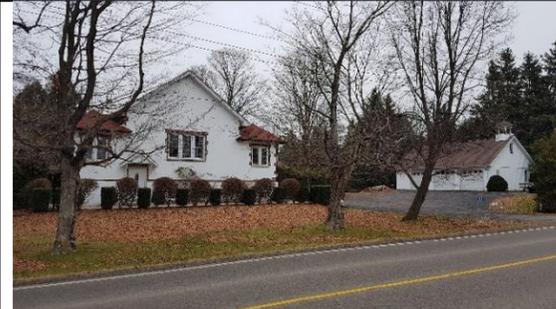
CHR21	201 Columbus Road West	Identified during field review	Residence	<p>Design: A one-and-a-half storey residence that is obscured by vegetation. From the east elevation, the building appears to have a Gothic Revival style roof with a T-shaped floor plan and a centre gable. A one storey rear addition is visible in the rear. The rear of the property features a stable.</p> <p>History: On mapping from 1877, a farmhouse is depicted near this location on a property owned by H. Adams.</p> <p>Context: The property is situated on the south side of Columbus Road West within a row of residential buildings within a rural context. Agricultural lands are situated to the south, west and north.</p>

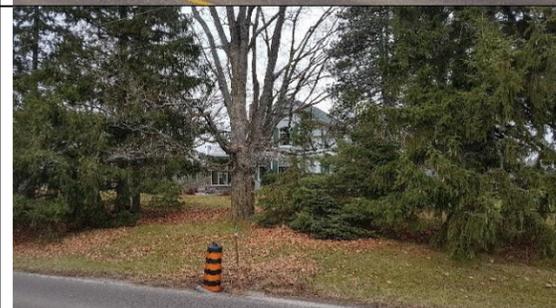
CHR23	342 Columbus Road West	Class B	Residence with barn	<p>Design: A two-storey residential building with a hipped roof and front-facing gable. The building is obscured by vegetation but a brick chimney, arched windows and a one-storey addition are visible.</p> <p>History: Two farmhouses are depicted on mapping from 1877 near the location of the existing residence. However, according to the Heritage Oshawa Inventory of City of Oshawa Heritage Properties, the residence was built in 1890.</p> <p>Context: The property is situated on the south side of Columbus Road West within an agricultural area. A ravine with significant vegetation is located to the west and north.</p>

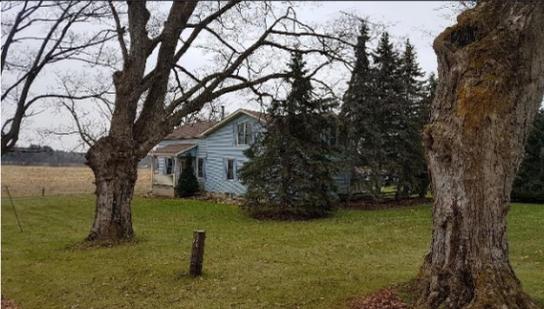
Feature ID	Address	Heritage Status	Resource Type	Description/Comments	Photograph(s)
CHR24	625 Columbus Road West	Class B	Residence with barn	<p>Design: A one-and-a-half storey residential building with an L-shaped plan with a cross-gable roof, front porch and flat-headed fenestration with six-over-six double-hung windows. A complex of barn buildings is situated in the rear.</p> <p>History: A farmhouse is depicted on mapping from 1877 near the location of the existing residence, owned by C. Luke.</p> <p>Context: The property is situated on the south side of Columbus Road West within an agricultural area.</p>

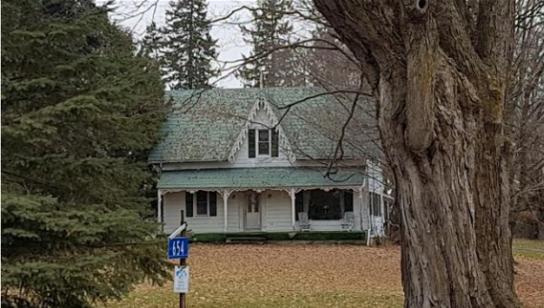
CHR25	654 Columbus Road West	Class B	Residence and farm complex	<p>Design: A one-and-a-half storey Gothic Revival residential building with a T-shaped plan with centre gable, wood trim, front porch and rear addition. The property includes a complex of agricultural buildings located to the east of the residential building dominated by a prominent barn with an L-shaped plan and gambrel roof.</p> <p>History: A farmhouse is depicted on mapping from 1877 near the location of the existing residence, owned by S. Holman.</p> <p>Context: The property is situated on the northwest corner of Columbus Road West and Thornton Road North within an agricultural area.</p>

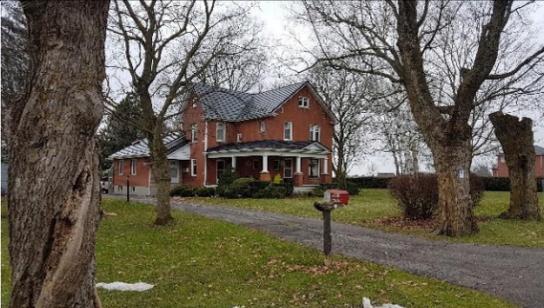
CHR26	655 Columbus Road West	Class B	Residence	<p>Design: A two-and-a-half storey brick residential building with an L-shaped plan, cross-gable roof, wraparound porch supported by brick and wood columns and a rear addition.</p> <p>History: A farmhouse is depicted on mapping from 1877 near the location of the existing residence, owned by C. Luke.</p> <p>Context: The property is situated on the south side of Columbus Road West within an agricultural area.</p>

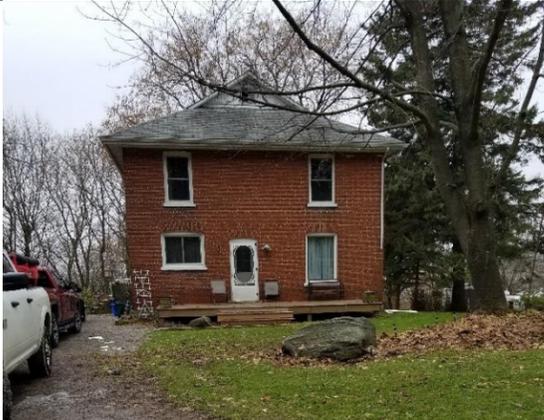
CHR27	3912 Dowson Road	Identified during field review	Residence	<p>Design: A two-storey red brick residence with a hipped roof and flat arch windows.</p> <p>History: A farmhouse is depicted on mapping from 1877 near the location of the existing residence, owned by H. Ross.</p> <p>Context: The property is located on the west side of Dowson Road adjacent to one other residential property. Behind the house is a large agricultural field.</p>

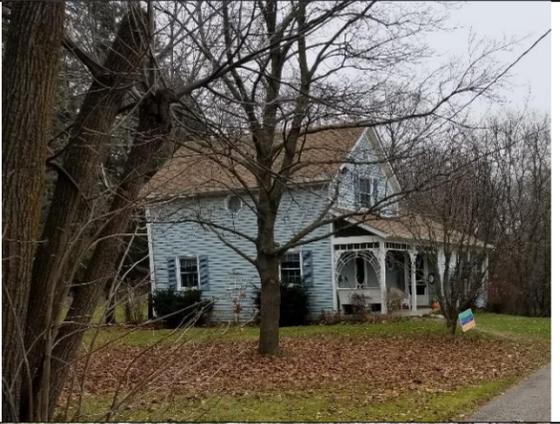
CHR31	3030 Ritson Road North	Identified during field review	Residence	<p><b>Design:</b> A one-and-a-half storey building with a T-shaped plan and rear addition. Vegetation obscures views to the building from the public realm but satellite images show a cross-gable roof with a centre gable and a porch.</p> <p><b>History:</b> According to mapping from 1877, the property was owned by E. Cole.</p> <p><b>Context:</b> The property is situated on the west side of Ritson Road North, north of Highway 407 East within a small grouping of residential properties. The area around the property is comprised of vegetation related to the adjacent ravine system. Agricultural land is found to the west.</p>

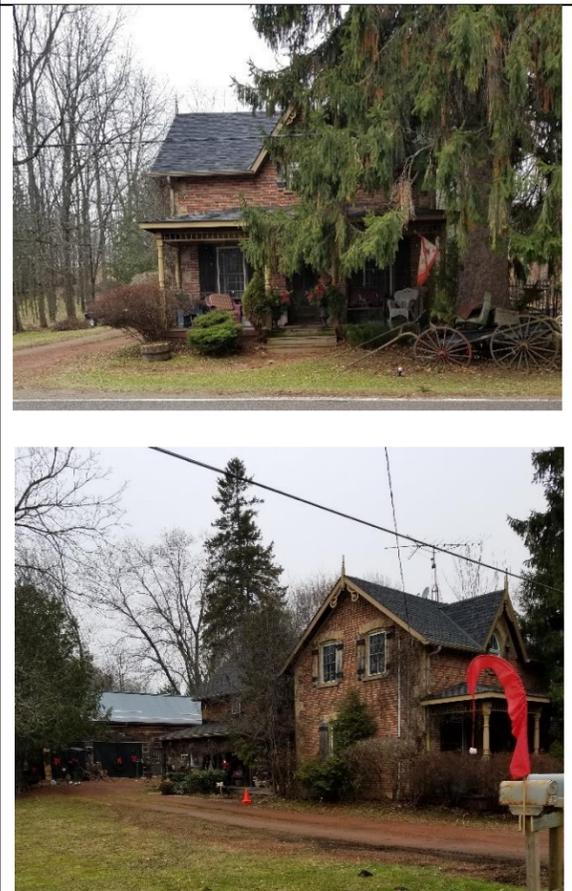
CHR33	3521 Ritson Road North	Identified during field review	Residence	<p>Design: The building is setback from the road and obscured by dense vegetation which fills most of the property. Satellite imagery suggests that the building has a cross-gable roof.</p> <p>History: According to mapping from 1877, the building was amongst a cluster of buildings located on the east side of Ritson Road North.</p> <p>Context: The property is situated on the east side of Ritson Road North. The area around the property is comprised of forest with agricultural land to the east and west.</p>

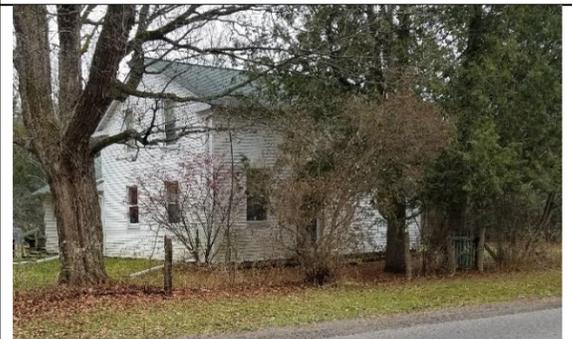
CHR35	3645 Ritson Road North	Identified during field review	Residence	<p>Design: The building is set back from the road and obscured by dense vegetation that fills most of the property. Satellite imagery suggests that the building has an L-shaped plan with a hipped roof.</p> <p>History: According to mapping from 1877, the building was amongst a cluster of buildings located on the east side of Ritson Road North.</p> <p>Context: The property is situated on the east side of Ritson Road North. The area around the property is comprised of forest with agricultural land to the east and west.</p>

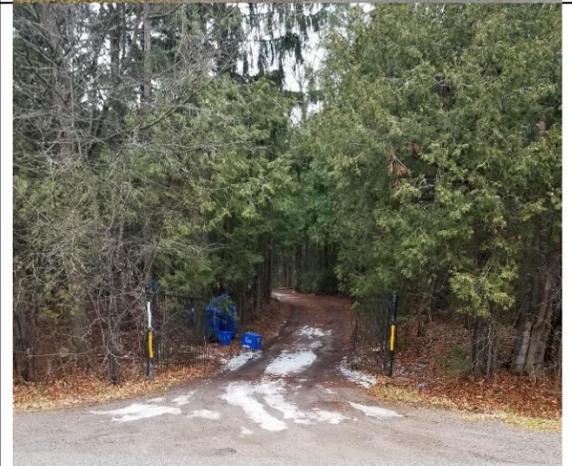
Feature ID	Address	Heritage Status	Resource Type	Description/Comments	Photograph(s)
CHR36	3695 Ritson Road North	Identified during field review	Residence and farmscape	<p><b>Design:</b> The two buildings on the property are setback from the road and obscured by vegetation. Satellite imagery shows a tree-lined driveway leading to a building with a gable roof. An additional building with a gable roof is situated to the north.</p> <p><b>History:</b> According to mapping from 1877, the building was amongst a cluster of buildings located on the east side of Ritson Road North, and the property may have been owned by Goodman.</p> <p><b>Context:</b> The property is situated on the east side of Ritson Road North. The area around the property is comprised of forest with agricultural land to the east and west.</p>

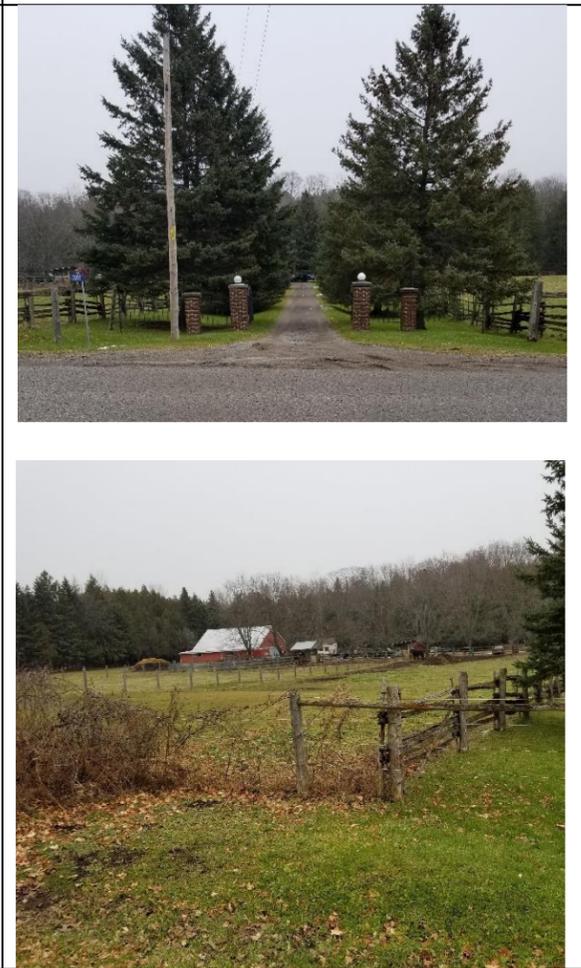
CHR37	3959 Ritson Road North	Class B	Residence and Farm complex	<p><b>Design:</b> A two-storey residential building with a hipped roof, front porch with wooden trim and a rear addition. A number of farm complex structures are situated to the north and east of the residence. The property is accessed via two driveways on Ritson Road North and one driveway on Howden Road East. A wood fence is used to separate the residential portion of the property from the barn complex and surrounding agricultural fields. A ravine associated with the Oshawa Creek divides the property into two.</p> <p><b>History:</b> According to the Heritage Oshawa Inventory of City of Oshawa Heritage Properties, the residence was built in 1865. Mapping from 1877 notes a building near the location of the existing building on the property, owned by J. McKenzie.</p> <p><b>Context:</b> The property is located on the southeast corner of the intersection of Ritson Road North and Howden Road East. The surrounding area is rural in context with agricultural lands to the north and west and a forested ravine to the south and east.</p>

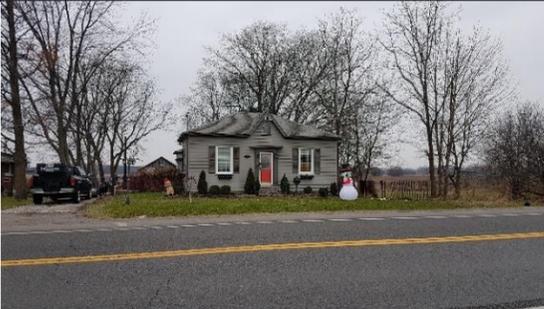
CHR39	3130 Simcoe Street North	Identified during field review	Residence and farm complex	<p>Design: A one-and-a-half storey residence with a gable roof which chimneys at each end, flat-headed windows and vinyl siding. Two outbuildings are situated to the south of the residence.</p> <p>History: Three buildings are depicted on mapping from 1877 in the vicinity of the existing building. Their ownership is not noted.</p> <p>Context: The property is located on the west side of Simcoe Street North, on the southern edge of the historic Hamlet of Columbus. Agricultural lands are situated to the east and west.</p>

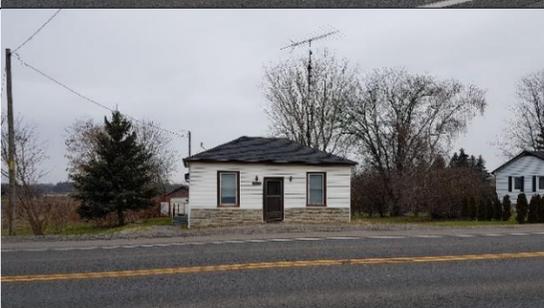
CHR41	3180 Simcoe Street North	Identified during field review	Residence	<p>Design: A one-storey residential building with a hipped roof, aluminum and stone veneer siding, flat-headed window and a rear addition.</p> <p>History: Two buildings are depicted on mapping from 1877 in the vicinity of the existing building on a property.</p> <p>Context: The property is located on the west side of Simcoe Street North, on the southern edge of the historic Hamlet of Columbus. Agricultural lands are situated to the east and west.</p>

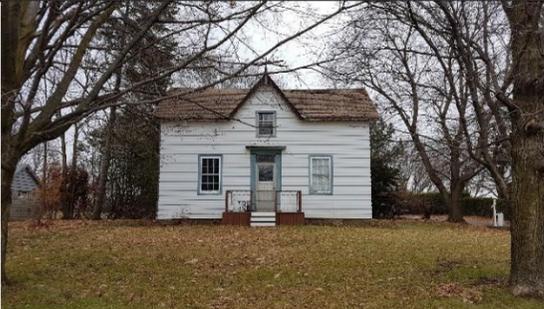
Feature ID	Address	Heritage Status	Resource Type	Description/Comments	Photograph(s)
CHR42	3245 Simcoe Street North	Class B	Residence	<p>Design: A one-and-a-half storey Gothic Revival residence with a T-shaped plan, cross-gable roof with centre gable, aluminum siding, six-over-six double hung wood windows and a rear addition.</p> <p>History: According to the Heritage Oshawa Inventory of City of Oshawa Heritage Properties, the residence was built in 1860.</p> <p>Context: The property is located on the east side of Simcoe Street North, on the southern edge of the historic Hamlet of Columbus, surrounded by residential properties.</p>

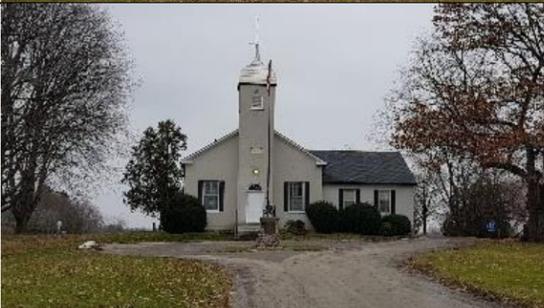
CHR43	3265 Simcoe Street North	Designated Part IV	Recreational Building	<p>Design: The Columbus Community Centre is a one-storey recreational building with a cross-gable roof and prominent tower with an ogee-style metal tower and gothic arch windows. The entrance has a semi-circular transom. The windows are flat-headed with twelve-over-twelve double hung wood windows. A cairn with a bell is located in front of the building.</p> <p>History: According to the City of Oshawa Register of Properties of Cultural Heritage Value or Interest, the building was constructed in 1859. It is the original Old Township Hall. The property was designated by the City of Oshawa under By-law #47-2011 (March 21 2011)</p> <p>Context: The property is located on the east side of Simcoe Street North, on the southern edge of the historic Hamlet of Columbus, surrounded by residential properties.</p>

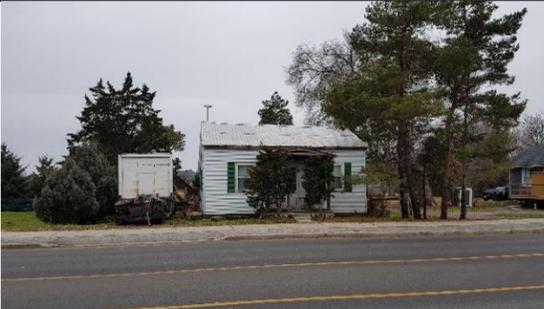
CHR47	3300 Simcoe Street North	Identified during field review	Residence	<p>Design: A one-and-a-half storey Gothic Revival residential building clad in Insulbrick with a gable roof with a centre gable with bargeboard, a Gothic arch window beneath the gable, stone foundation and a rear addition.</p> <p>History: According to mapping from 1877, the property is situated within the developed area of the historic Hamlet of Columbus.</p> <p>Context: The property is located on the west side of Simcoe Street North, near to the centre of the historic Hamlet of Columbus, surrounded by residential properties.</p>

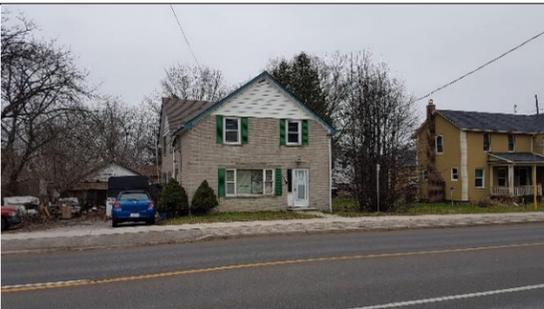
CHR49	3320 Simcoe Street North	Identified during field review	Residence	<p>Design: A two storey buff brick residential building with a cross-gable roof, flat headed windows with precast sills and aluminum siding beneath the gable.</p> <p>History: According to mapping from 1877, the property is situated within the developed area of the historic Hamlet of Columbus.</p> <p>Context: The property is located on the west side of Simcoe Street North, near to the centre of the historic Hamlet of Columbus, surrounded by residential properties.</p>

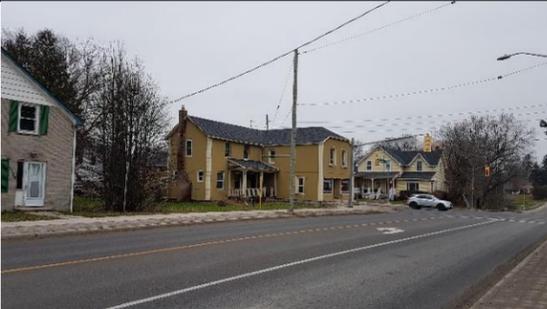
Feature ID	Address	Heritage Status	Resource Type	Description/Comments	Photograph(s)
CHR50	3330 Simcoe Street North	Identified during field review	Residence	<p>Design: A two-storey mixed use building with a commercial storefront. The building has had stucco and an exterior insulation and finish system applied to its exterior. The building has had at least three additions, primarily along Columbus Road West.</p> <p>History: According to mapping from 1877, the property is situated within the developed area of the historic Hamlet of Columbus.</p> <p>Context: The property is located on the southwest corner of the intersection of Simcoe Street north and Columbus Road at the centre of the historic Hamlet of Columbus, surrounded by residential properties.</p>

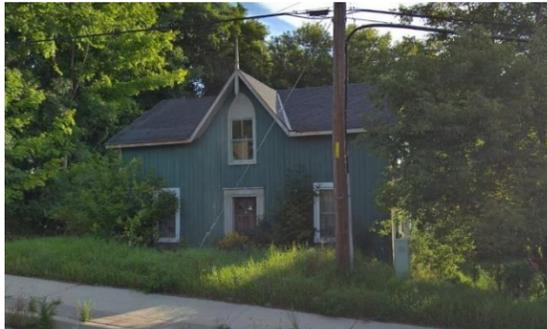
CHR51	3395 Simcoe Street North	Class B	Residence	<p>Design: A one-and-a-half storey Gothic Revival residential building with a centre gable with a finial, gothic arched window and wooden trim around the centre doorway.</p> <p>History: According to mapping from 1877, the property is situated within the developed area of the historic Hamlet of Columbus.</p> <p>Context: The property is located on the east side of Simcoe Street North, north of Columbus Road, near to the centre of the historic Hamlet of Columbus.</p>

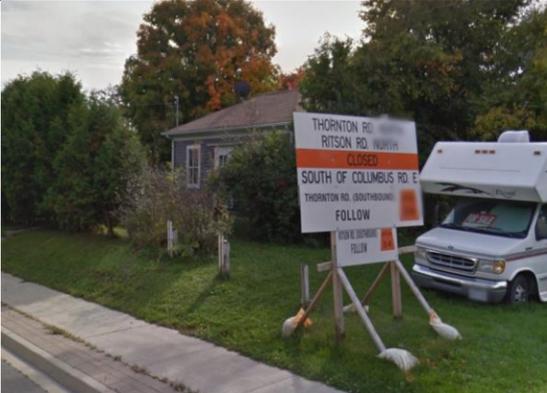
CHR52	3400 Simcoe Street North	Class B	Residence	<p>Design: A one-storey residential building with a hipped roof, centre entrance, flat-headed windows and a rear addition. The building is largely obscured by a roof of dense vegetation along Simcoe Street North.</p> <p>History: According to mapping from 1877, the property is situated within the developed area of the historic Hamlet of Columbus.</p> <p>Context: The property is located on the west side of Simcoe Street North, north of Columbus Road, near to the centre of the historic Hamlet of Columbus.</p>

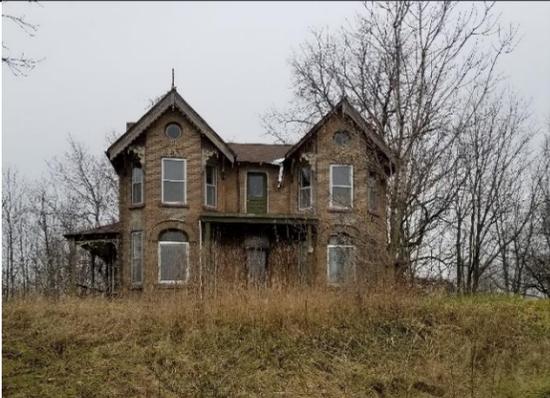
CHR57	2860 Thornton Road North	Identified during field review	Residence and farm complex	<p>Design: The property consists of two residential buildings, two farm complexes and a large farm. The residential buildings consist of:</p> <ul style="list-style-type: none"> <li>• A one-and-a-half storey residential building with a wraparound porch and a rear addition.</li> <li>• A one-storey residential building with a gable roof and front porch</li> </ul> <p>History: According to mapping from 1877 the property was owned by W. Smith.</p> <p>Context: The property is located on the west side of Thornton Road North, north of Winchester Road West. A creek runs through the property and agricultural fields are found to the east.</p>

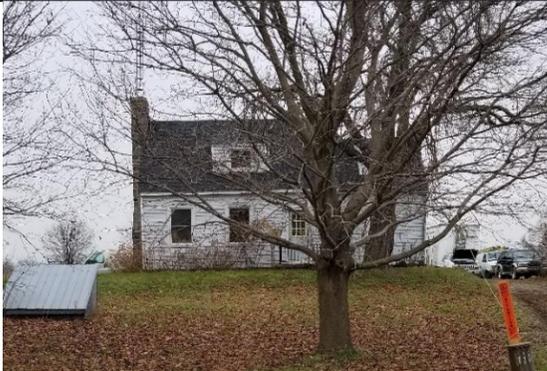
CHR59	2966 Thornton Road North	Identified during field review	Residence and farm complex	<p>Design: The property consists of a one-storey residential building with board and batten siding, a gable roof with a dormer, external brick chimney and a one-storey rear addition. A barn complex is situated to the south consisting of a wooden barn and a silo. Vegetation associated with the Oshawa Creek is situated to the west and north of the residential building.</p> <p>History: According to mapping from 1877, the property was owned by W. Smith. A building is depicted on this location in mapping from 1930.</p> <p>Context: The property is located on the west side of Thornton Road North, north of Winchester Road West. A creek runs through the property and agricultural fields are found to the east.</p>

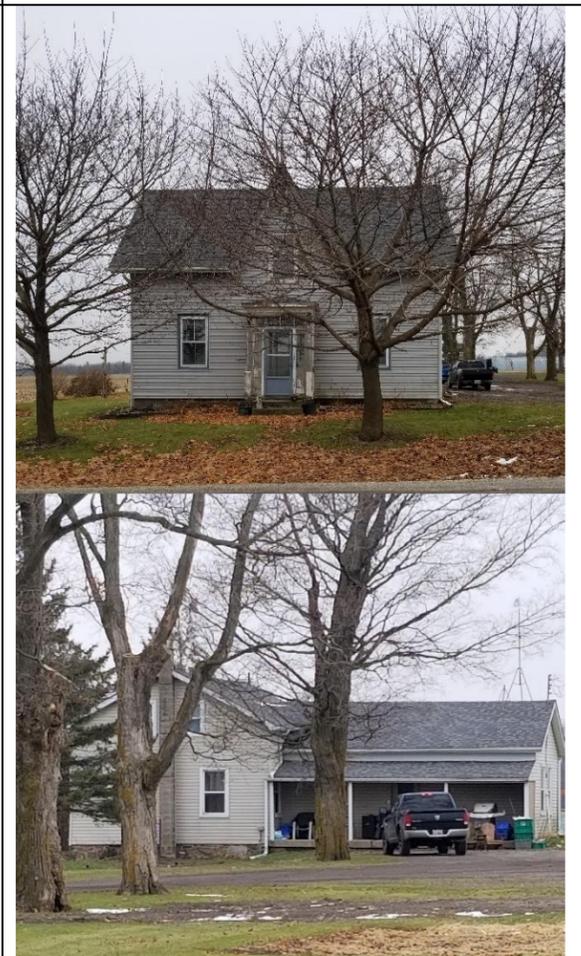
Feature ID	Address	Heritage Status	Resource Type	Description/Comments	Photograph(s)
CHR62	3856 Thornton Road North	Identified during field review	Residence and farm complex	<p>Design: The property consists of two residential buildings and a farm complex situated to the north of the residential buildings. The residential buildings consist of:</p> <ul style="list-style-type: none"> <li>• A one-and-a-half storey Gothic Revival residential building clad in siding with a gable roof and centre gable with a wood finial and decorative bargeboard. The building has an enclosed front porch, a one-storey rear addition.</li> <li>• A one-and-a-half storey residential building with a front porch.</li> </ul> <p>History: According to mapping from 1860 and 1877, the property was owned by R. Ormiston. One farmhouse is depicted on the location of the existing buildings in both maps, while a second farmhouse appears on the 1877 map.</p> <p>Context: The property is located on the west side of Thornton Road North, south of Howden Road West. The surrounding area is comprised of agricultural lands.</p>
