Harmony Creek Sites 2 & 3 Erosion Control Class Environmental Assessment

PUBLIC INFORMATION CENTRE
September 28th, 2022

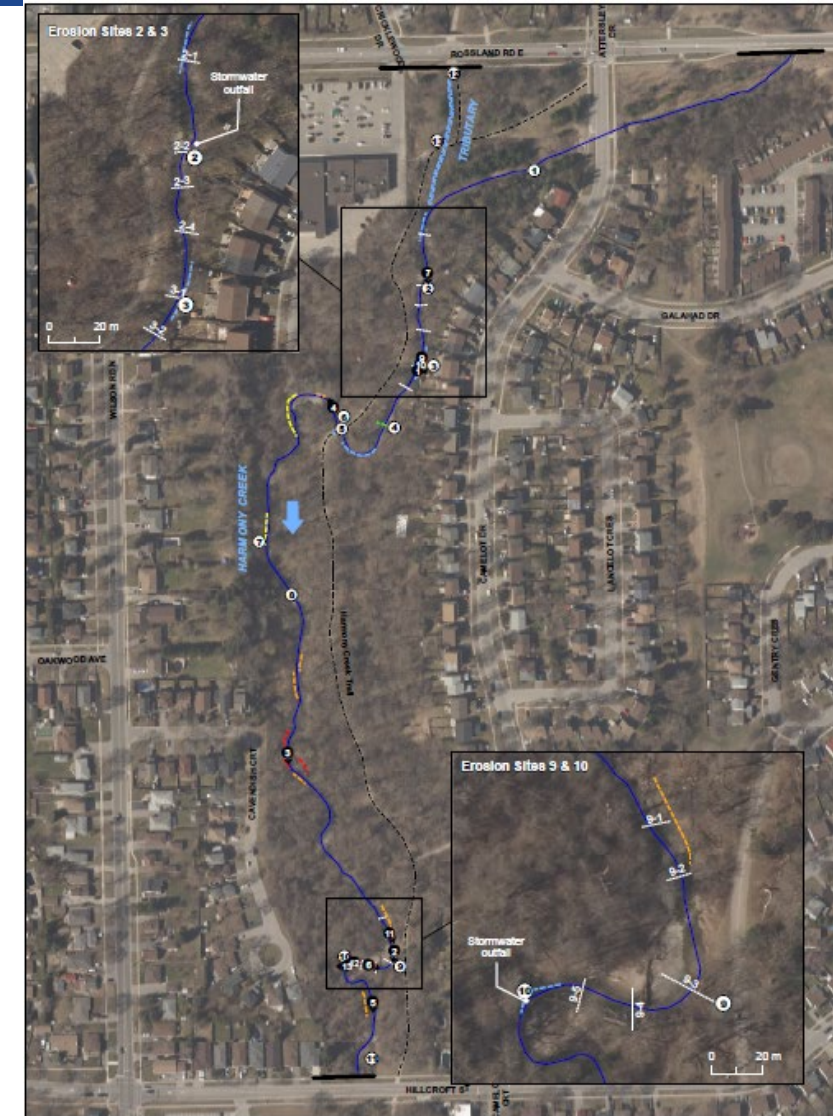
Harmony Creek Branch 3 - Fluvial Geomorphological Study and Erosion Assessment

- Previous study commissioned by the City in 2021
- Identified 13 erosion sites between Rossland Road and Hillcroft Street
- 4 sites were prioritized for more detailed follow up due to potential risk to City property, private property and/or infrastructure (Sites 2, 3, 9 and 10)

Erosion sites between Rossland and Hillcroft

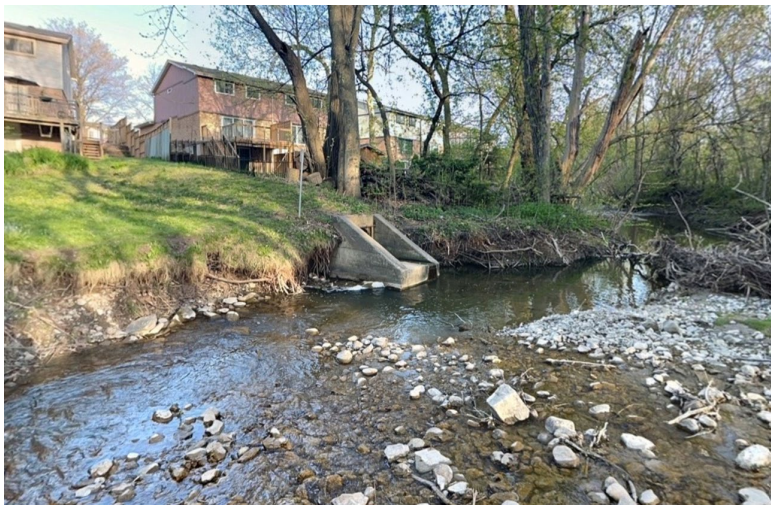
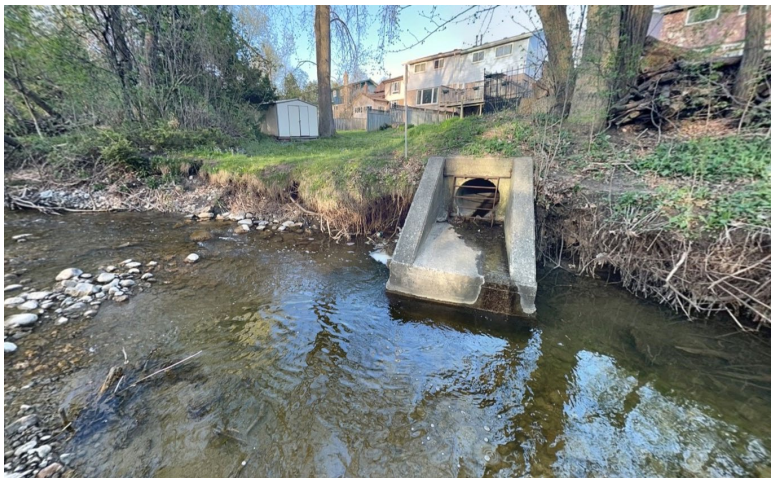
Existing Conditions - Site 2

Looking downstream

Looking upstream

City owned **stormwater outfall** has been outflanked and undermined, which may lead to its eventual collapse. Adjacent private property along Camelot Drive is at risk if outer bank erosion continues.

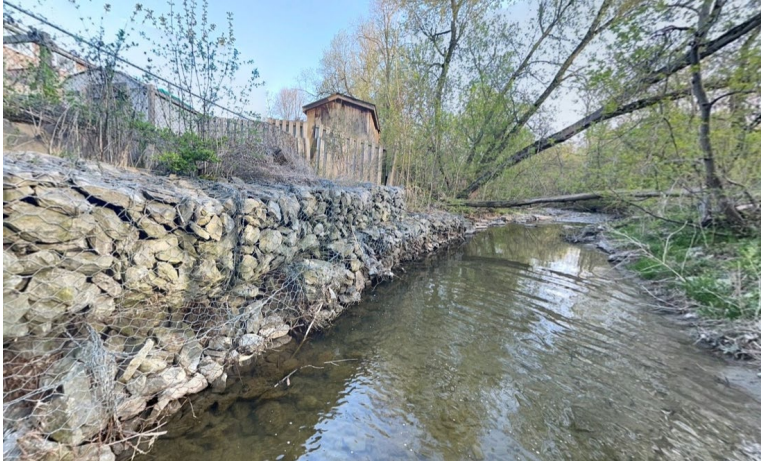
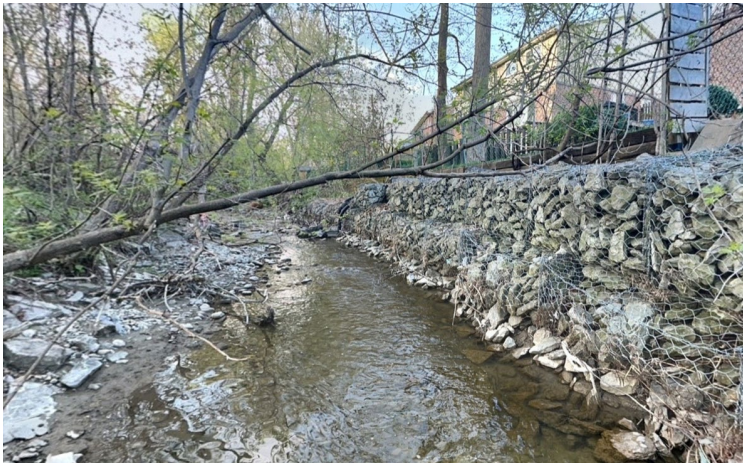
Existing Conditions - Site 3

Looking downstream

Looking upstream

30 m-long **gabion basket wall** is deteriorated along its entire length and is leaning into the channel. Infrastructure and private properties along Camelot Drive are at risk if the gabion wall continues to deteriorate and eventually fails.

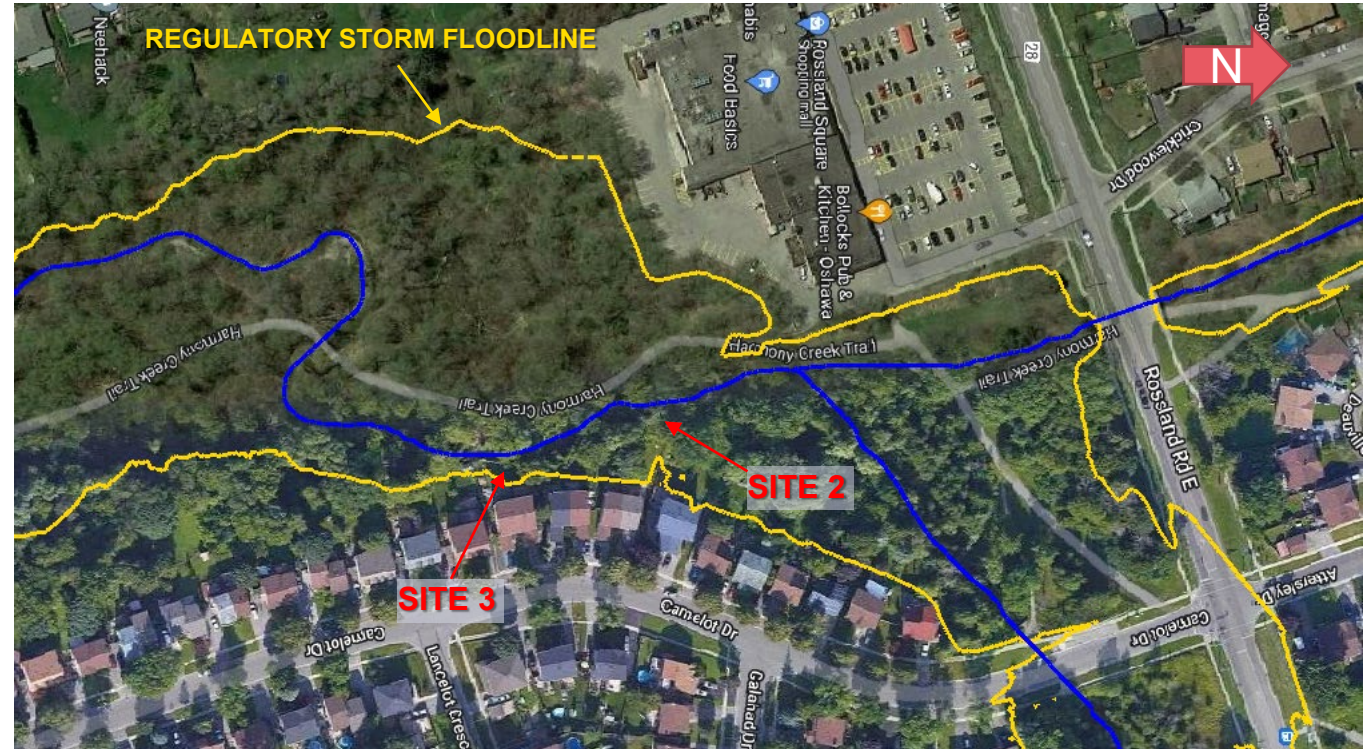
- Hydrology and Hydraulics of Harmony Creek were studied
- Provided information on how much water flows through the creek, the forces it exerts under normal and extreme conditions, and the extent of flooding
- This information is used to ensure proposed mitigative solutions do not worsen or impact flooding in the area
- The limits of the Regulatory floodplain are shown below as a yellow outline.

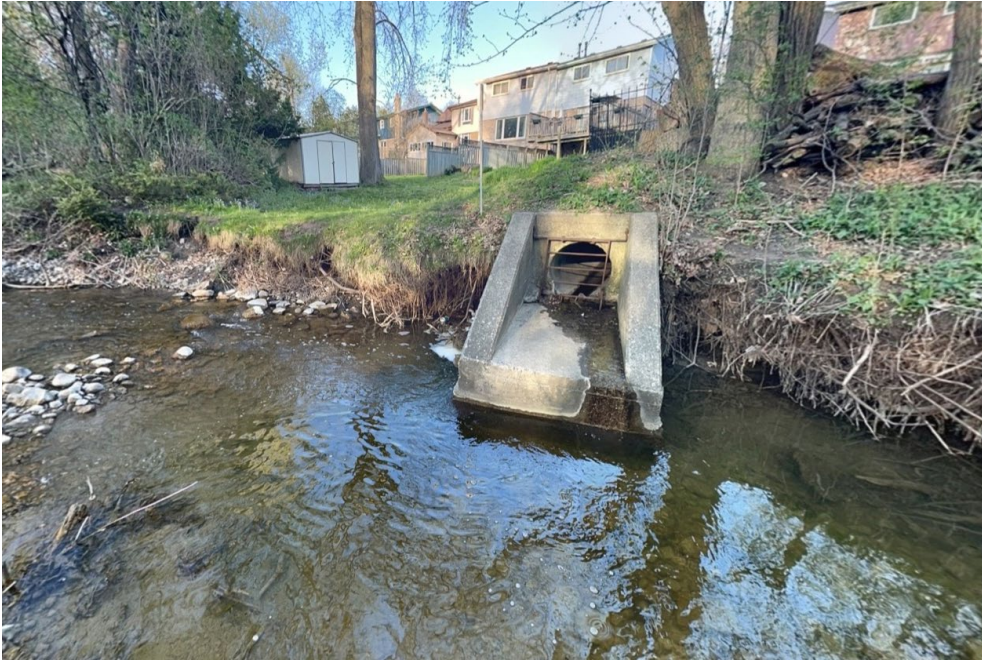
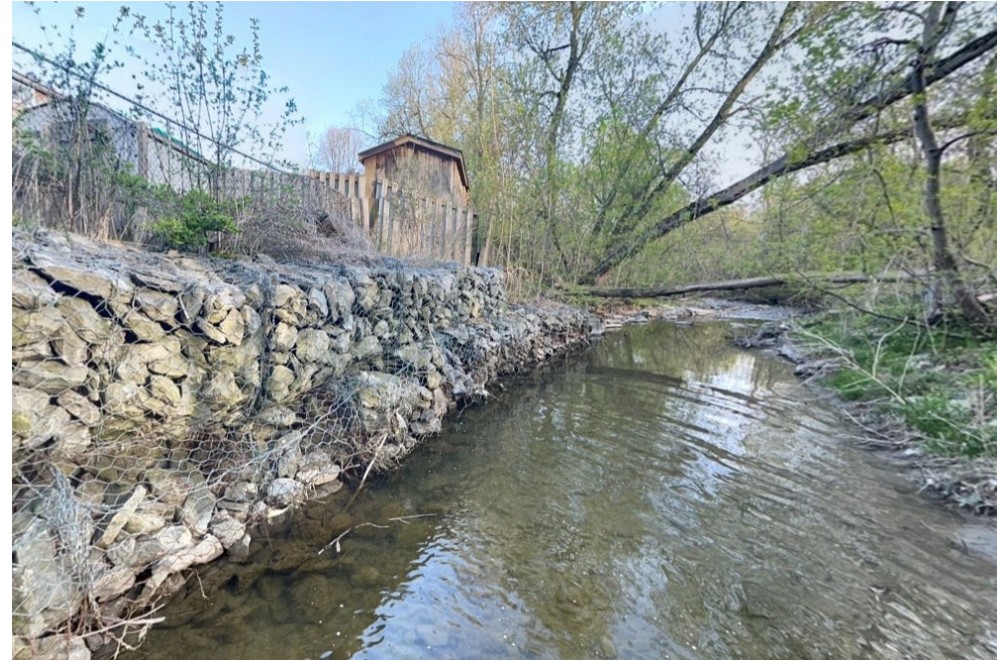
Alternative 1 – Do Nothing

- No restoration measures implemented
- This alternative would involve leaving the existing creek, including the stormwater outfall and gabion basket wall, to continue failing.
- Existing risks associated with eroding streambanks, failure of the stormwater outfall, failure of the gabion wall and damage to private property remain.
- No upfront capital cost. Under emergency conditions (i.e. failure), works would occur. Ongoing monitoring would be necessary.

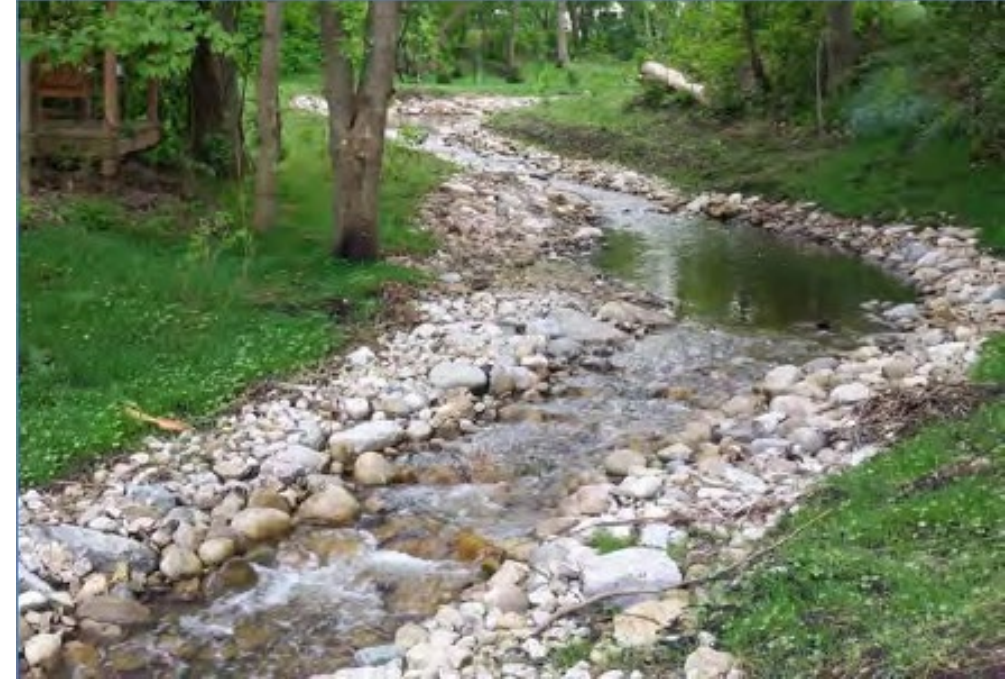
Example of Natural Channel Realignment

- Natural channel realignment would reposition the creek toward the center of the valley bottom, mitigating risk to the outfall and private properties.
- Combines Sites 2 and 3 into one project, maximizing efficiency and minimizing disruption to residents.
- The existing channel would be backfilled with clean fill and compacted to prevent reoccupation during flood events.
- This alternative involves the highest level of disruption to the study area and would require local realignment of the Harmony Creek Trail.
- Once completed, however, it would provide long-term erosion protection and improved conditions in terms of natural function and processes of the watercourse.
