Existing Conditions Transportation Assessment

Existing Conditions Transportation Assessment – Final Report

Stevenson Road North Environmental Assessment (EA) Study – Schedule ‘C’

Date: August 23, 2023

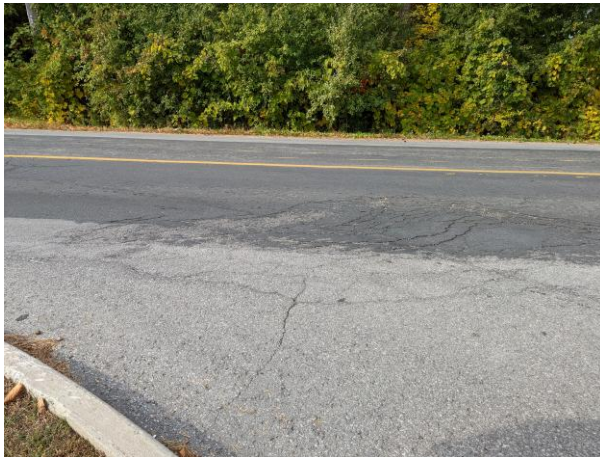
The study corridor has a two-lane cross section with unpaved shoulders. A solid yellow centerline runs along the corridor for its entirety. Pavement markings on the travel lanes throughout the corridor were observed to be in poor condition. Cracks in pavement can be seen at sporadic locations along Stevenson Road. Examples of the observed pavement conditions are presented in **Figure 3** and **Figure 4**

Figure 3: Cracks in Pavement on NB Lane, approx. 90m north of Taunton

- Pavement markings on the travel lanes throughout the corridor were observed to be in poor condition. Cracks in pavement can be observed at multiple locations along the study corridor. Sample photos are provided in the report. *The pavement condition can be improved through the City's regular road maintenance program including crack sealing and resurfacing projects.*

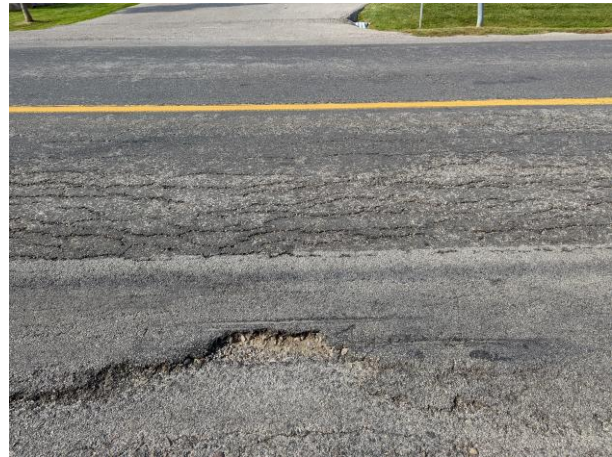
Figure 4: Cracks and Hole in Pavement on NB Lane, approx. 1.1 km south of Conlin

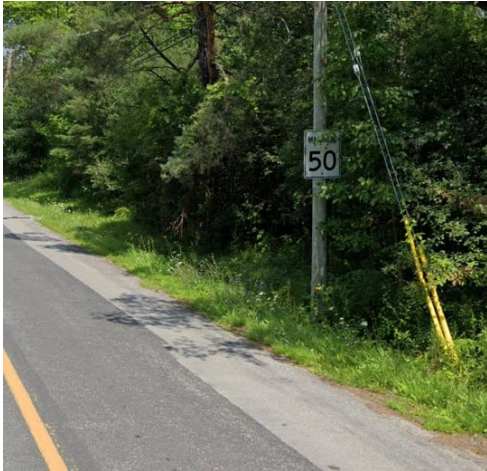
- **Regulatory Signage (OTM Book 5)**
 - Stop Sign: Stop sign exists on the south approach at Conlin Road which is a minor-stop controlled. No deficiencies were observed.
 - Speed Control Sign: Posted speed limit signs (maximum 50) are adequate and present. During the desktop review, it was noted a posted speed sign approximately 180m north of Taunton Road for the northbound direction was only *partially* visible due to vegetation based on Google Streetview dated in July 2021 (refer to **Figure 5**). The visibility of the subject sign was reviewed during the site visit conducted in October, and no visibility issues was noted, as shown in **Figure 6**. Vegetation control can be considered to trim any over-extended branches or brushes that may obstruct the sign visibility, especially during the summer.

Figure 5: Posted Speed Sign, approx.180m north of Taunton (Source: Google Streetview, July 2021)

- A posted speed sign approximately 180m north of Taunton Road for the northbound direction was noted to be only partially visible due to vegetation based on Google Streetview dated in July 2022. *No sign visibility issue was noted during the site visit; however, vegetation control can be considered to trim any over-extended branches or brushes that may obstruct the sign visibility, especially during the summer months.*

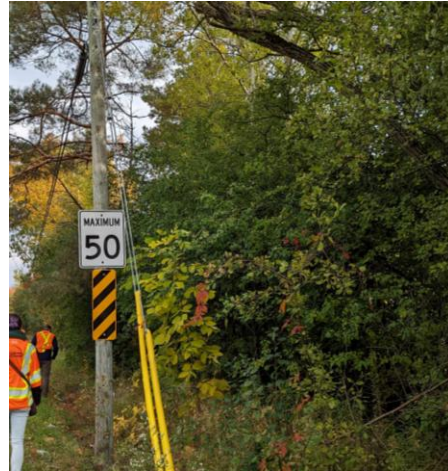
Figure 6: Posted Speed Sign, approx.180m north of Taunton (Source: Site Visit, Oct 12, 2022)

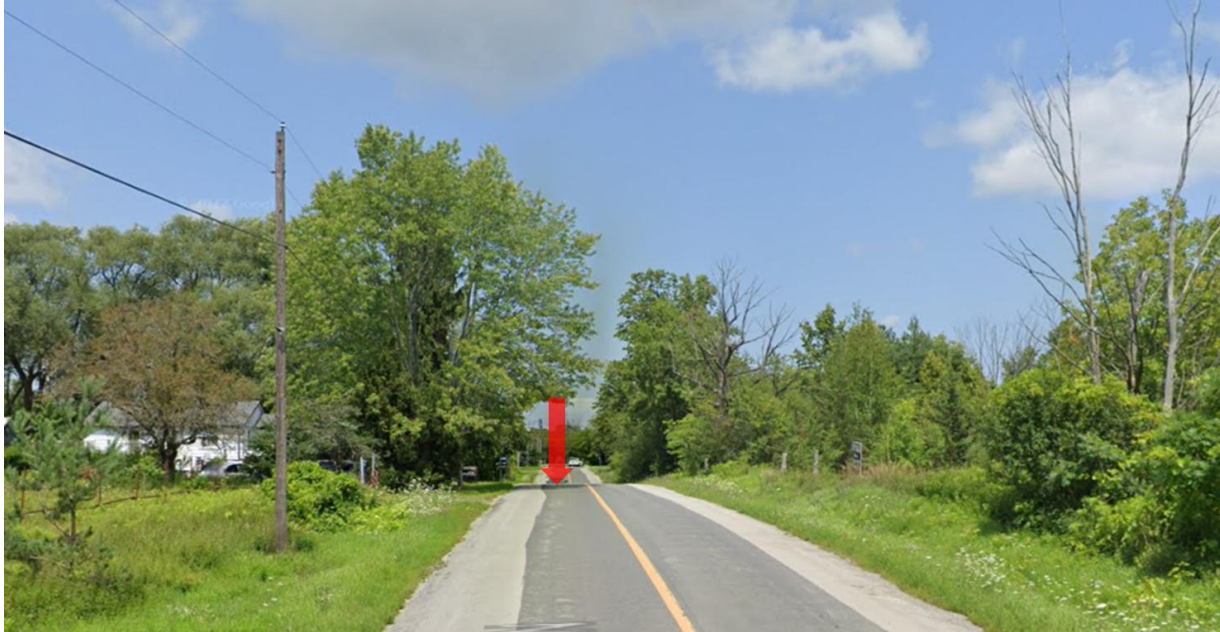
A crest vertical curve can be observed within the northern section of the study corridor, as depicted in **Figure 7**. A qualitative review of the sightlines along Stevenson Road and its intersections with driveway accesses were conducted and there were no impediments identified for road users. The sightline at the existing driveway accesses appeared to be adequate approaching this vertical curve. Nevertheless, sight stopping distances should be reviewed for any future driveway accesses along the study corridor to ensure that the required sight distance is provided. Since Stevenson Road is proposed for a design speed of 70km/hr, a minimum stopping sight distance of 105 metres should be provided on crest vertical curves according to Section 3.3.3 of the TAC guideline.

Figure 7: Crest Vertical Curve on Stevenson Rd, Looking North approx. 500m South of Conlin Road

- A high-level sightline review along Stevenson Road and its intersections with driveway accesses were conducted and there were no impediments identified for road users. A crest vertical curve can be observed within the northern section of the study corridor, approximately 500m south of Conlin Road. However, the sightline at the existing driveway accesses appeared to be adequate approaching this vertical curve. *The sight stopping distances should be reviewed for any future driveway accesses along the study corridor to ensure that the required sight distance is provided. Since Stevenson Road is proposed for a design speed of 70km/hr, a minimum stopping sight distance of 105 metres should be provided on crest vertical curves according to Section 3.3.3 of the TAC guideline.*
