# Heritage Research Report

**37 Adelaide Avenue West**

**City of Oshawa, Ontario**

## **Final Report**

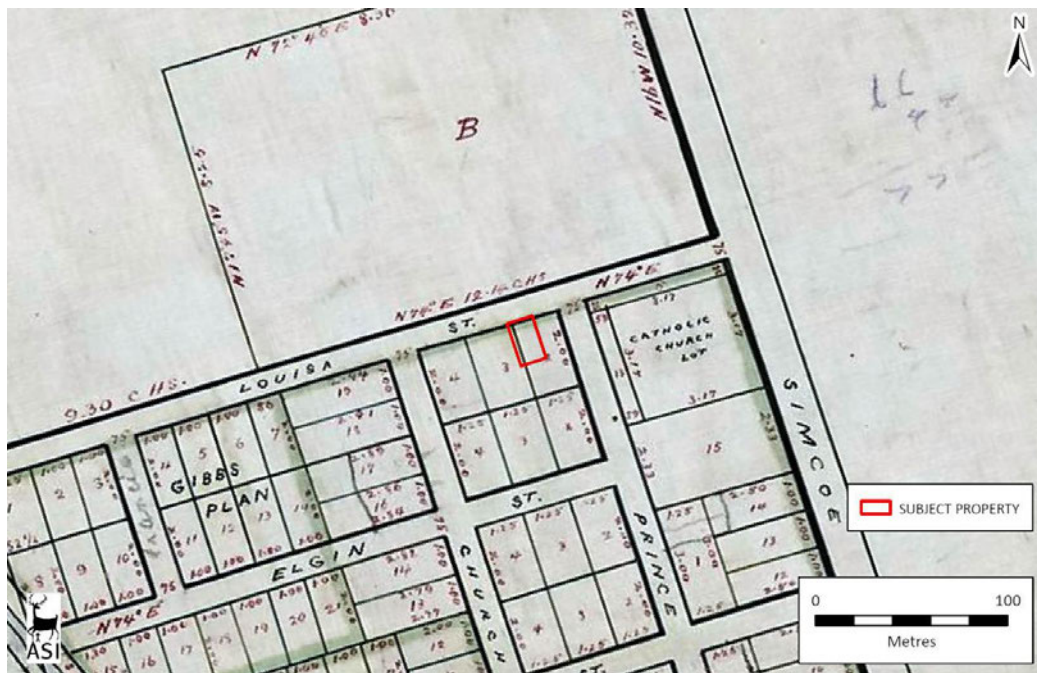
Figure 5: The location of the subject property overlaid on the 1894 Municipal Plan of the Town of Oshawa (Deans, 1894).

The 1894 Municipal Plan of Oshawa shows the property on the south side of Louisa Street, just west of Prince Street. The Catholic Church lot is located on the east side of Prince Street and the large lot on the northwest corner of Louisa and Simcoe streets is now home to the Parkwood Estate (Figure 5).

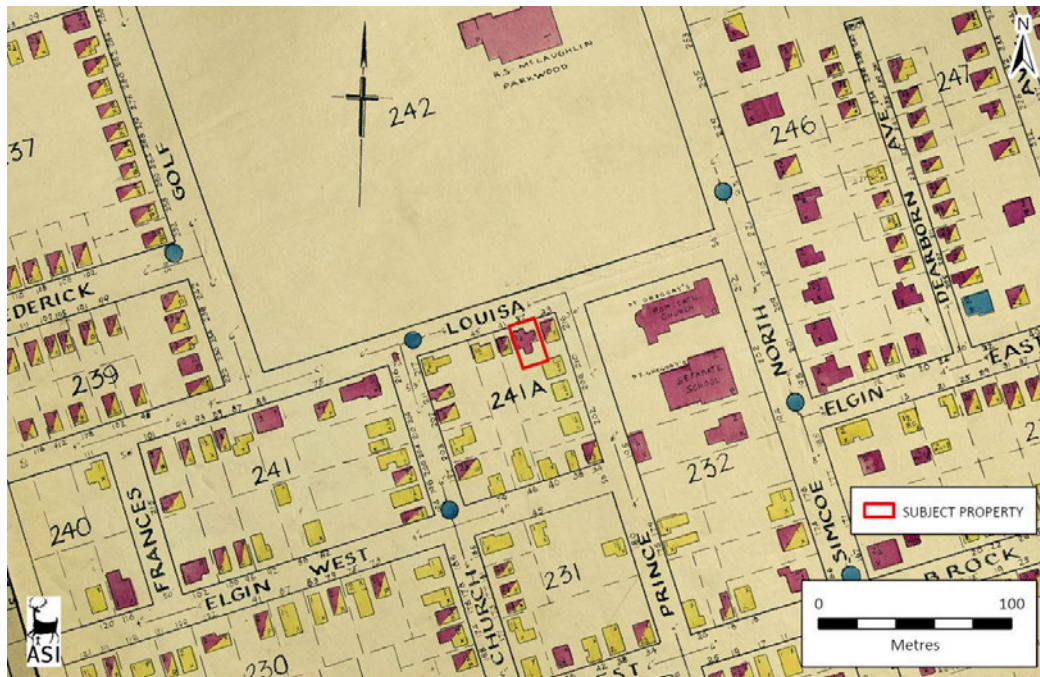
Figure 7: The location of the subject property overlaid on a 1938 City of Oshawa Fire Insurance Plan (Underwriter's Survey Bureau Ltd, 1938).

The Leasks continued to occupy the residence into the early 1930s. The 1931 census identifies the occupants of the residence (now listed as having seven rooms likely indicating an interior renovation) as Mary Leask and her daughter Helen Marion, who was a bookkeeper in a real estate office (Library and Archives Canada, 1931). In 1932, Mary Leask and one of her daughters moved to Sarnia. For the following 11 years, Helen Leask, who remained the property owner, appears to have rented out the residence to different tenants, including Robert Tait, who worked at General Motors, from 1933 to 1935, and Edgar Thomas, a janitor at the Regent Theatre, from 1936 to 1940 (see City Directories from 1930s and 1940s). The 1938 Fire Insurance Plan depicts the residence now with a house on either side of it (33 and 41 Louisa), as well as more residential in-fill in the surrounding area (Figure 7).

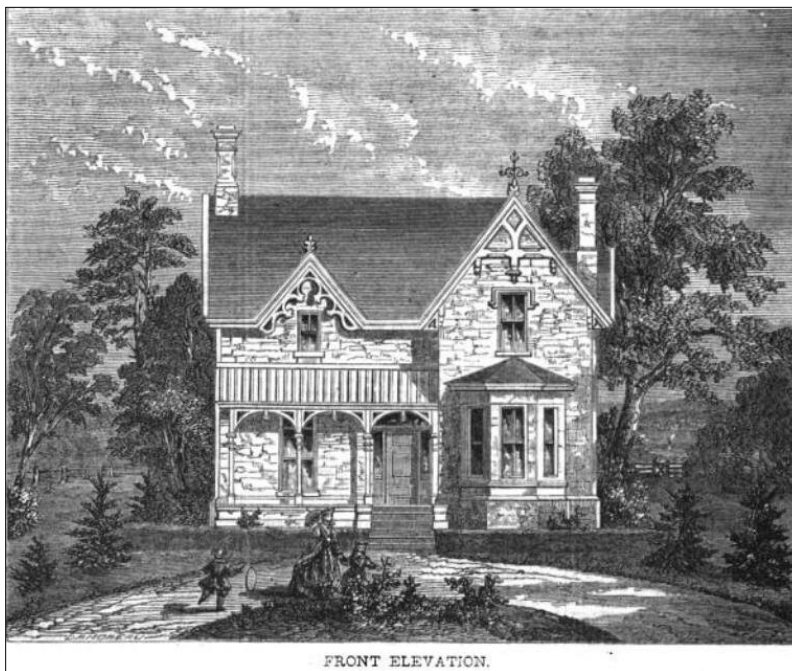
The residence on the subject property is a vernacular interpretation of the Gothic Revival architectural style. Gothic Revival residences are distinguished by their gables and use of Gothic detailing, including arched windows, bargeboards, and finials. This style was one of the most common domestic styles in Ontario amongst European settlers, though often taking the form of a vernacular cottage. While architect-designed Gothic Revival buildings are found throughout Ontario, the prevalence of the Gothic Revival style is owed more to the availability of plans and forms set in pattern books that were popular with the middle class, farmers, and other rural settlers (Mikel, 2004). These Gothic vernacular cottages were typically one-and-a-half storeys, would have a gable-end, symmetrically balanced with a central door flanked by a window on either side. The houses would be individualized with available details and finishes including arched windows and decorative trim (Mikel, 2004). Another feature was the use of two tones of brick, usually a red brick with buff or yellow brick to highlight. This is known as dichromatic brickwork, which was a vernacular attempt at producing the polychromatic effect (Blumenson, 1990). Typical designs for Gothic Revival homes from the period are included below in Figure 10 and Figure 11, the subject residence closely follows the T-shaped plan shown in Figure 11, with very few exceptions.

Figure 11: Illustration of a vernacular Gothic Revival house from *The Canada Farmer*, vol. 1, 1864 (Clarke, 1864).

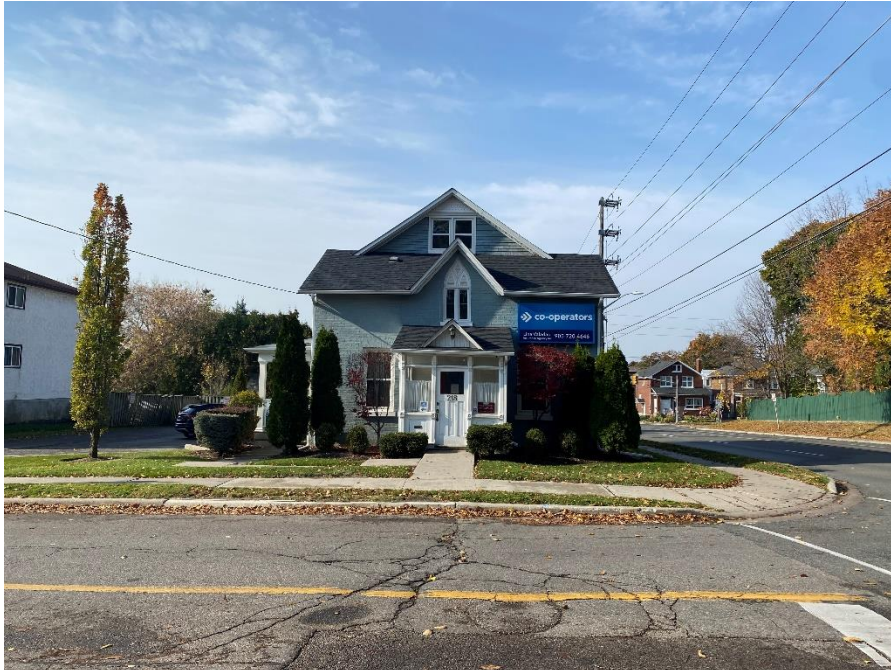
Figure 12: The structure at 218 Centre Street North, looking west (A.S.I., 2024).

Within the same neighbourhood as the subject property is 218 Centre Street North. The house is a vernacular Gothic Revival residence, constructed in 1868. The property is listed as a “Class B” property in the Heritage Oshawa Inventory of City of Oshawa Heritage Properties (Heritage Oshawa, 2023). Set at the southwest corner of Adelaide Avenue West and Centre Street North, the original portion of the residence faces east and appears to have had a rectangular plan. There is a large two-storey addition on the rear of the structure which includes a sizeable front-facing gable above the original roofline and a covered porch on the southern elevation. The porch on the primary façade (eastern elevation) has been enclosed. The structure has an ogee window in a front-facing gable on the primary façade, though the frame and sash appears to have been replaced. While the structure was constructed as a residence, it has since been converted for commercial use and presently houses the offices of an insurance company (Figure 12).

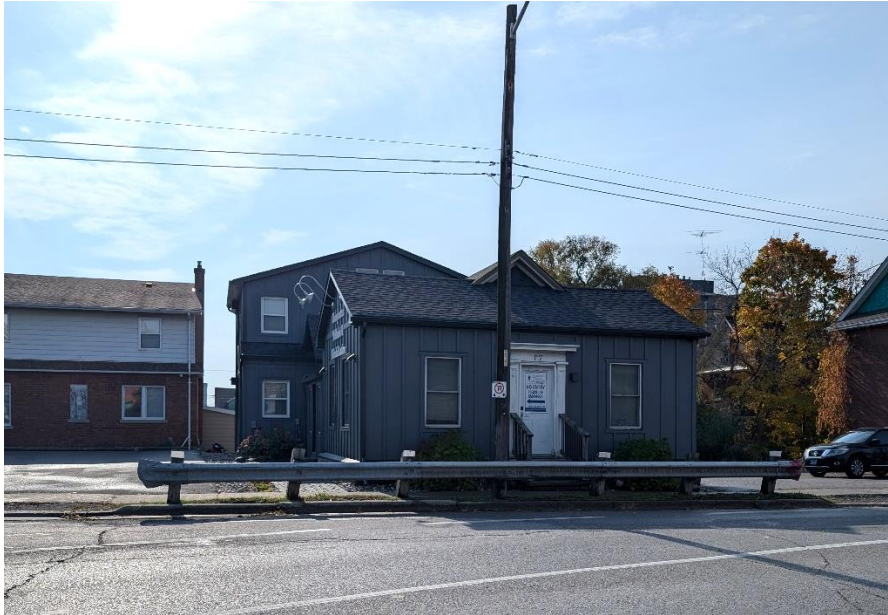
Figure 13: The structure at 17 Brock Street West, looking west (A.S.I., 2024).

Another example within the neighbourhood is the property at 17 Brock Street West and the residence was constructed in 1860. The property is listed as a “Class A” property in the Heritage Oshawa Inventory of City of Oshawa Heritage Properties (Heritage Oshawa, 2023). The original structure is a single-storey residence with an irregular plan, irregular gable roof, and cut stone foundations. There is a large two-storey addition on the rear of the structure (which was constructed after 2020 based on a review of images on Google Streetview) and a covered entryway on the southern elevation which appears to be a twentieth-century addition. The entire structure, including the rear addition is clad in dark blue aluminum siding. The door surround on the primary façade (eastern elevation) appears to be original, however the windows and doors on the original structure appear to be modern replacements within their original openings. While the structure was constructed as a residence, it has since been converted for commercial use and presently houses a medical office (Figure 13).

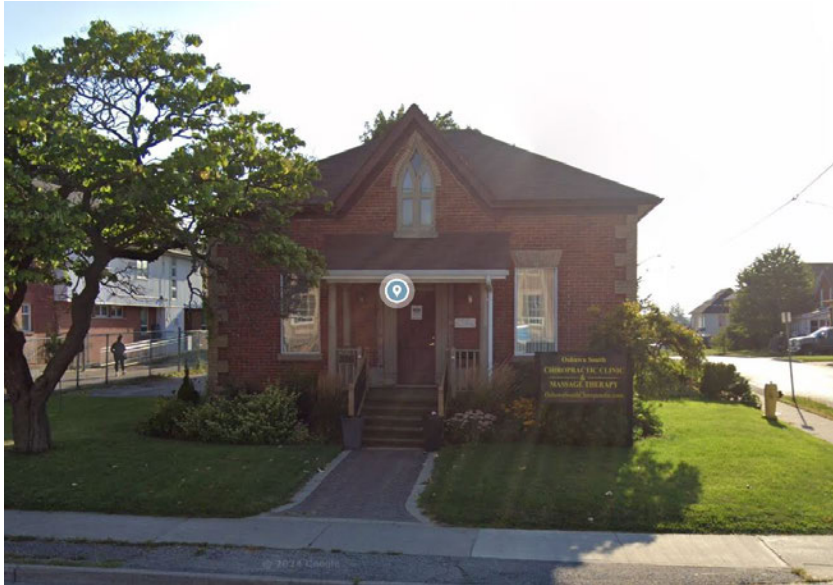
Figure 14: The structure at 356 Simcoe Street South, looking west (Google Streetview, 2024).

Located approximately 1.8 kilometres from 37 Adelaide Avenue West is 356 Simcoe Street South. The Gothic Revival residence was constructed in 1880. The property is listed as a “Class B” property in the Heritage Oshawa Inventory of City of Oshawa Heritage Properties (Heritage Oshawa, 2023). The building is a single-storey residence with a rectangular plan, a rear extension, central gable on the front façade (eastern elevation), hipped roof, and fieldstone foundations. There is an ogee window beneath the central gable. The windows appear to have all been replaced; however, the openings appear to be original. The building has dichromatic brickwork and the buff brick is used for the quoining and window arches. While the structure was constructed as a residence, it has since been converted for commercial use and presently houses a medical office (Figure 14).

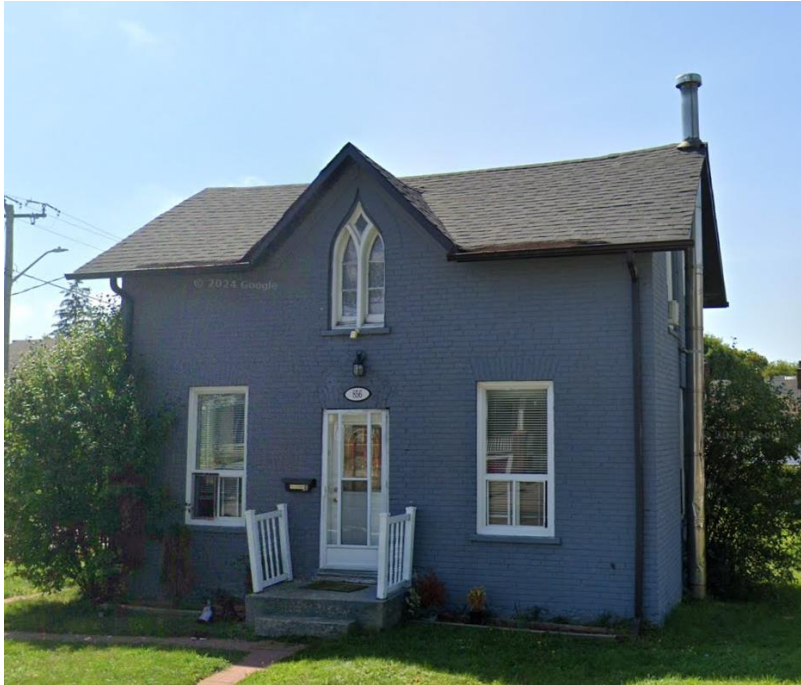
Figure 15: The residence at 856 Simcoe Street South, looking west (Google Streetview, 2024).

Located approximately 3.2 kilometres from 37 Adelaide Avenue West is 856 Simcoe Street South. The Gothic Revival residence was constructed in 1870 and is listed as a “Class B” property in the Heritage Oshawa Inventory of City of Oshawa Heritage Properties (Heritage Oshawa, 2023). The structure is a one-and-a-half storey brick residence with a rectangular plan and a rear extension, central gable on the front façade (eastern elevation), hipped roof, and fieldstone foundations (Figure 15). There is an ogee window beneath the central gable. The windows appear to have all been replaced; however, the openings appear to be original. Minutes from a Heritage Oshawa meeting that discussed this residence noted the ogee window as a rare design (Heritage Oshawa, 2020).

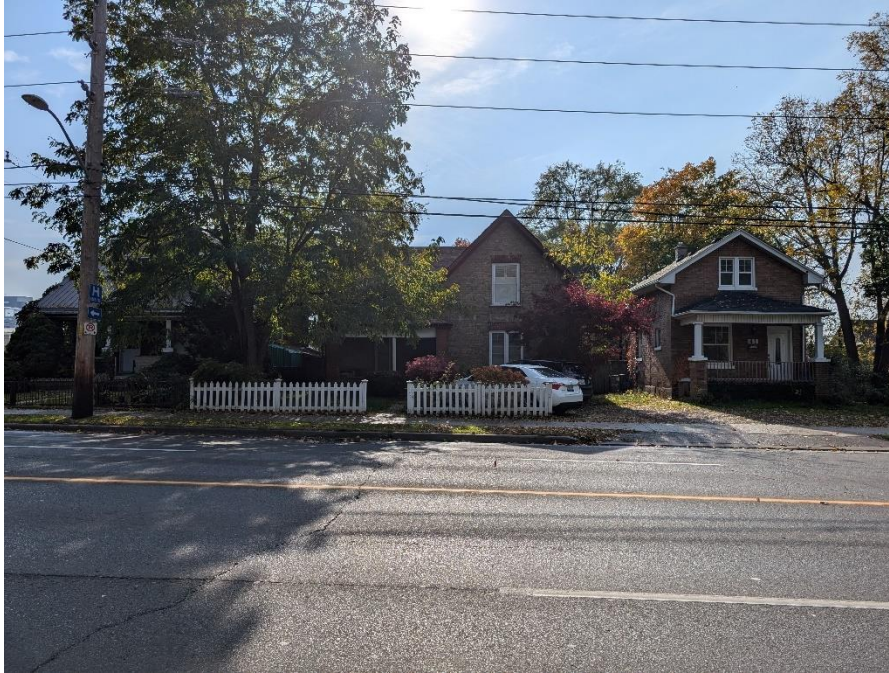
Figure 17: The front of the subject property at 37 Adelaide Avenue West, looking south (A.S.I., 2024).

covered porch at the entryway to the home. A short white picket fence runs along the front of the property at the sidewalk. There are gardens between the driveway and the pathway and along the eastern property line where there is also a large mature tree. There is a small Japanese Maple tree near the northwest corner of the residence (Figure 17).

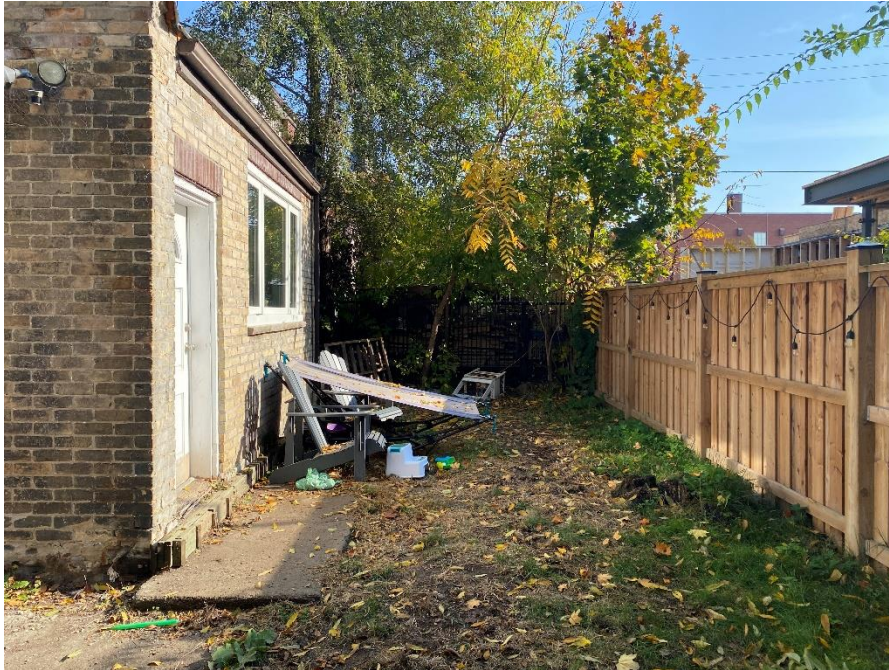
Figure 18: The back yard of the subject property looking east from the southwest corner of the property (A.S.I., 2024).

The backyard is surrounded by wooden privacy fencing on the south and west sides and an aluminium fence on the east. There are several shrubs and small trees around the property at the fence line (Figure 18).

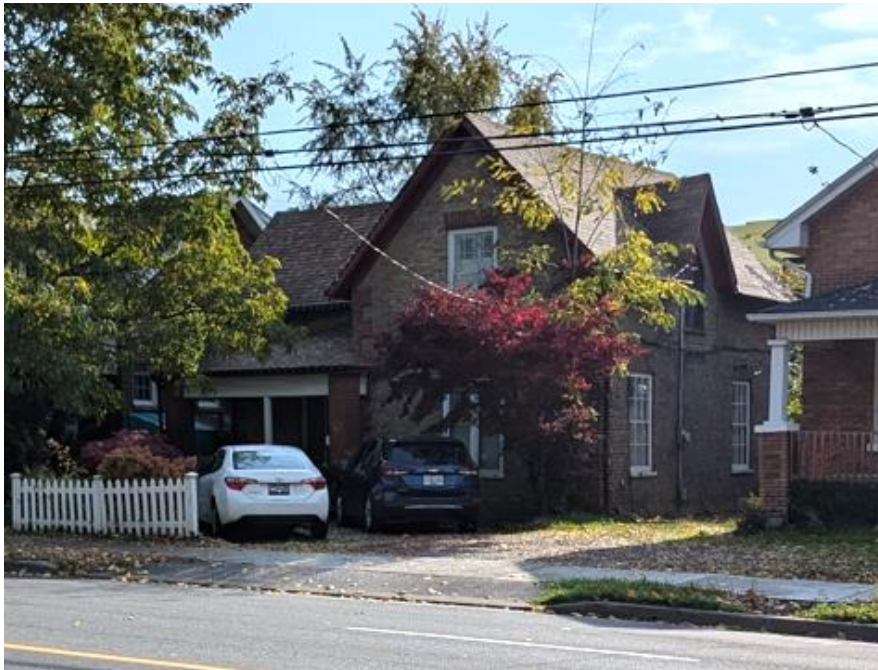
Figure 19: The primary façade (northern elevation) and eastern elevation of the subject residence (A.S.I., 2024).

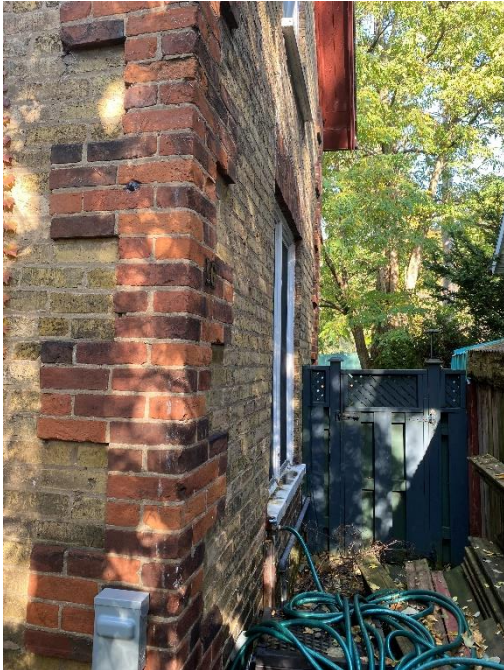
Figure 20: Detail view of the quoining on the eastern elevation showing the dichromatic brick (A.S.I., 2024).

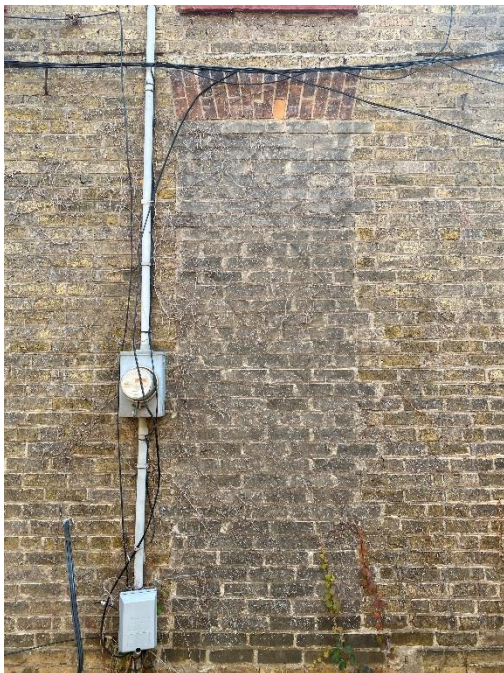
Figure 21: A bricked in window on the western elevation (A.S.I., 2024).

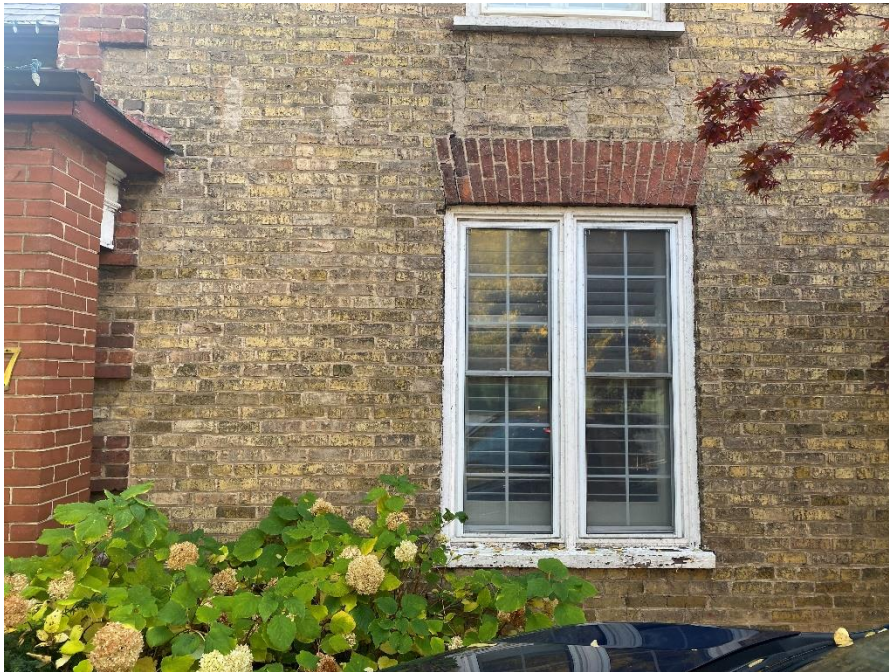
Figure 22: A former casement window on the northern elevation (A.S.I., 2024).

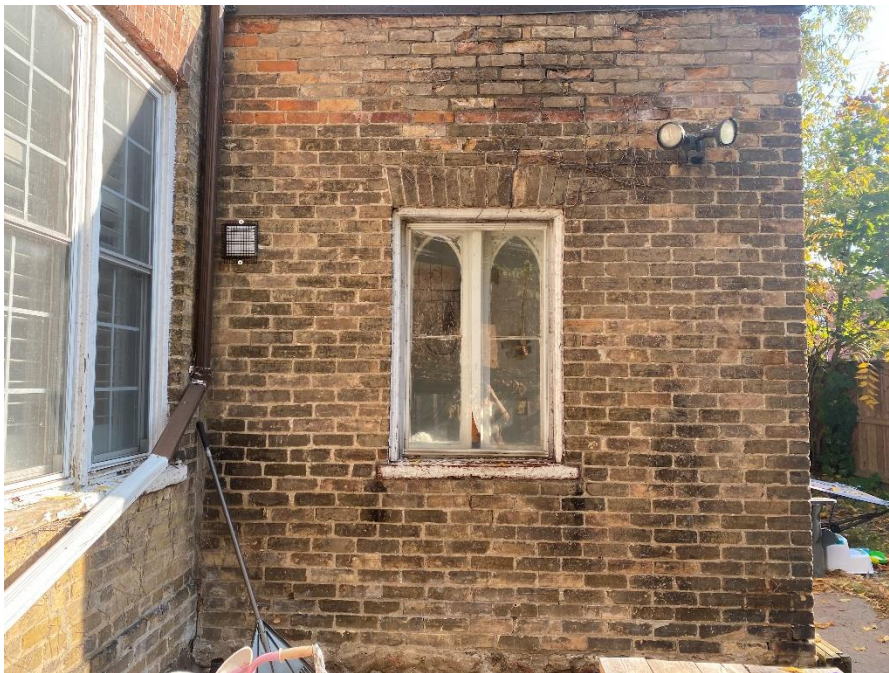
Figure 23: The Gothic casement window on the rear extension (A.S.I., 2024).

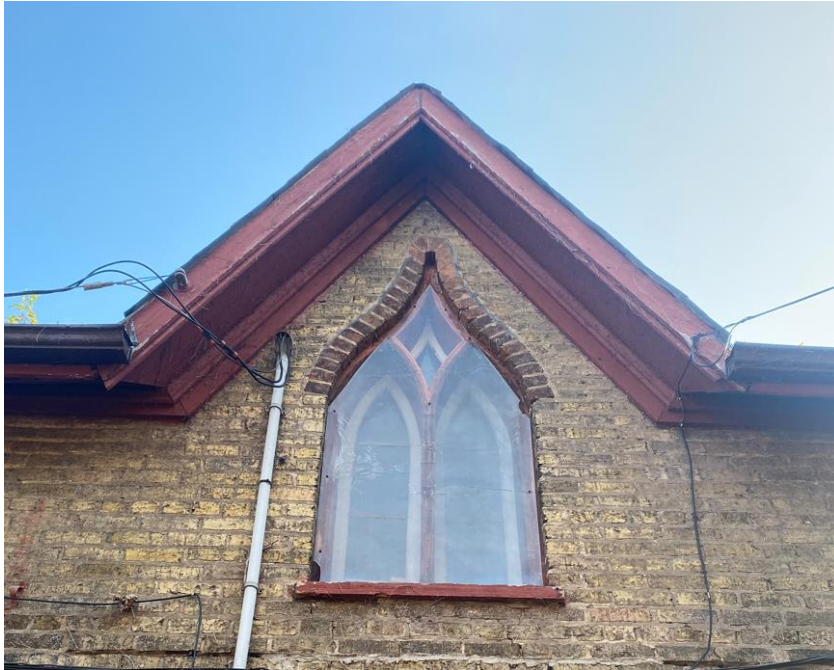
Figure 24: Detail view of the ogee window in the western façade (A.S.I., 2024).

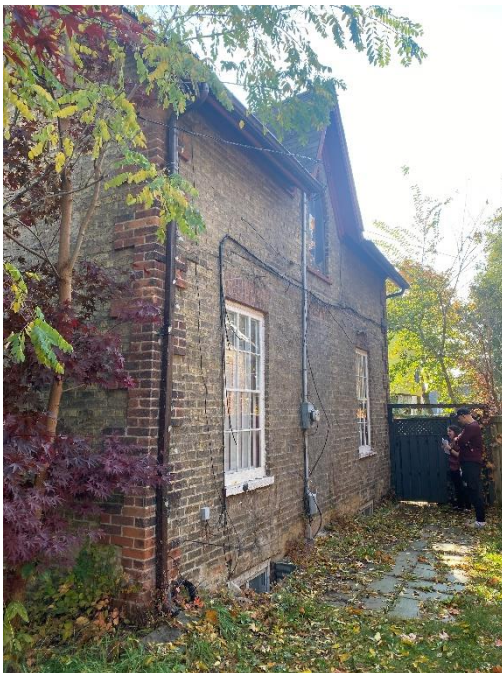
Figure 25: The western façade of the subject residence looking south (A.S.I., 2024).

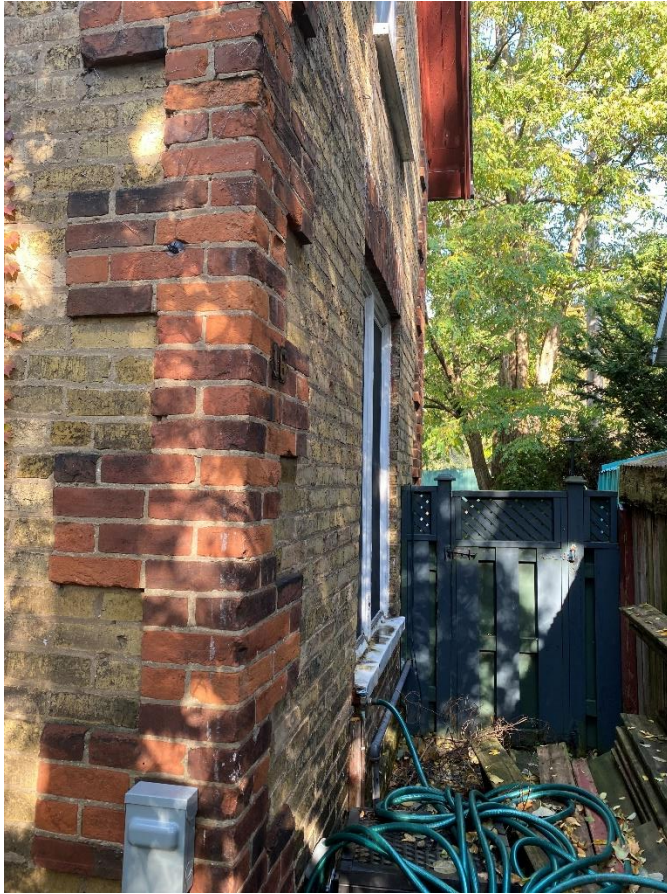
Figure 26: The eastern elevation of the subject residence looking north. The number 16 is just visible in the red brick quoining (A.S.I., 2024).

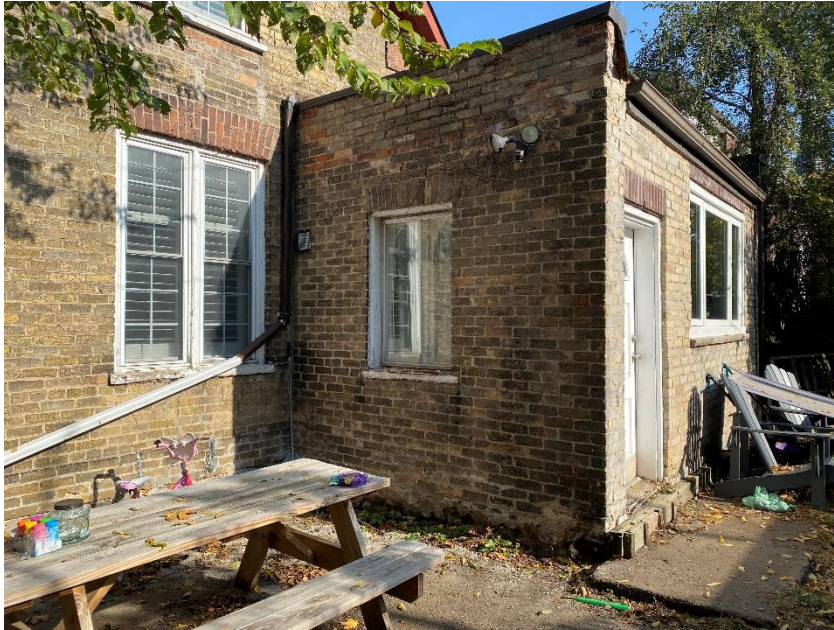
The rear extension is constructed of similar buff brick to the main residence, indicating it was likely added not long after the construction of the original building. The building interior with exposed exterior brick walls confirms that this portion of the building was likely not part of the original construction or had a much different configuration or relationship to the T-shaped portion of the building. The extension appears to have been repaired and rebuilt several times, with sections where the brick has been replaced and portions of the brick showing residual signs of metal lathe and plaster (Figure 27). The foundations of the extension are fieldstone with cement parging on the southern and western elevations. There are pieces of lumber up against the foundations along most of the southern elevation.

Figure 27: The rear extension, looking northeast (A.S.I., 2024).

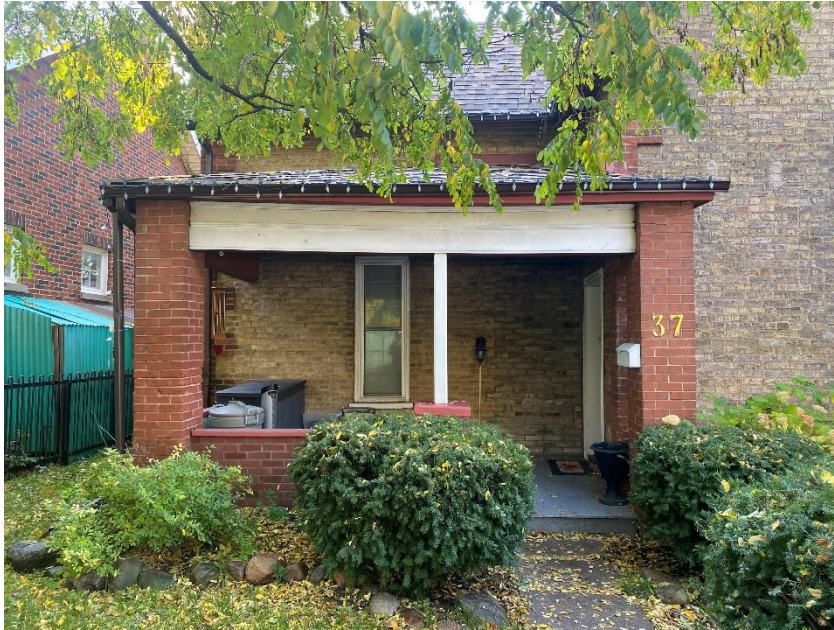
The present-day porch over the entry way is likely an early- to mid-twentieth century addition. While the brick used in the porch matches the red colouring of the original structure, it is a much harder, smooth faced brick (Figure 35). Marks in the brick on the primary façade indicate that this porch replaced an earlier

Figure 35: The early- to mid-twentieth century porch on the primary façade (northern elevation) (A.S.I., 2024).

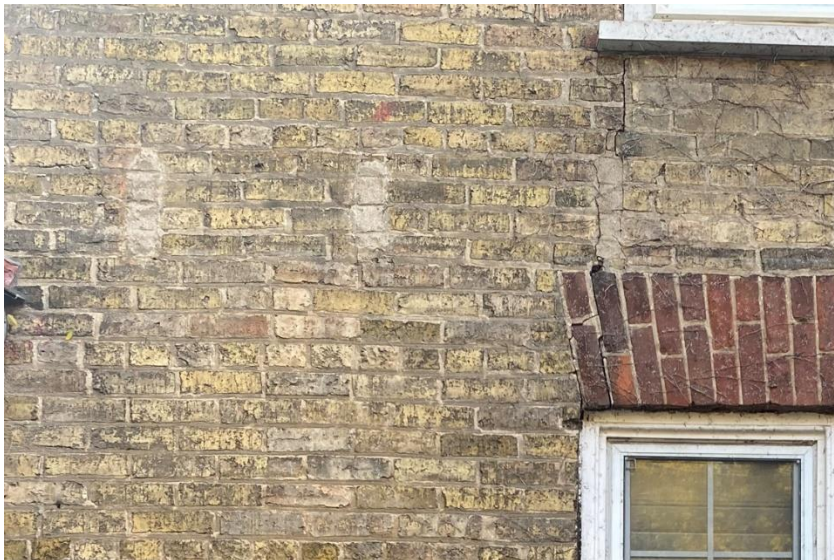
Figure 36: Detail view of the markings on the brick in the northern façade indicating an early covered porch (A.S.I., 2024).

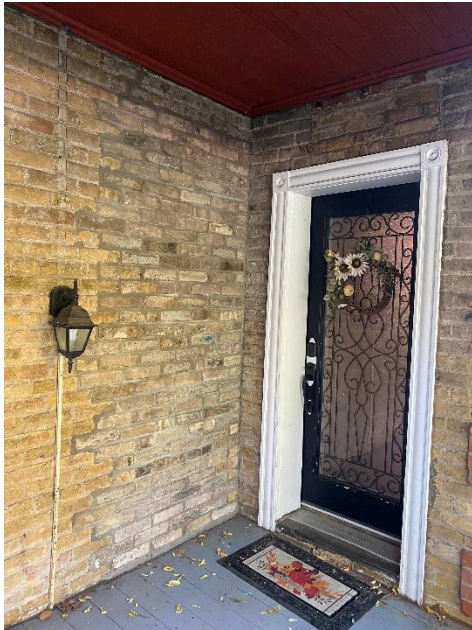
Figure 37: The present-day front door and the location of the original front door to the left. (A.S.I., 2024). Note the different colour brick.

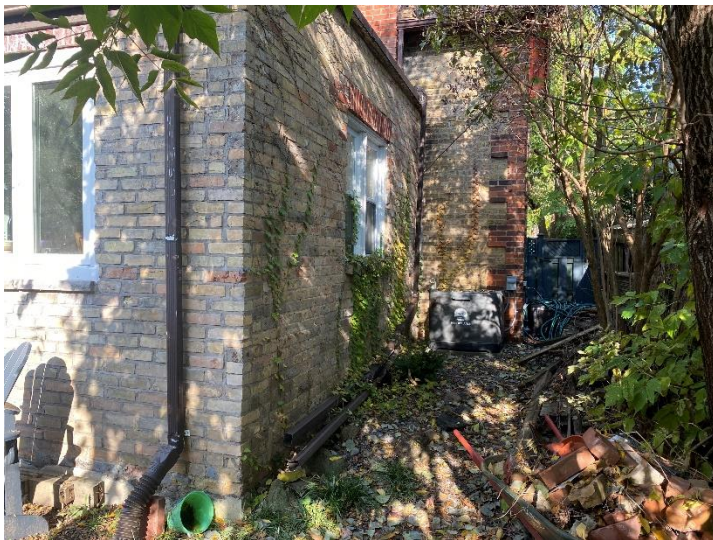
Due to the similarity of the brick used in the construction of the rear extension to the brick used in the original residence, it is assumed that the extension was added soon after the construction of the main house. Differences in the brick in the extension walls, indicate that it has been repaired and reconstructed several times (Figure 38). The former exterior wall of the residence is visible from inside the kitchen in the rear extension (Figure 39).

Figure 38: The southeast corner of the rear extension (A.S.I., 2024). Note the different bricks and visible repairs to the walls.
