Fluvial Geomorphological Assessment of Oshawa Creek and Evaluation of Erosion Mitigation Strategies at Prioritized Sites

Thomas Street to Wentworth Street West

Palmer Project #

1510206

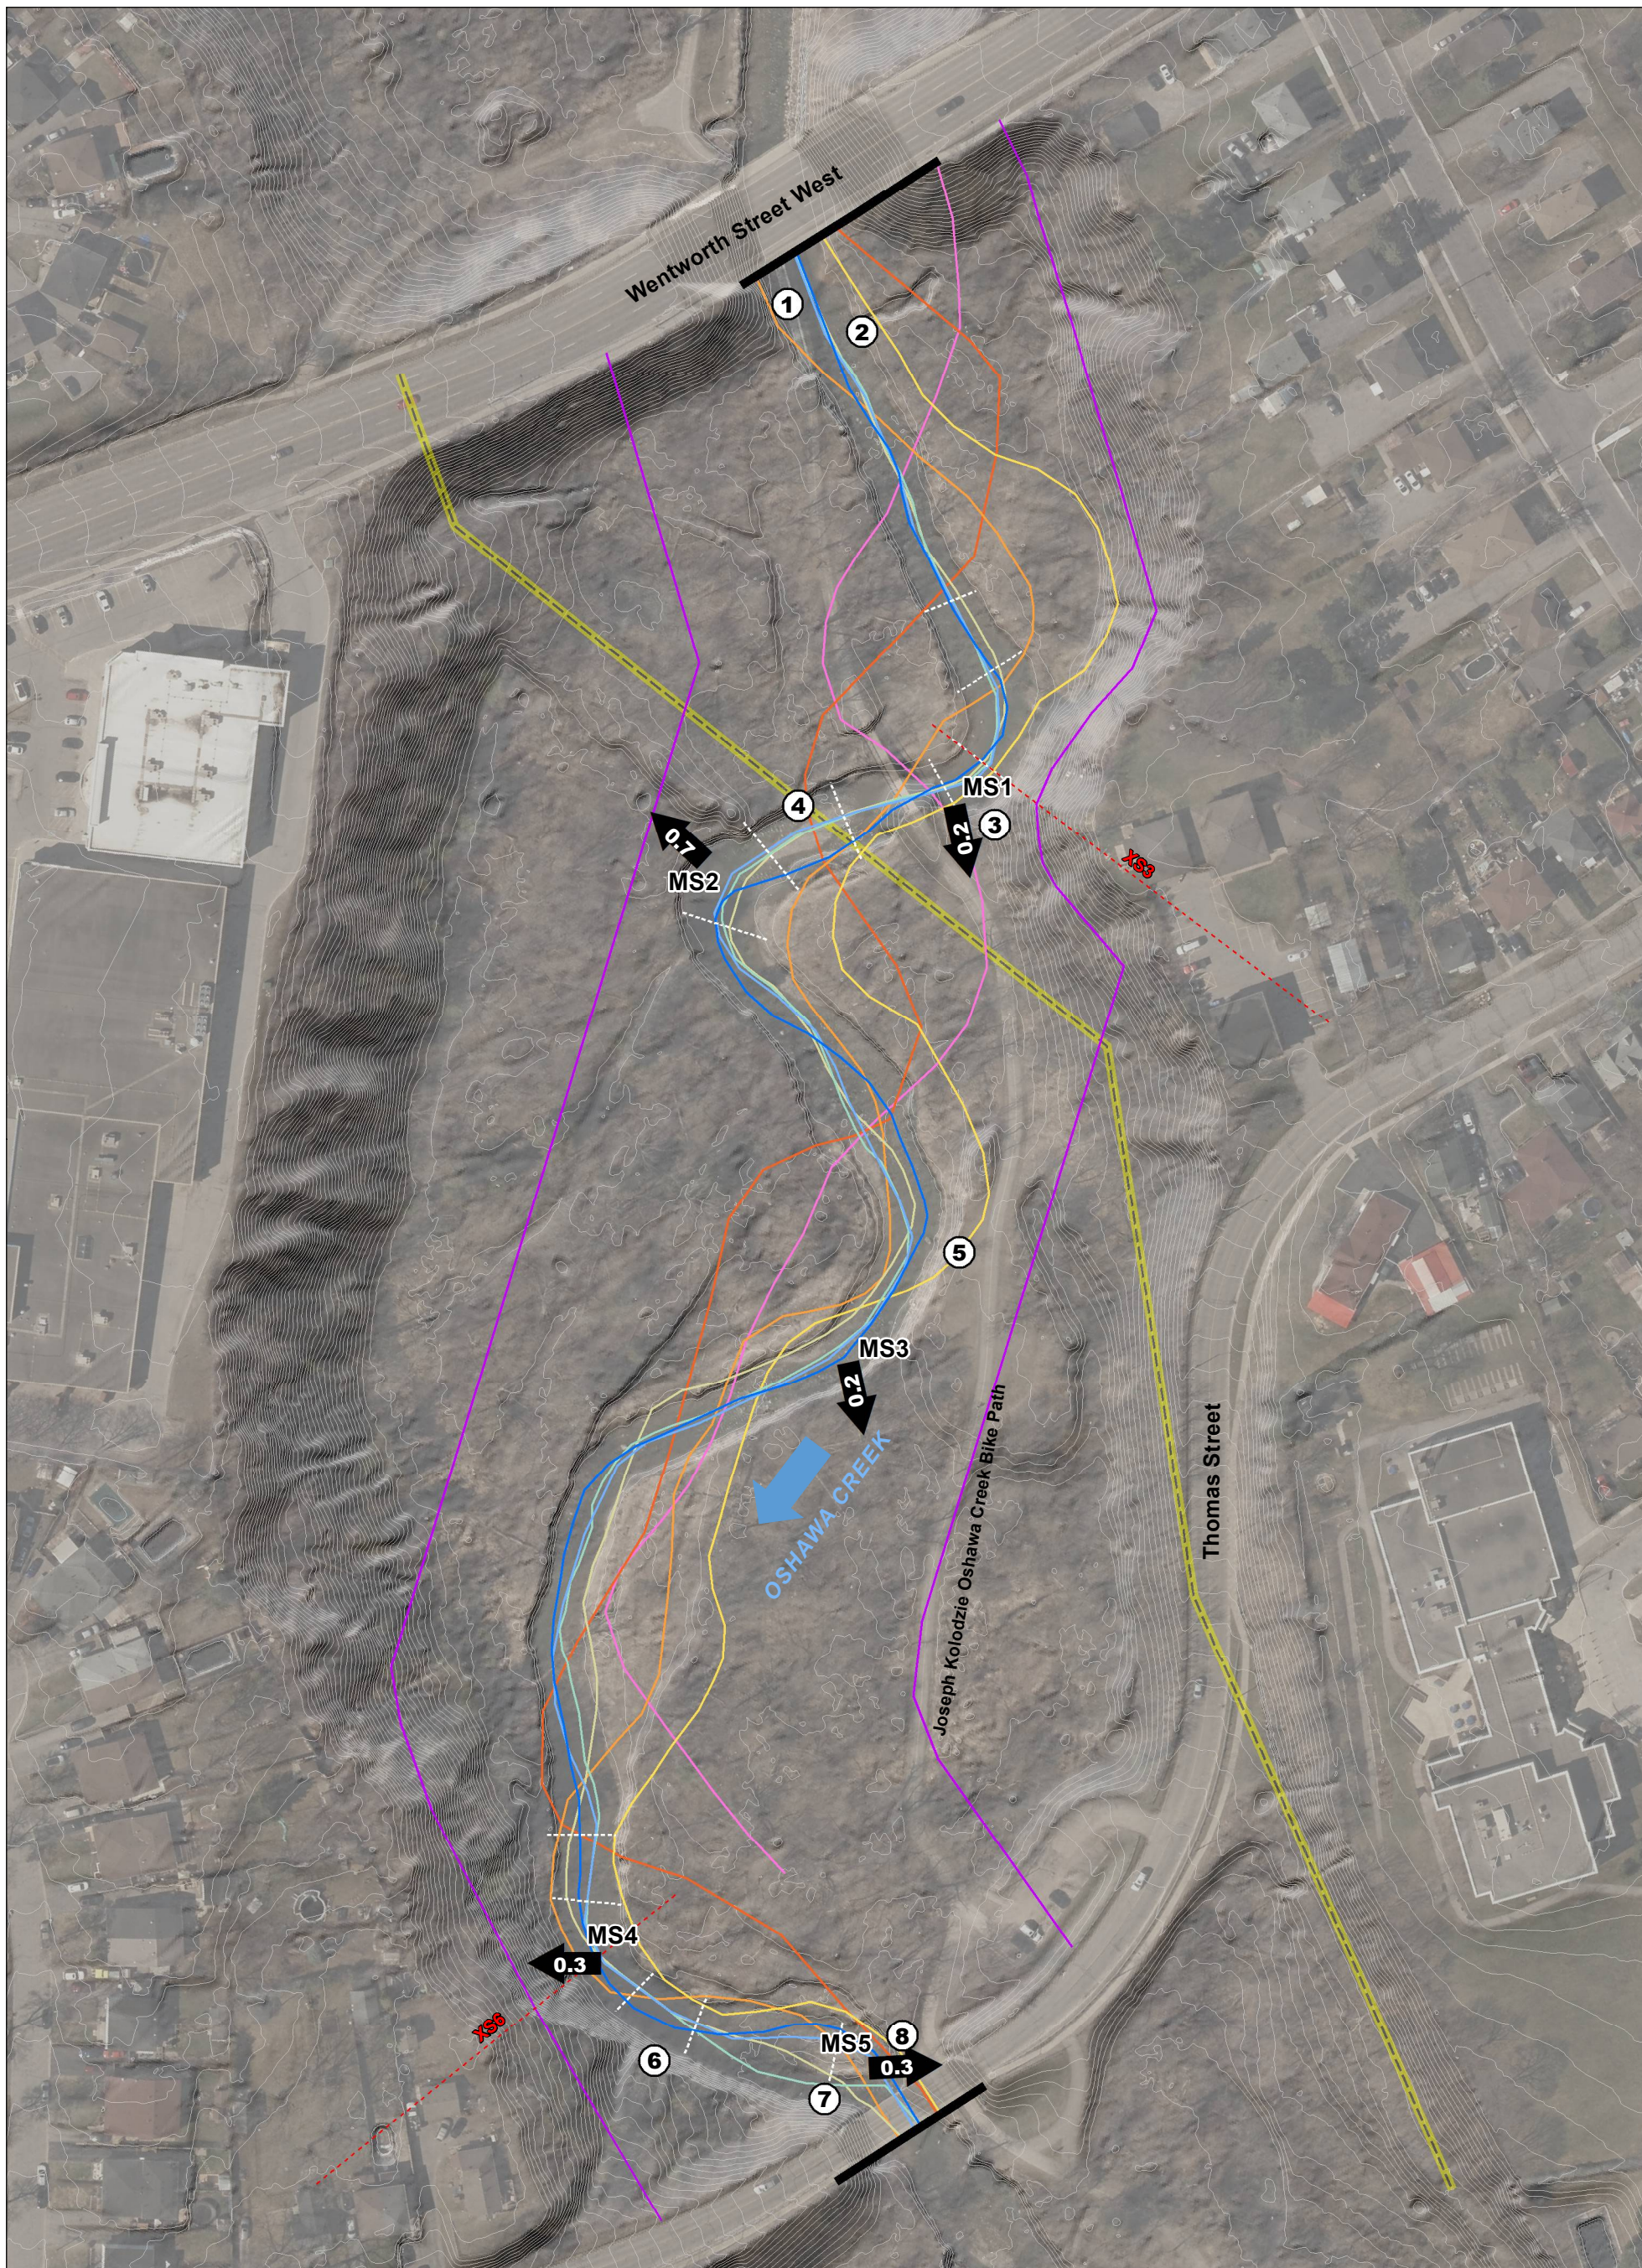
FIGURE NO. 1	REVISION: 1-2	PROJECT NO. 1510206
--------------	---------------	---------------------

Downstream transfer of energy from the erosion-resistant valley wall has started to outflank and undermine the boulder revetment protecting the bridge abutment (**Figure 1; Photo 7**). The bridge is located immediately downstream of the meander apex, where erosive energy is naturally concentrated, with its left (outer bank) abutment set back much closer to the thalweg than its right (inner bank) abutment. The siting and skew of the bridge abutments exacerbate erosion along the outer bank. The bridge abutment along the outer bank projects into the channel, creating a point of erosion concentration. If bridge abutments were shifted approximately 10 m to the south, erosion risk to the bridge would have been significantly reduced. A deep scour pool has formed along the outside of the meander, exacerbated by a point bar that has formed along the inner bank. The scour pool extends downstream, beneath the pedestrian bridge, the left abutment of which is at risk of being undermined.

Site 6 is located along the outer bank of a meander in contact with the western valley wall of Oshawa Creek, just upstream of the Thomas Street bridge (**Figure 1**). The crest of the valley wall is approximately coincident with the edge of private property, with a dwelling and outbuildings setback approximately 10 m on adjacent tableland. Over the historical record (1927 – 2020), the radius of curvature of the impinging meander had increased, such that channel contact with the valley wall has lengthened from about 75 m to 150 m. Planimetric adjustment has slowed since 2005, although the presence of meander scrolls along the inner bank highlights migration into and along the valley wall at Site 6, since prior to the earliest available aerial photography (i.e., 1927). Continued fluvial scour and associated mass movements have the potential to impact properties along Valley Court in the long-term, without intervention.

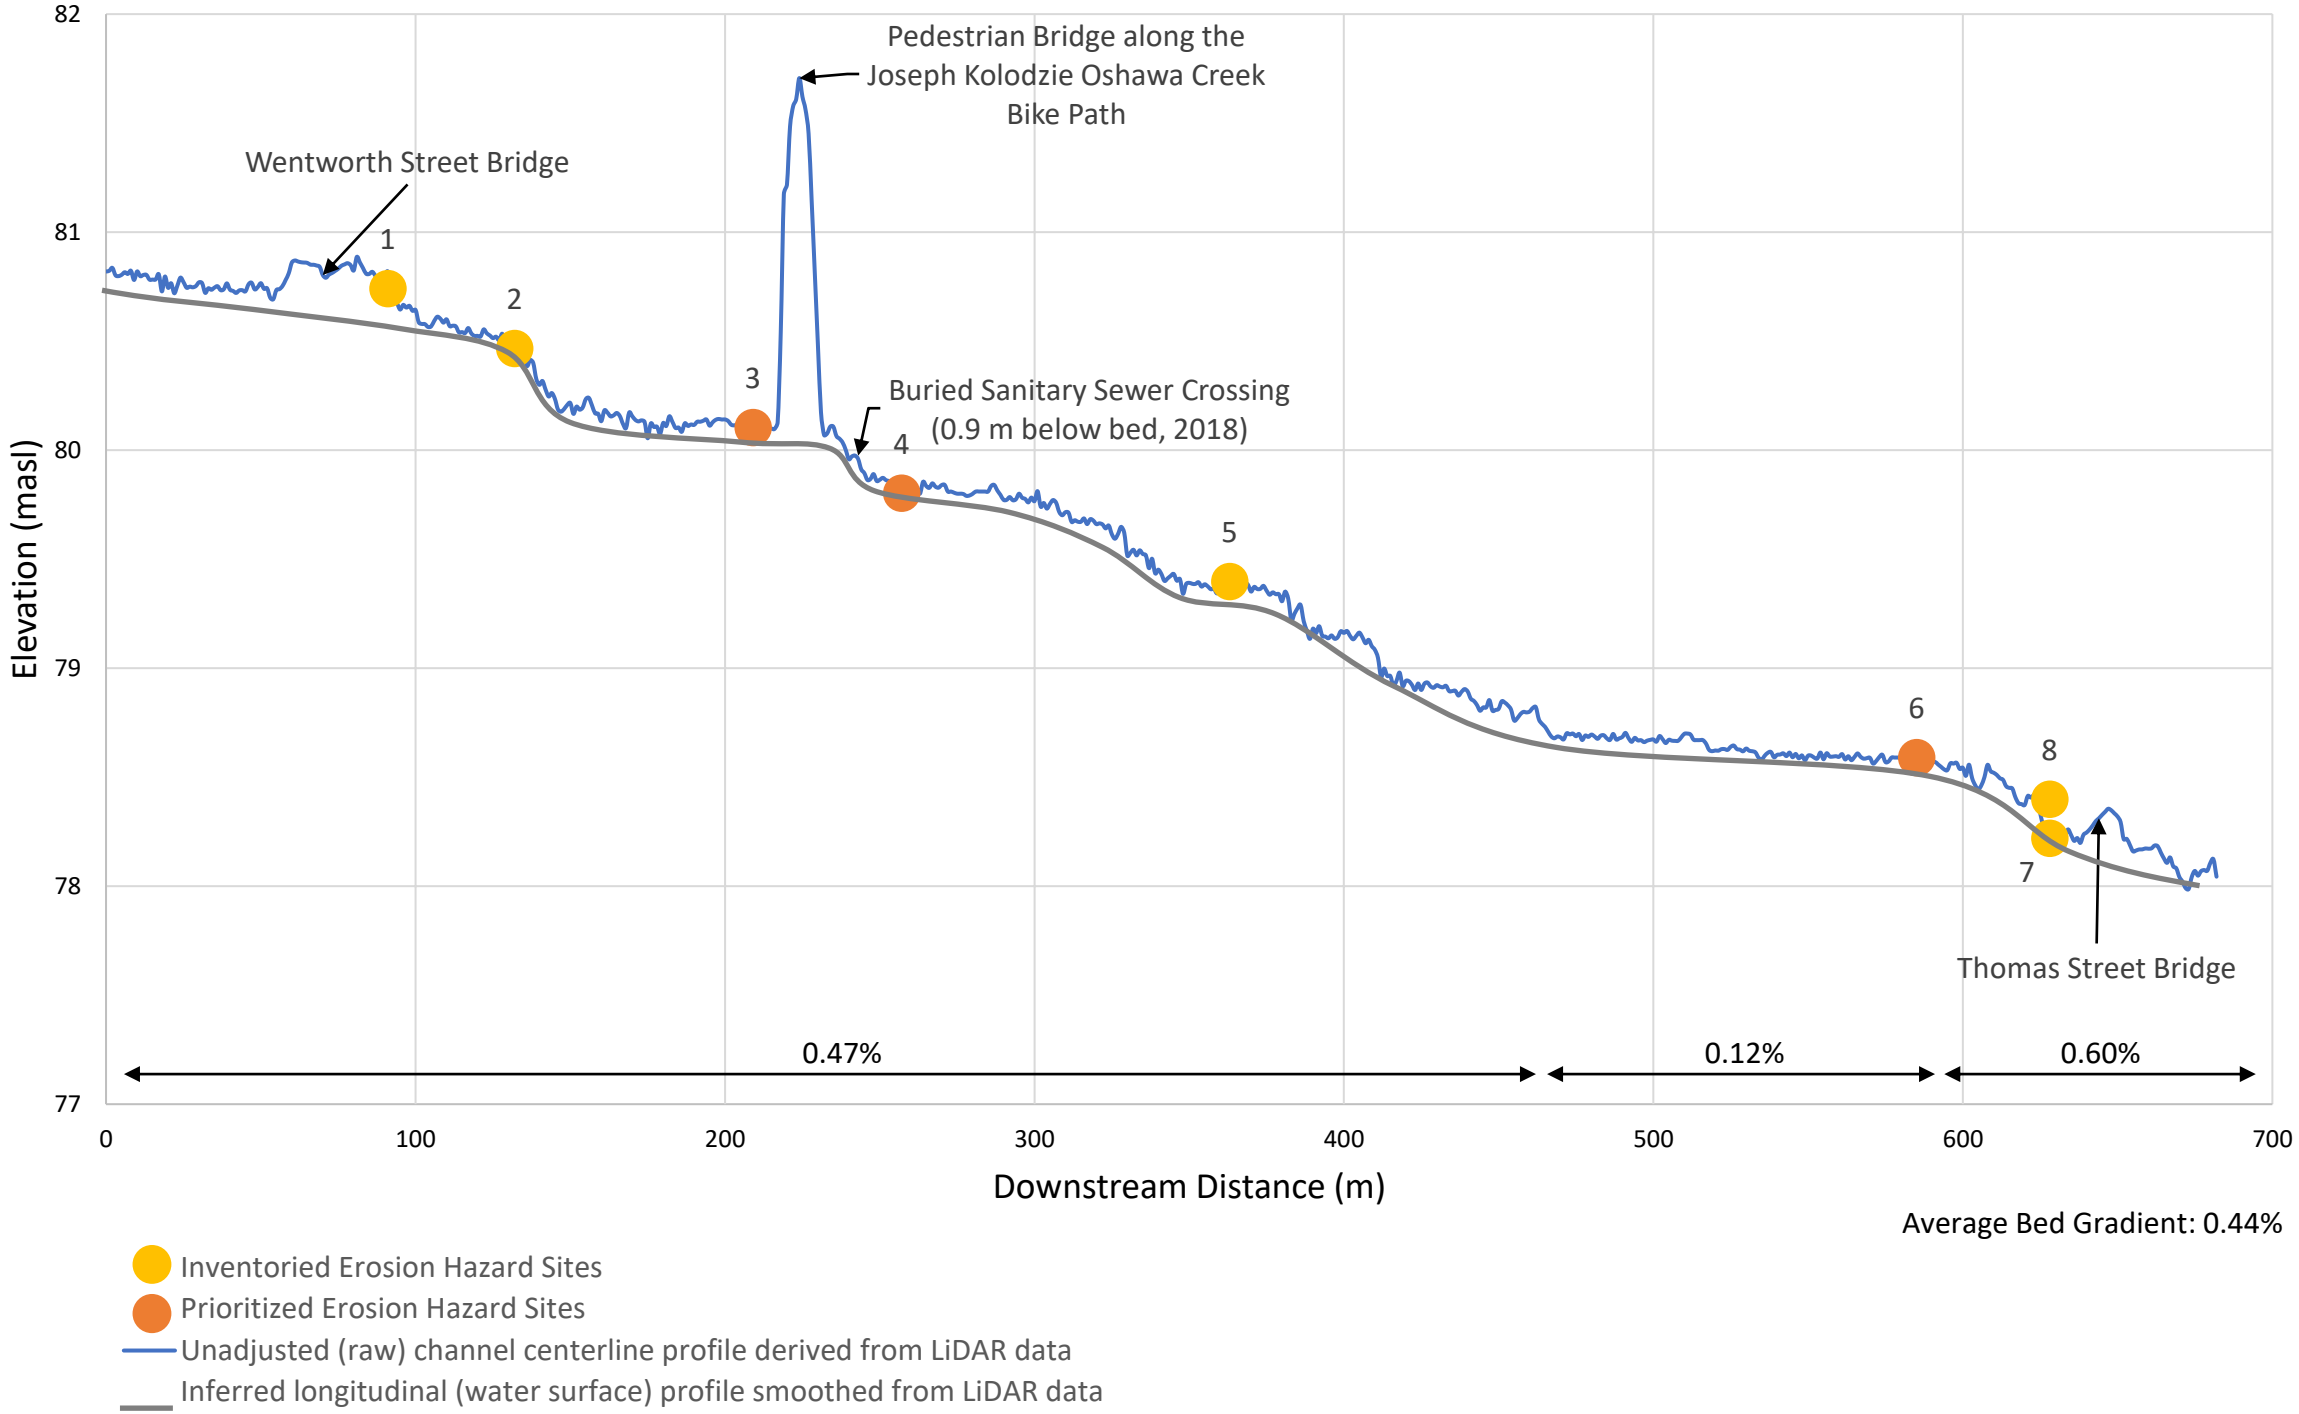
Figure 4. LiDAR-derived longitudinal profile of Oshawa Creek.

The channel is generally well connected to its floodplain as evidenced by low banks and overbank deposition. Average bed gradient is 0.44% along the entire study corridor, with no overall concavity/convexity in the longitudinal profile (**Figure 4**). Bed gradient is gentler than average between Sites 5 and 6 (0.2%) and steeper than average from Site 6 to the downstream end of the study corridor (0.6%). This difference may be explained by the original Thomas Street Bridge crossing, situated at approximately the same location as the change in gradient before its removal sometime between 1927 and 1954 (**Figure 5**). Sediment deposition upstream of the crossing, and subsequent erosion downstream of the crossing, could explain this abrupt change in gradient.

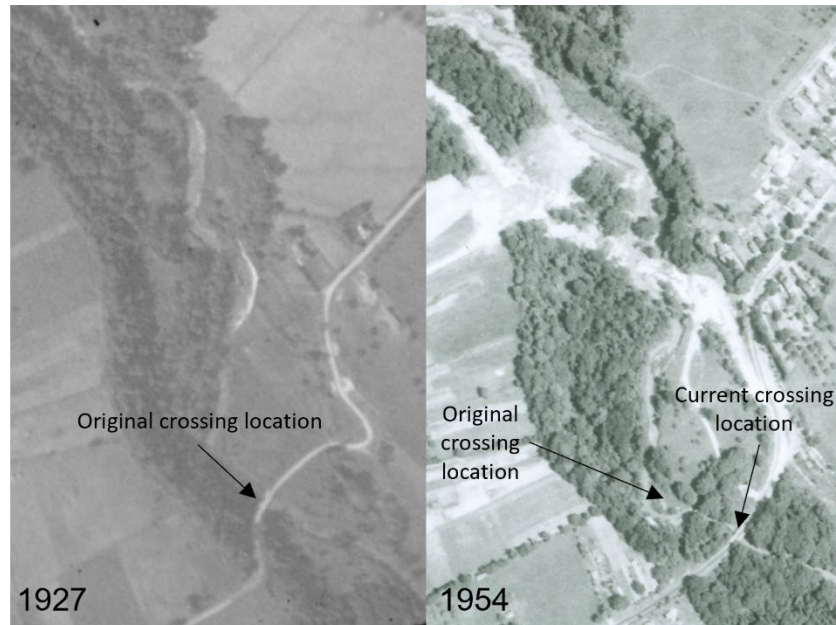
Figure 5. *Location of original and current Thomas Street Bridge crossing in 1927 and 1954 aerial photography. Original crossing was removed between 1927 and 1954.*

The Wentworth Street and Thomas Street bridge crossings define the upstream and downstream extent of the study corridor, respectively (**Figure 1**). The Thomas Street crossing was constructed before 1927 but was moved approximately 250 m downstream sometime between 1927 and 1954. The Wentworth Street crossing was constructed sometime between 1954 and 1967. Additionally, a pedestrian bridge, constructed in the 1990s or early 2000s, crosses the channel approximately 150 m downstream of the Wentworth Street bridge crossing. A sanitary main, constructed before 1954, crosses beneath the watercourse immediately downstream of the pedestrian crossing.

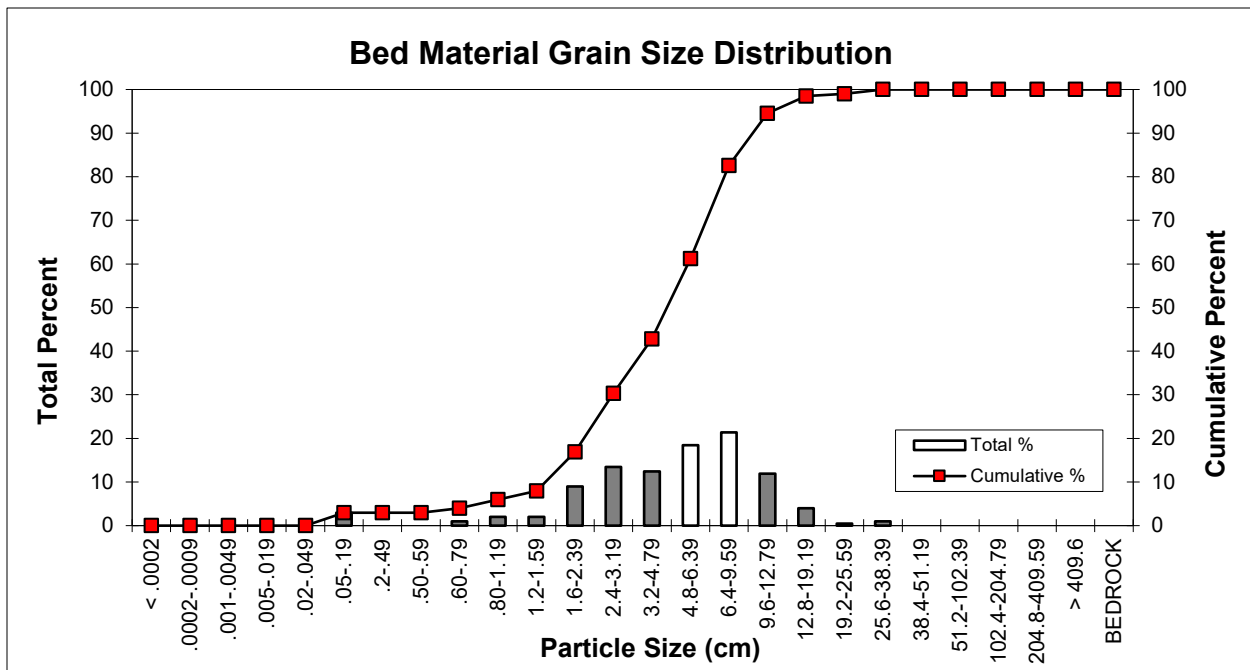
Figure 6. *Integrated grain size distribution of bed material from pebble counts (100 count at Site 3/4 and 100 count at Site 6) conducted along Oshawa Creek.*

Bed materials within Oshawa Creek are relatively well sorted, ranging from coarse sand to cobbles, and are dominated by gravels and small cobbles (**Figure 6**). Extensive fine-grained deposits blanket pool bottoms and a thin veneer of sand embeds larger particles in pools and riffles, potentially sourced from eroding valley walls or transported from former headpond deposits from the Cedardale Dam, upstream of the study corridor (Palmer, 2020). The representative median grain size (D_{50}) of Oshawa Creek, within the study corridor, is approximately 50 mm (5 cm). There are several locations along the study corridor where underlying till is exposed on the bed (e.g., downstream of Site 4 and Site 6). Abundant woody debris has accumulated along the channel, derived mainly from downstream rafting of trees that have fallen into the channel following erosion and undercutting of adjacent banks. Conspicuous traces of organic matter in overbank areas demarcate the limits of recent flood inundation (**Photo 5**). Long sections of undercut bank expose elevated armoured (cobble) layers, providing at least localized evidence of historic degradation (down-cutting) from a former (higher) channel bed (**Photo 6**).

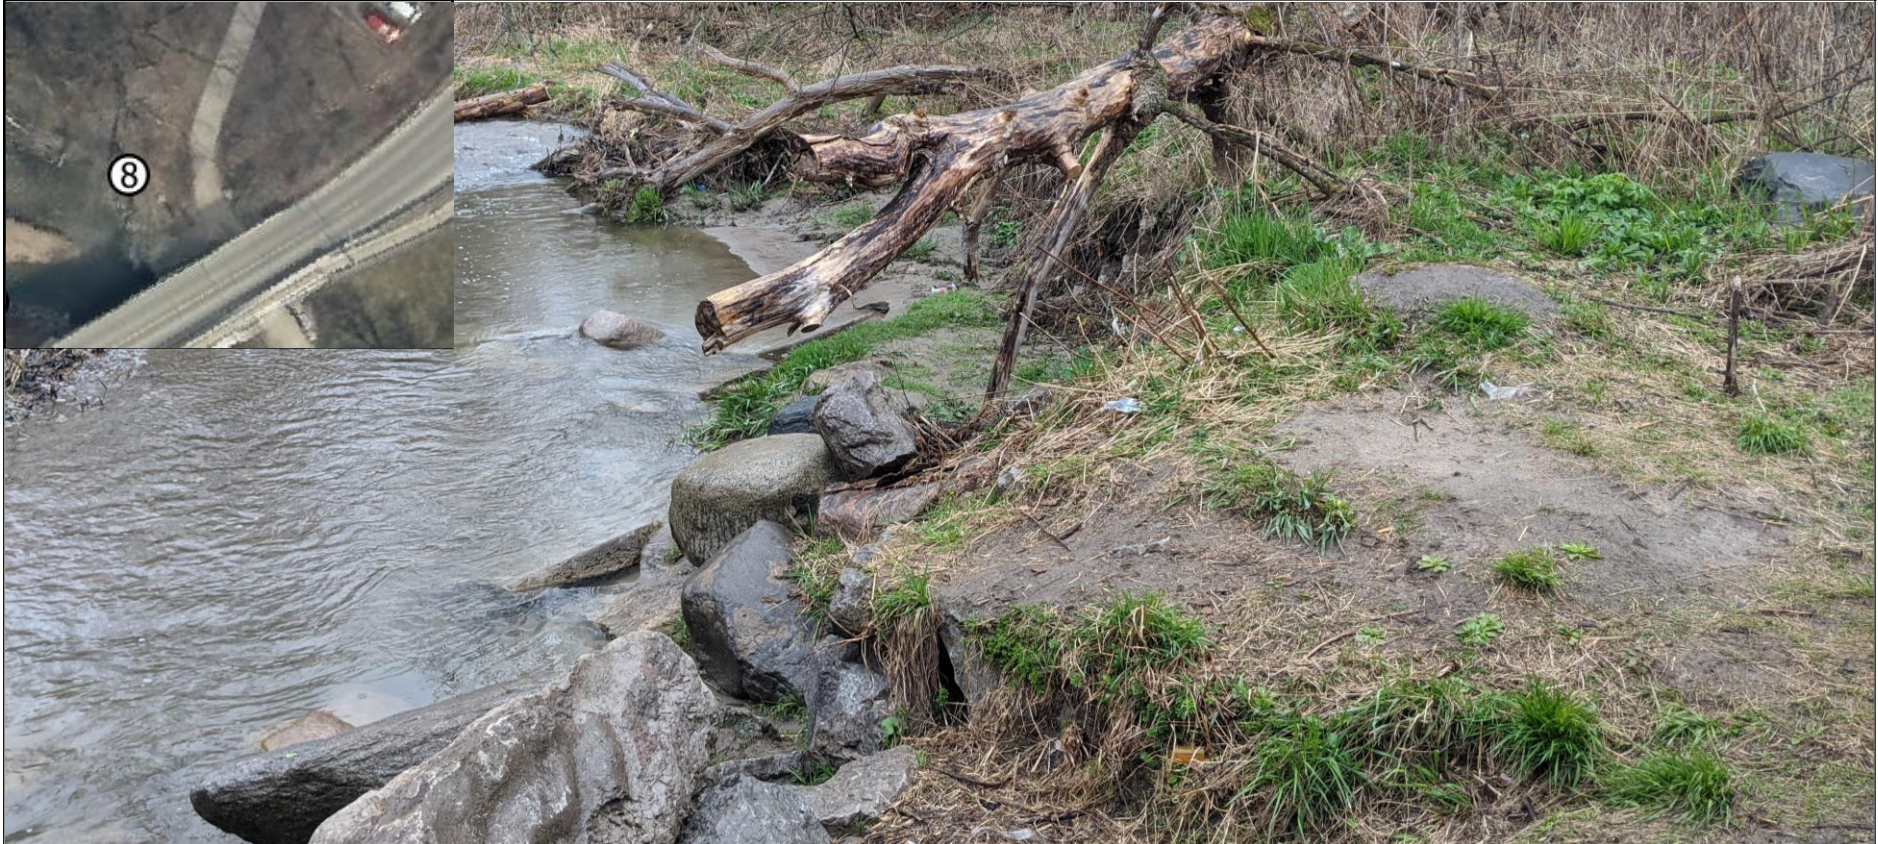
Boulder riprap revetments installed along the left bank immediately upstream of the Thomas Street bridge protect the bridge footings. A medial bar locally concentrates flow along the left bank, which could eventually undermine or outflank the revetment and pose a risk to the adjacent Joseph Kolodzie Oshawa Creek Bike Path and eastern bridge footing. Additionally, concentration of surface runoff from the parking lot northwest of the creek winnows fine material from behind the revetments and forms small collapse areas. Flow: top to bottom.

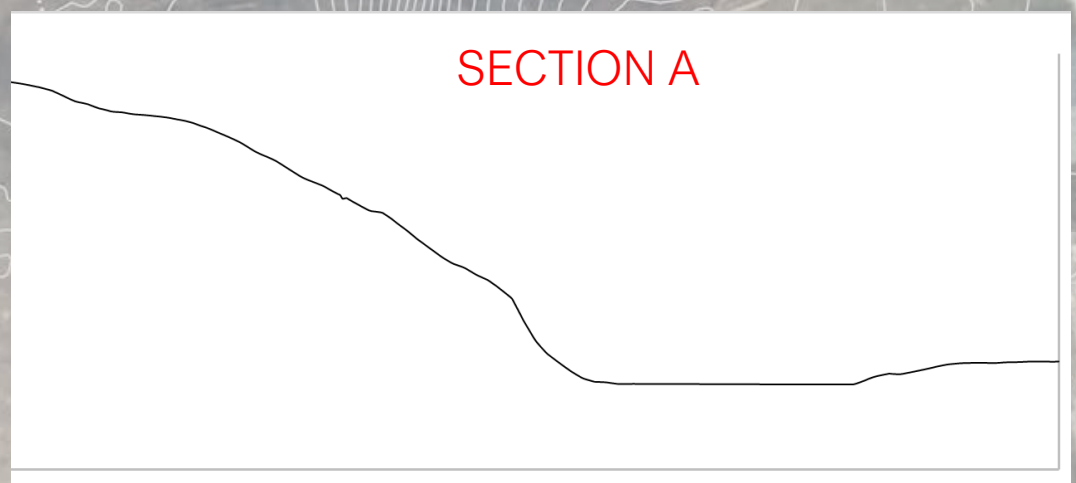
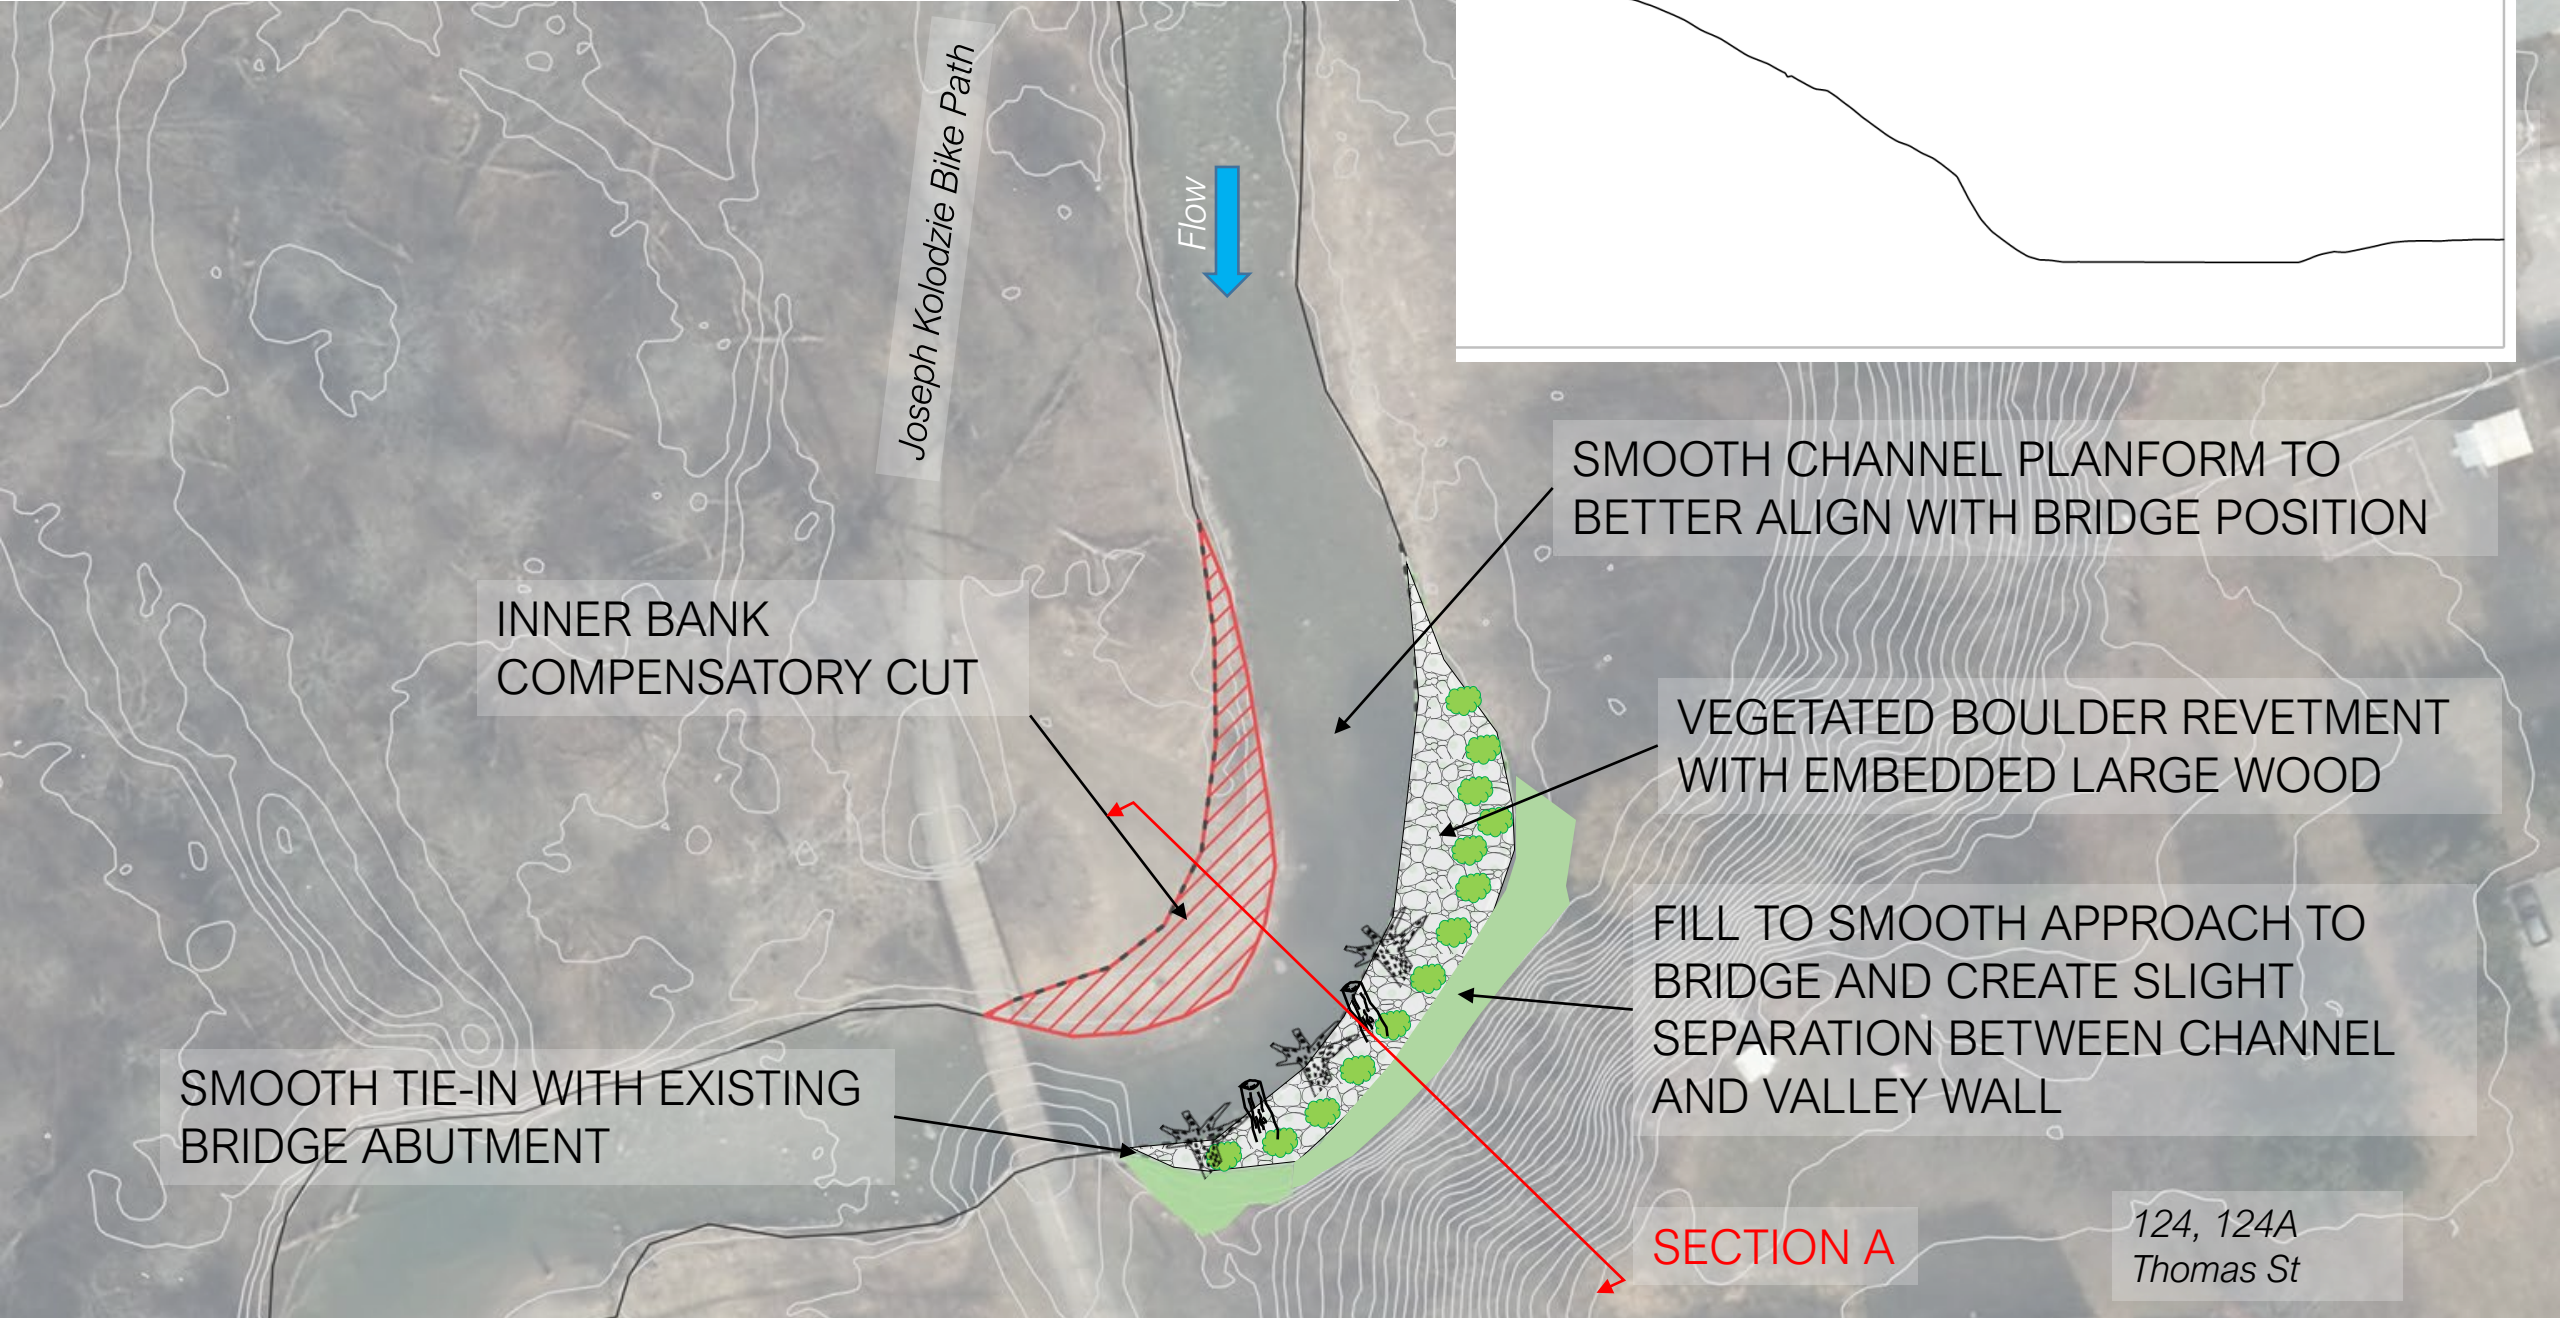
Site 3 – Concept 1 – Slight Channel Realignment and Boulder Toe Protection

Feature at Risk:	Distance to Feature	Condition of Bank and/or Existing Erosion Protection:	Mechanism(s) of Failure:	Risk	Recommended Action(s):
Site 3	Pedestrian bridge and private property on valley crest	0 m (contact)	Functional, but deteriorating	Outflanking and/or undermining	High	Design and construct protection for toe of valley wall and bridge

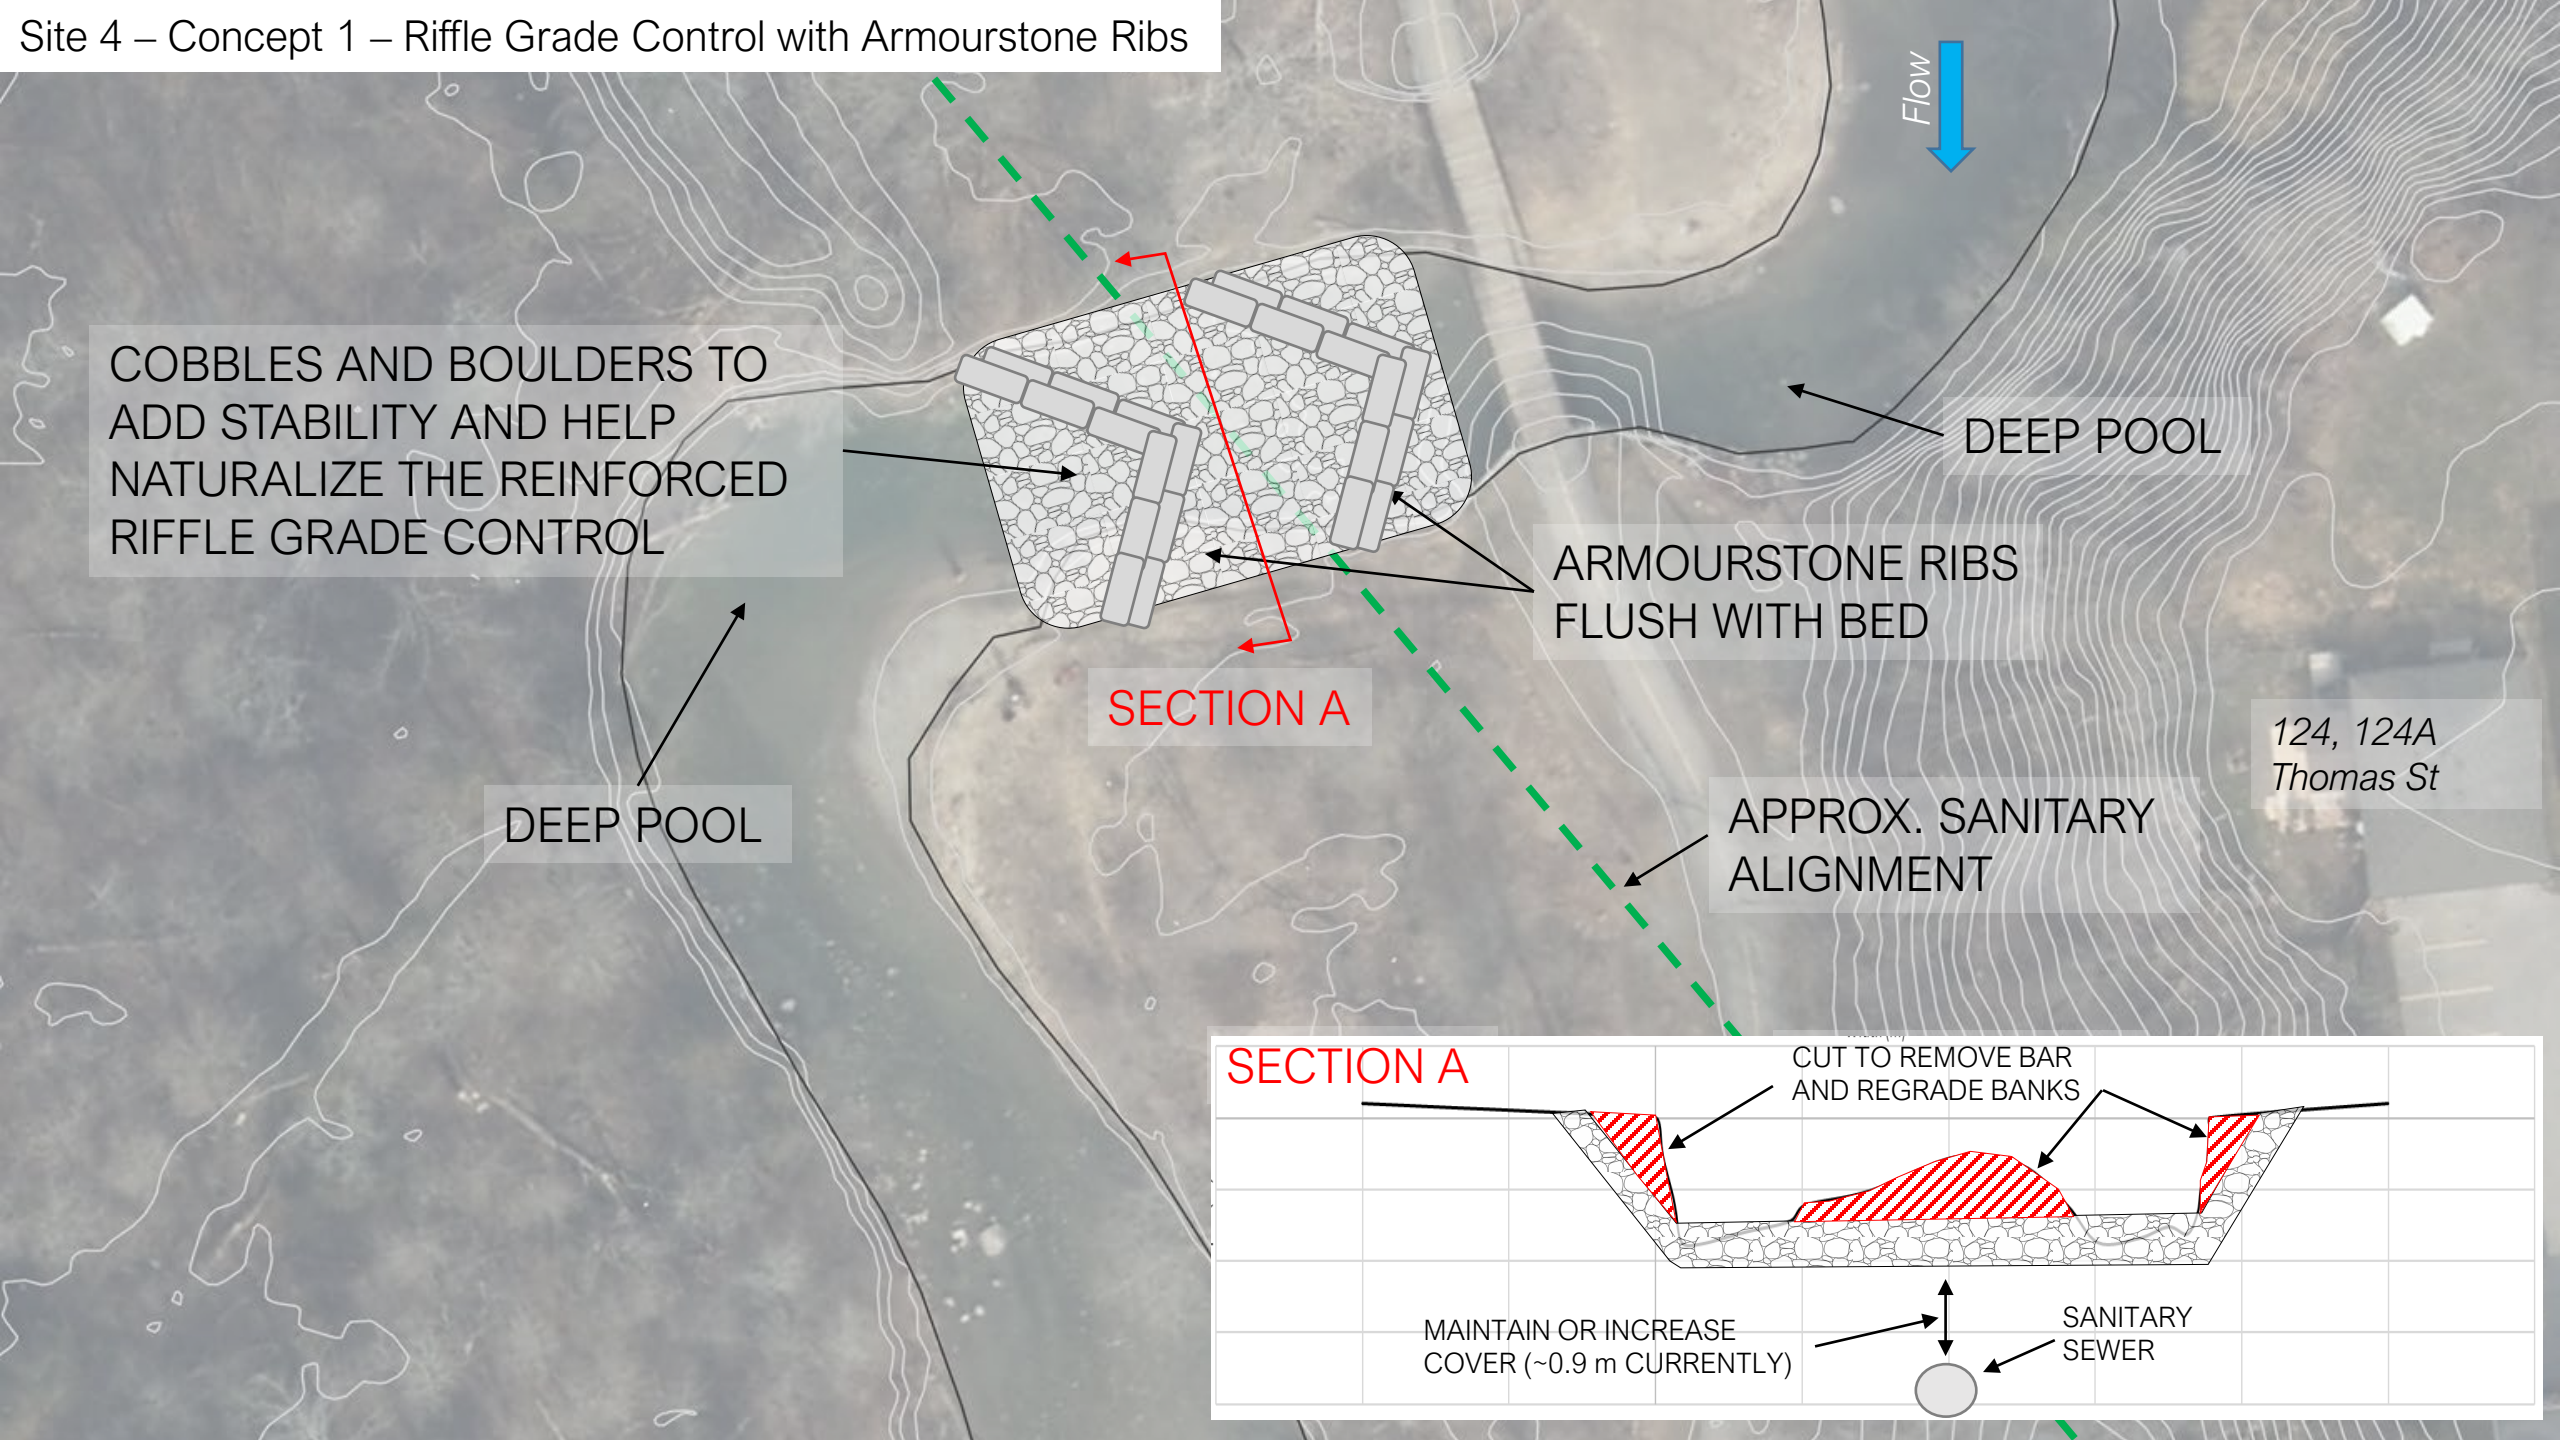
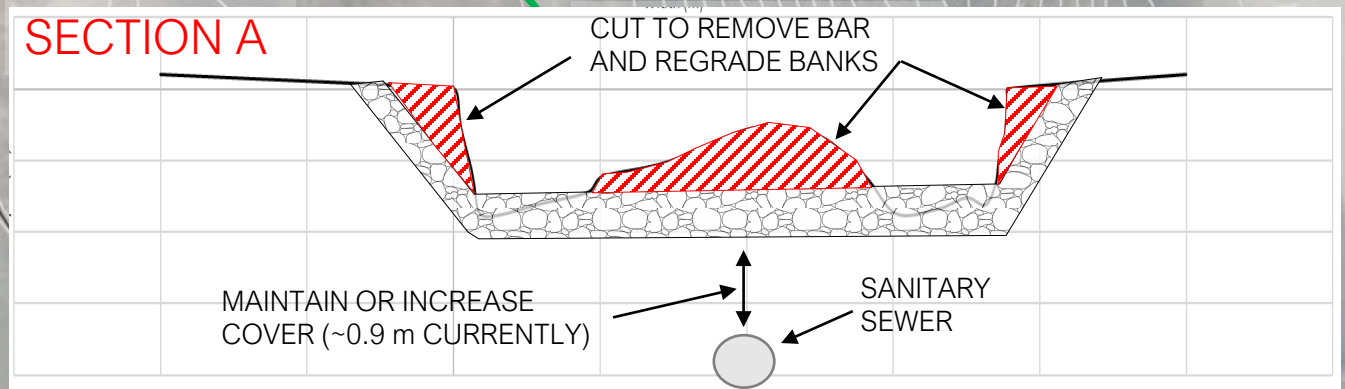
Site 4 – Concept 1 – Riffle Grade Control with Armourstone Ribs

Feature at Risk:	Distance to Feature	Condition of Bank and/or Existing Erosion Protection:	Mechanism(s) of Failure:	Risk	Recommended Action(s):
Site 4	Sanitary sewer	0.9 m (depth of cover)	Steep, eroded banks; no protection from continued bed scour	Bed scour and medial bar migration	Moderate	Protect sanitary sewer (based on assumed works to be completed at Site 3)

COBBLES AND BOULDERS TO ADD STABILITY AND HELP NATURALIZE THE REINFORCED RIFFLE GRADE CONTROL
