Fluvial Geomorphological Assessment of Oshawa Creek and Evaluation of Erosion Mitigation Strategies at Prioritized Sites

Thomas Street to Wentworth Street West

Palmer Project #

1510206

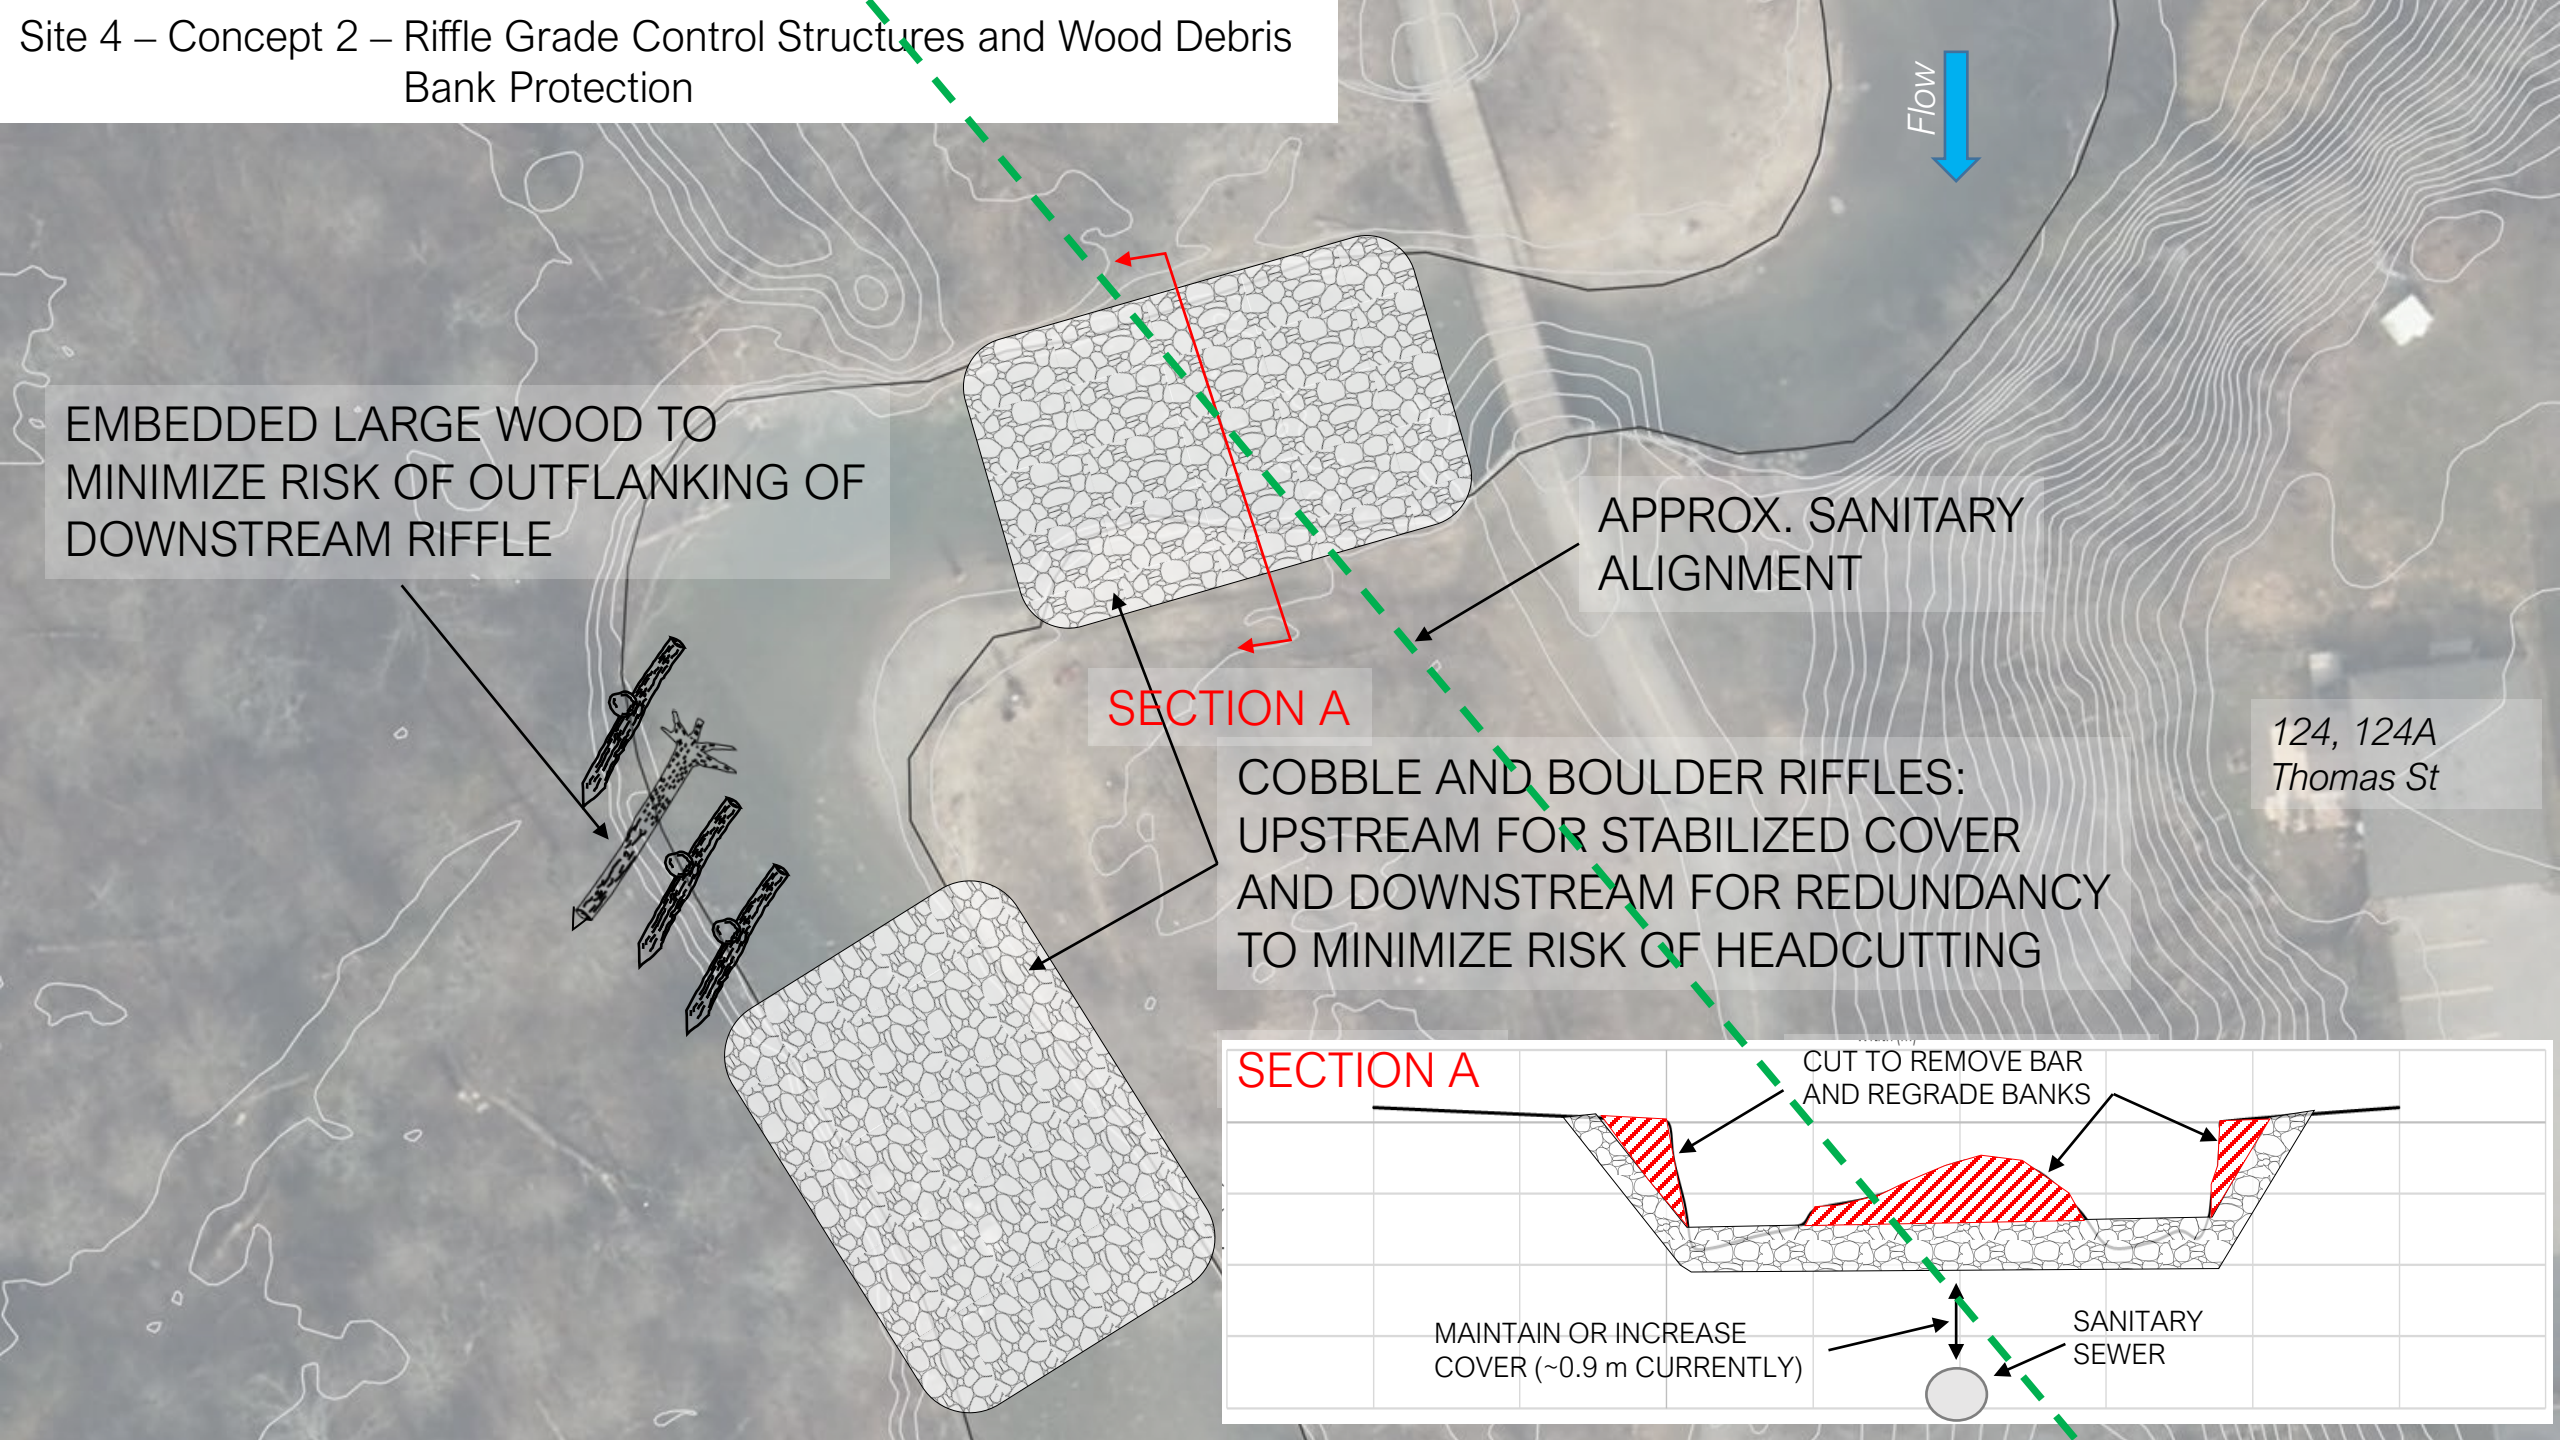
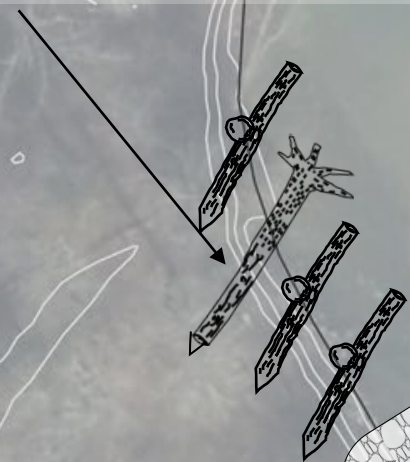
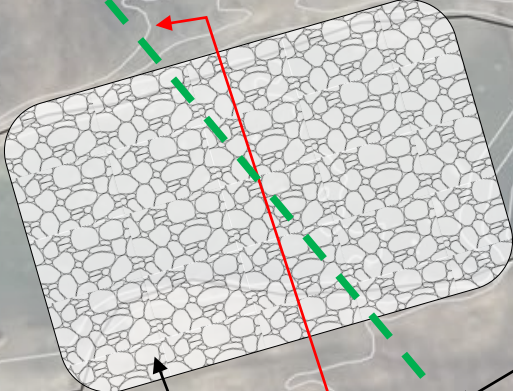
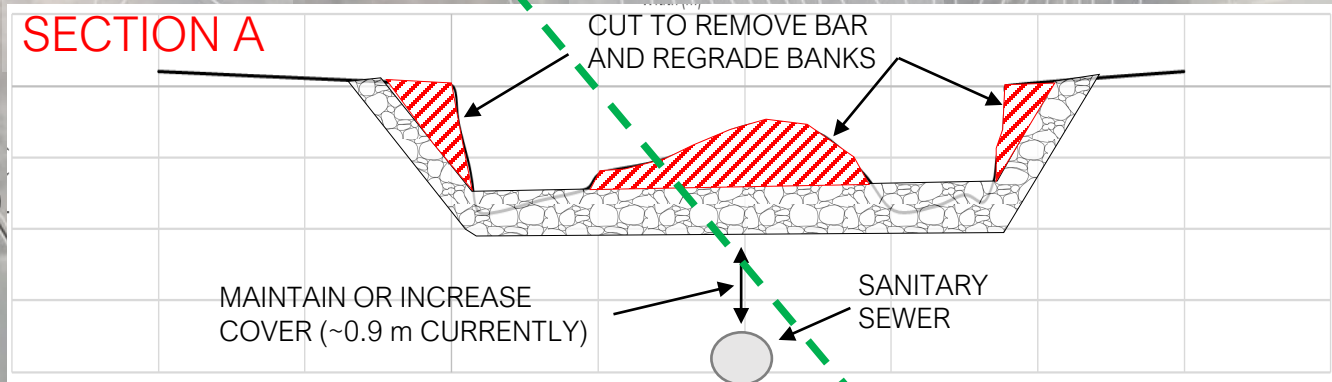
Site 4 – Concept 2 – Riffle Grade Control Structures and Wood Debris Bank Protection

Feature at Risk:	Distance to Feature	Condition of Bank and/or Existing Erosion Protection:	Mechanism(s) of Failure:	Risk	Recommended Action(s):
Site 4	Sanitary sewer	0.9 m (depth of cover)	Steep, eroded banks; no protection from continued bed scour	Bed scour and medial bar migration	Moderate	Protect sanitary sewer (based on assumed works to be completed at Site 3)

EMBEDDED LARGE WOOD TO MINIMIZE RISK OF OUTFLANKING OF DOWNSTREAM RIFFLE

COBBLE AND BOULDER RIFFLES: UPSTREAM FOR STABILIZED COVER AND DOWNSTREAM FOR REDUNDANCY TO MINIMIZE RISK OF HEADCUTTING

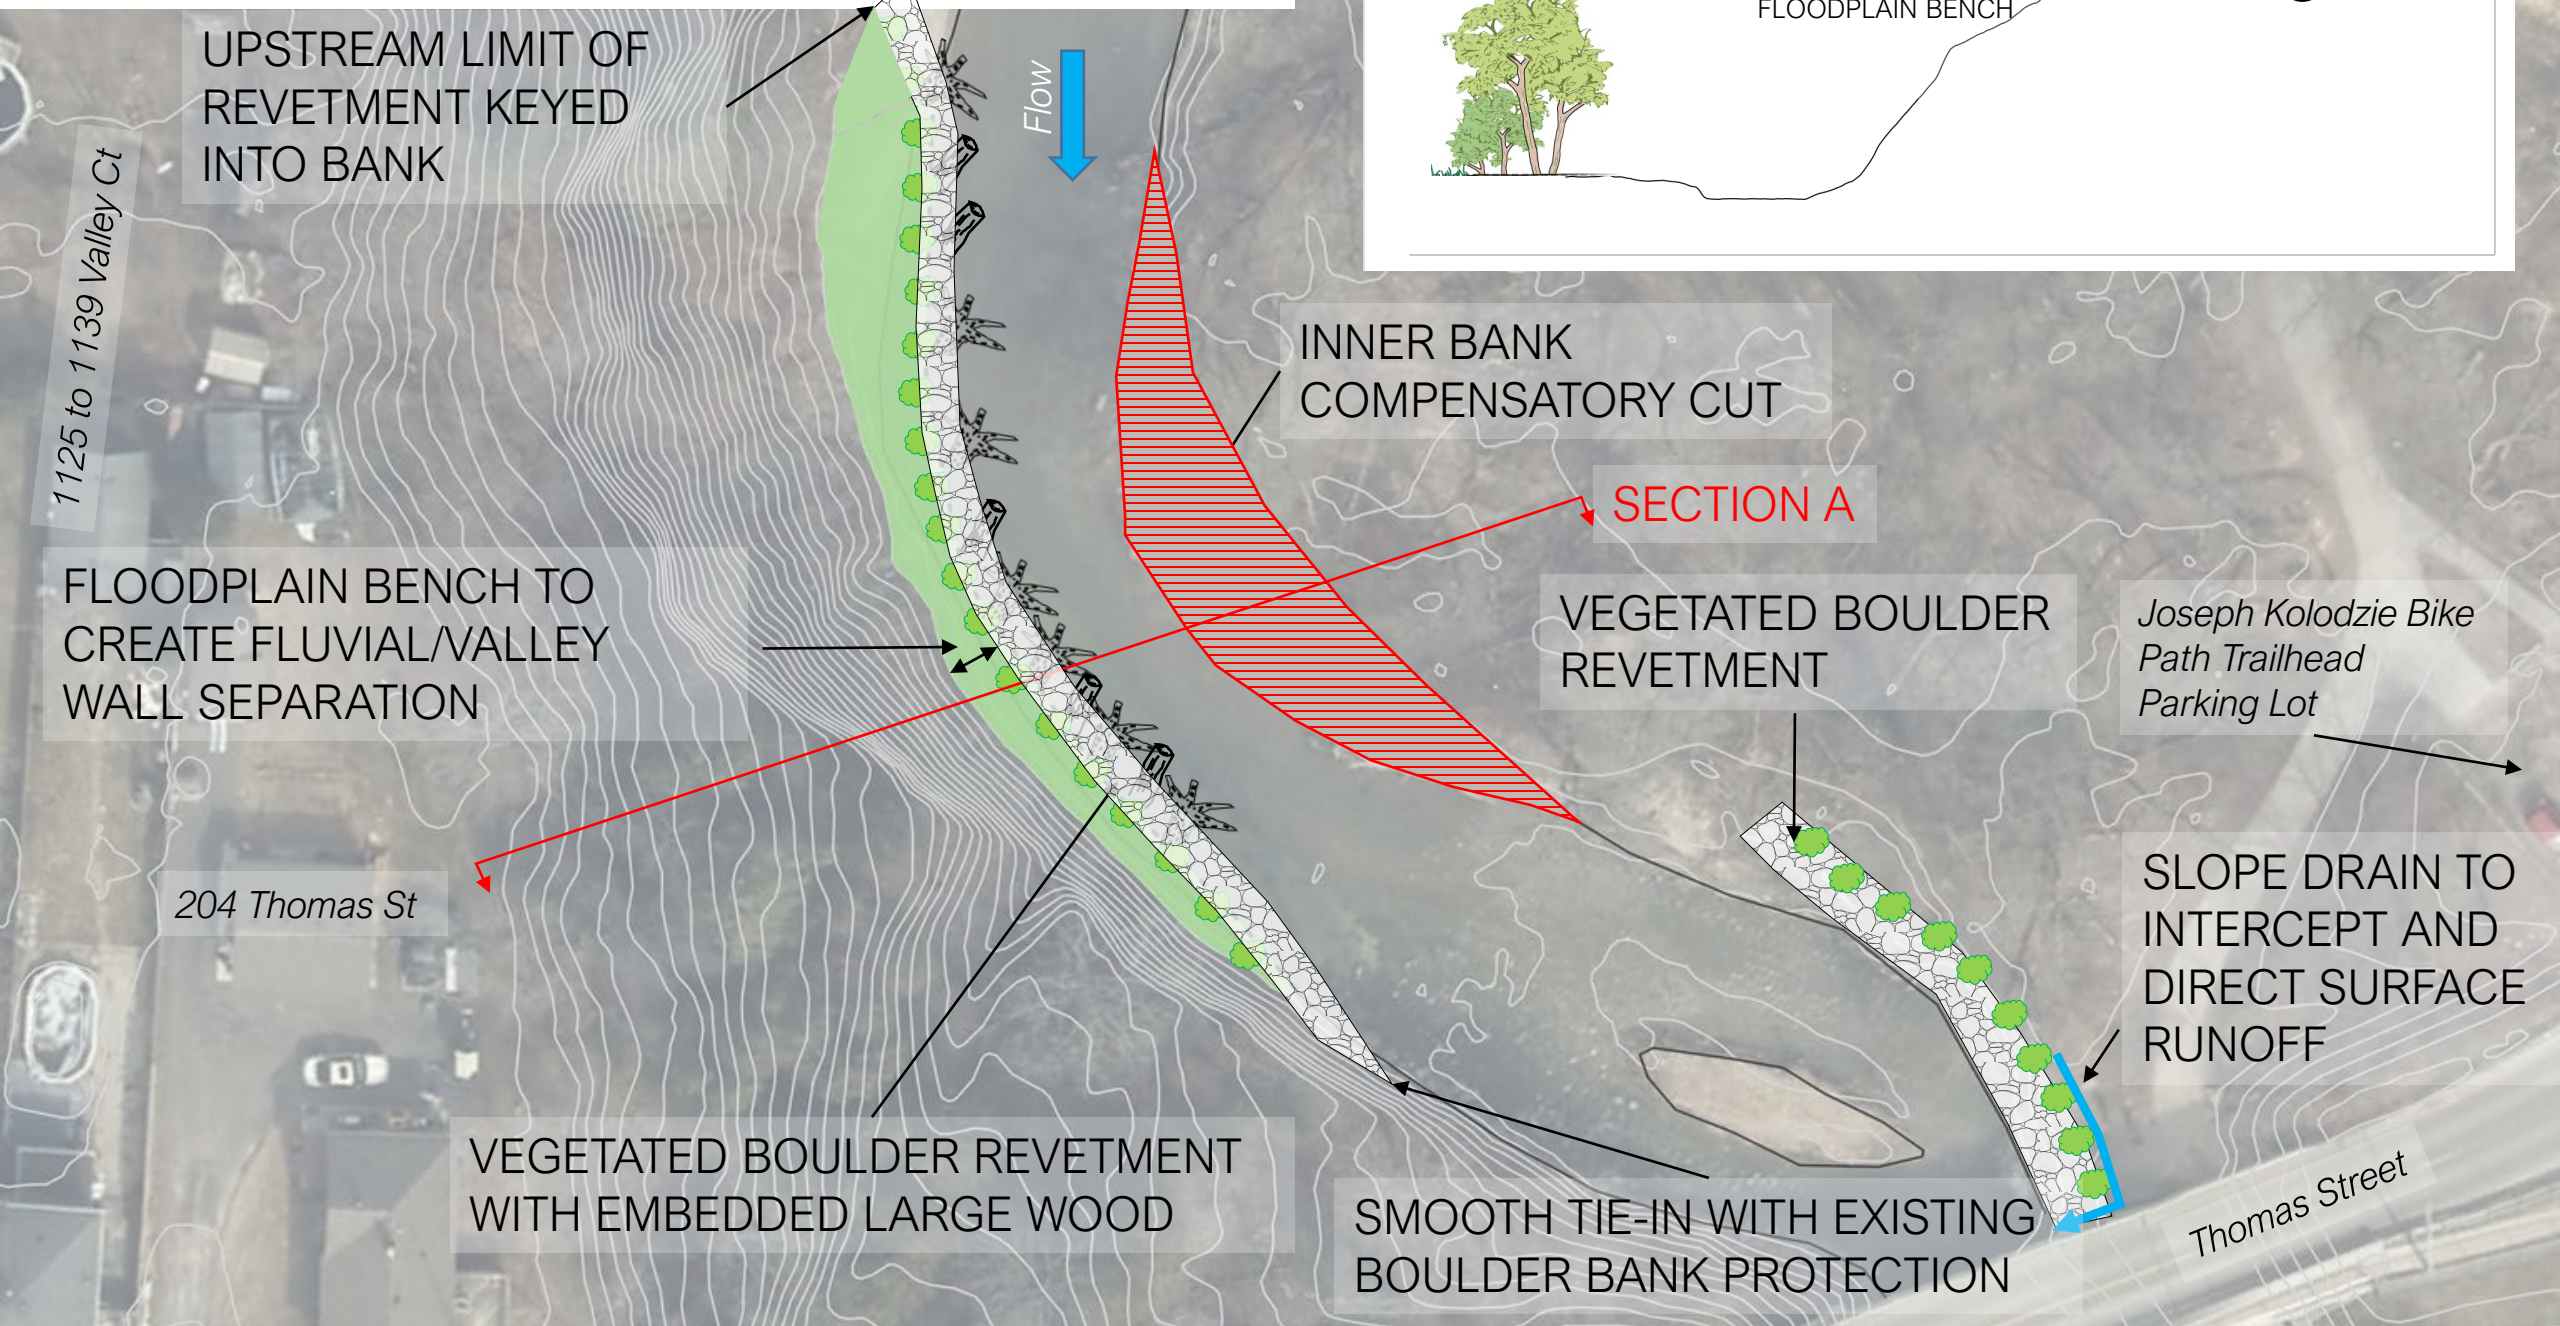
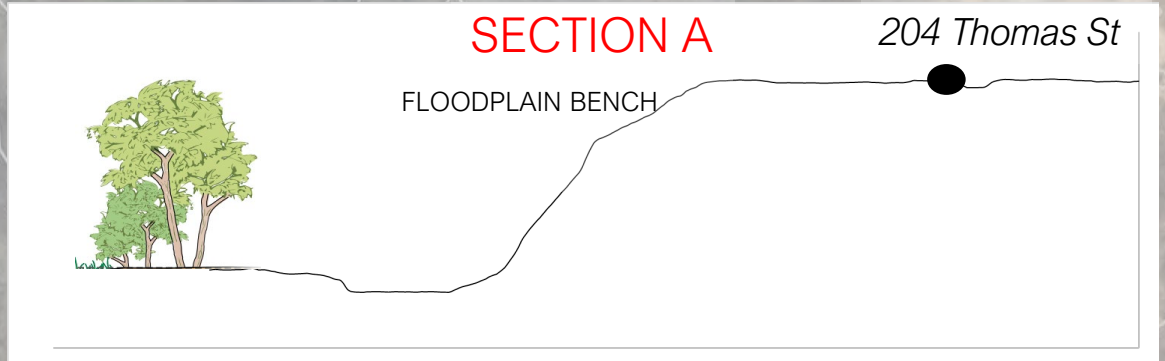
Site 6 – Concept 1 – Boulder Protected Slope Toe Bench and Surface Runoff Control

Feature at Risk:	Distance to Feature	Condition of Bank and/or Existing Erosion Protection:	Mechanism(s) of Failure:	Risk	Recommended Action(s):
Site 6	Property at edge of adjacent tableland	10 m	Approximately 18 m high, 150 m long erosion scar along lower valley wall	Repeated fluvial scour and mass movements	High	Design and implement measures to protect valley wall from continued fluvial interaction

UPSTREAM LIMIT OF REVETMENT KEYED INTO BANK

SLOPE DRAIN TO INTERCEPT AND DIRECT SURFACE RUNOFF
