HERITAGE IMPACT ASSESSMENT

## Cedardale Public School

827 GORDON STREET  
OSHAWA, ONTARIO

ISSUE DATE: JULY 29, 2022

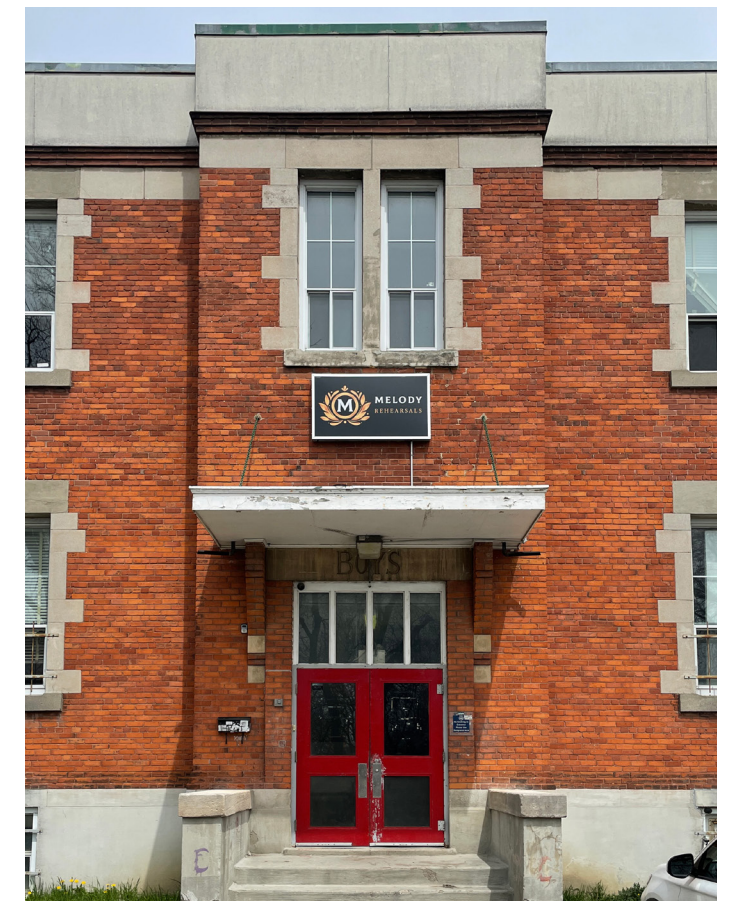
Figure 6: Main entrance. EVOQ.

The poured concrete stairs at the main entrance are in poor condition and in need of replacement as they are eroding and cracking.
