Fluvial Geomorphological Assessment of Oshawa Creek and Evaluation of Erosion Mitigation Strategies at Prioritized Sites

Thomas Street to Wentworth Street West

City of Oshawa

October 8, 2021

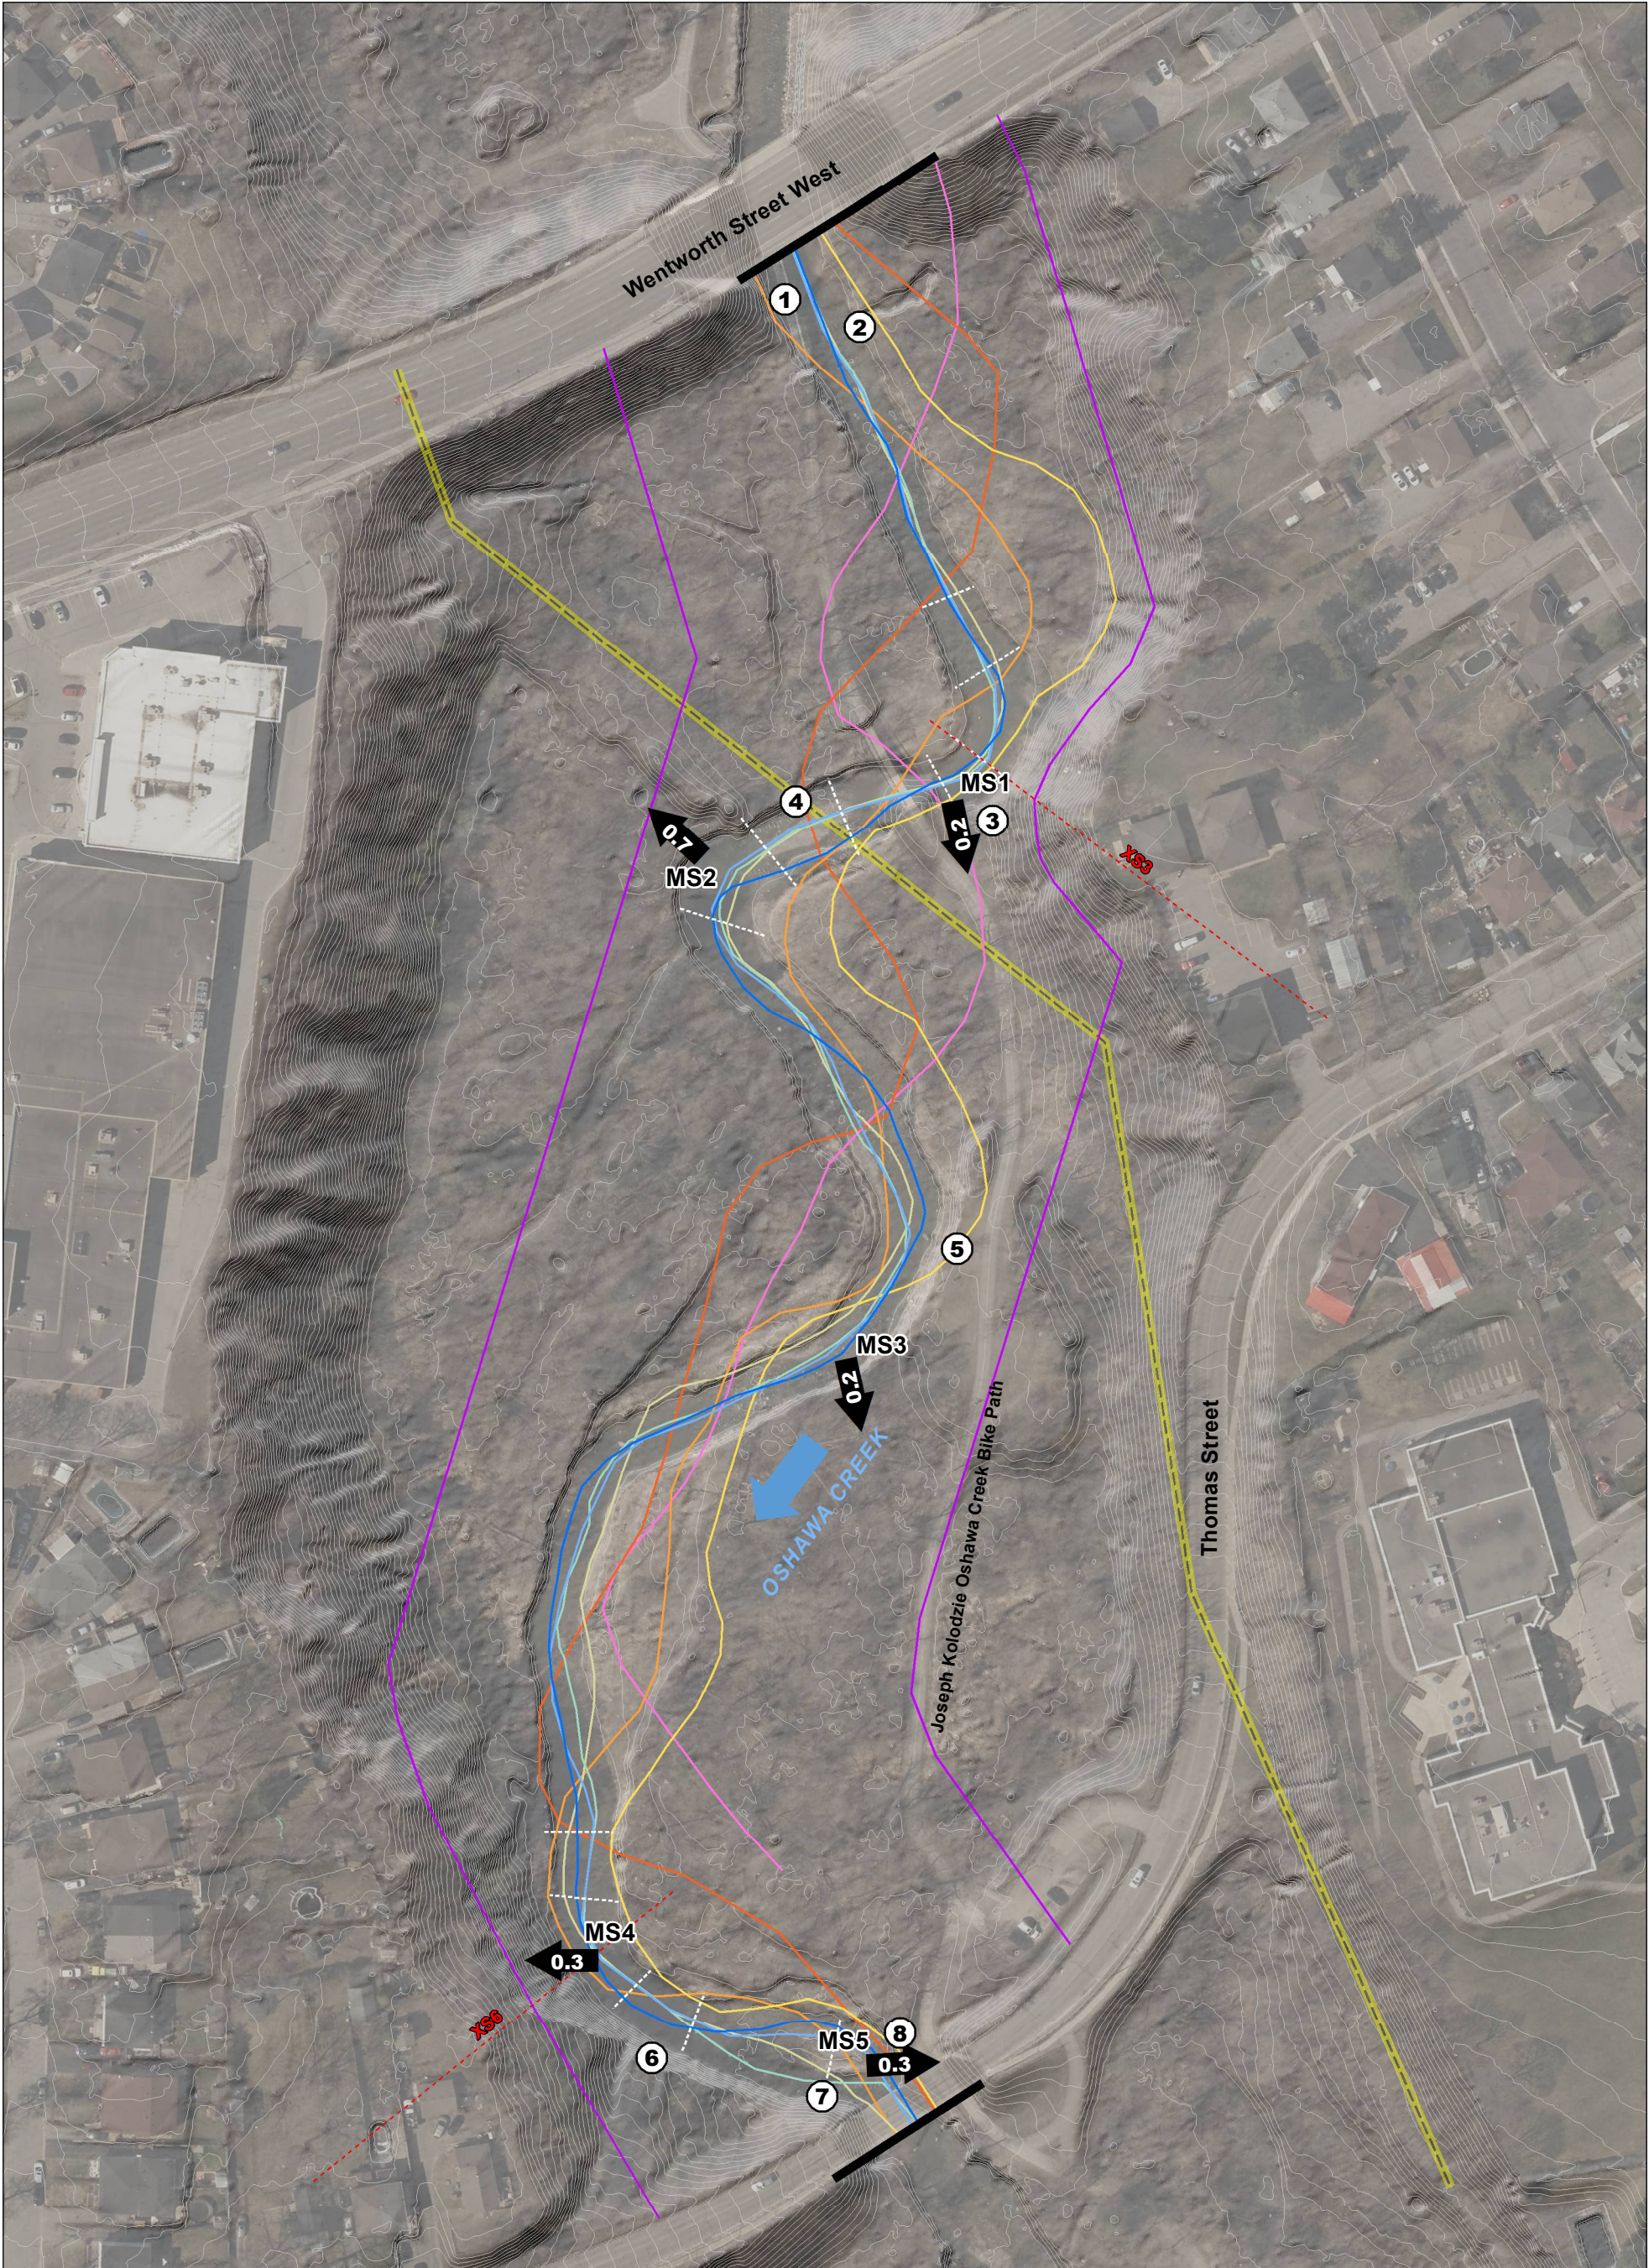
FIGURE NO.	1	REVISION:	1-2	PROJECT NO.	1510206
------------	---	-----------	-----	-------------	---------

Between 2005 and 2010, the outer bank of Oshawa Creek, just upstream of the Thomas Street crossing and pedestrian crossing, was reinforced with boulder and armourstone revetments to prevent lateral erosion and subsequent outflanking of bridge footings.

Downstream transfer of energy from the erosion-resistant valley wall has started to outflank and undermine the boulder revetment protecting the bridge abutment (**Figure 1; Photo 7**). The bridge is located immediately downstream of the meander apex, where erosive energy is naturally concentrated, with its left (outer bank) abutment set back much closer to the thalweg than its right (inner bank) abutment. The siting and skew of the bridge abutments exacerbate erosion along the outer bank. The bridge abutment along the outer bank projects into the channel, creating a point of erosion concentration. If bridge abutments were shifted approximately 10 m to the south, erosion risk to the bridge would have been significantly reduced. A deep scour pool has formed along the outside of the meander, exacerbated by a point bar that has formed along the inner bank. The scour pool extends downstream, beneath the pedestrian bridge, the left abutment of which is at risk of being undermined.

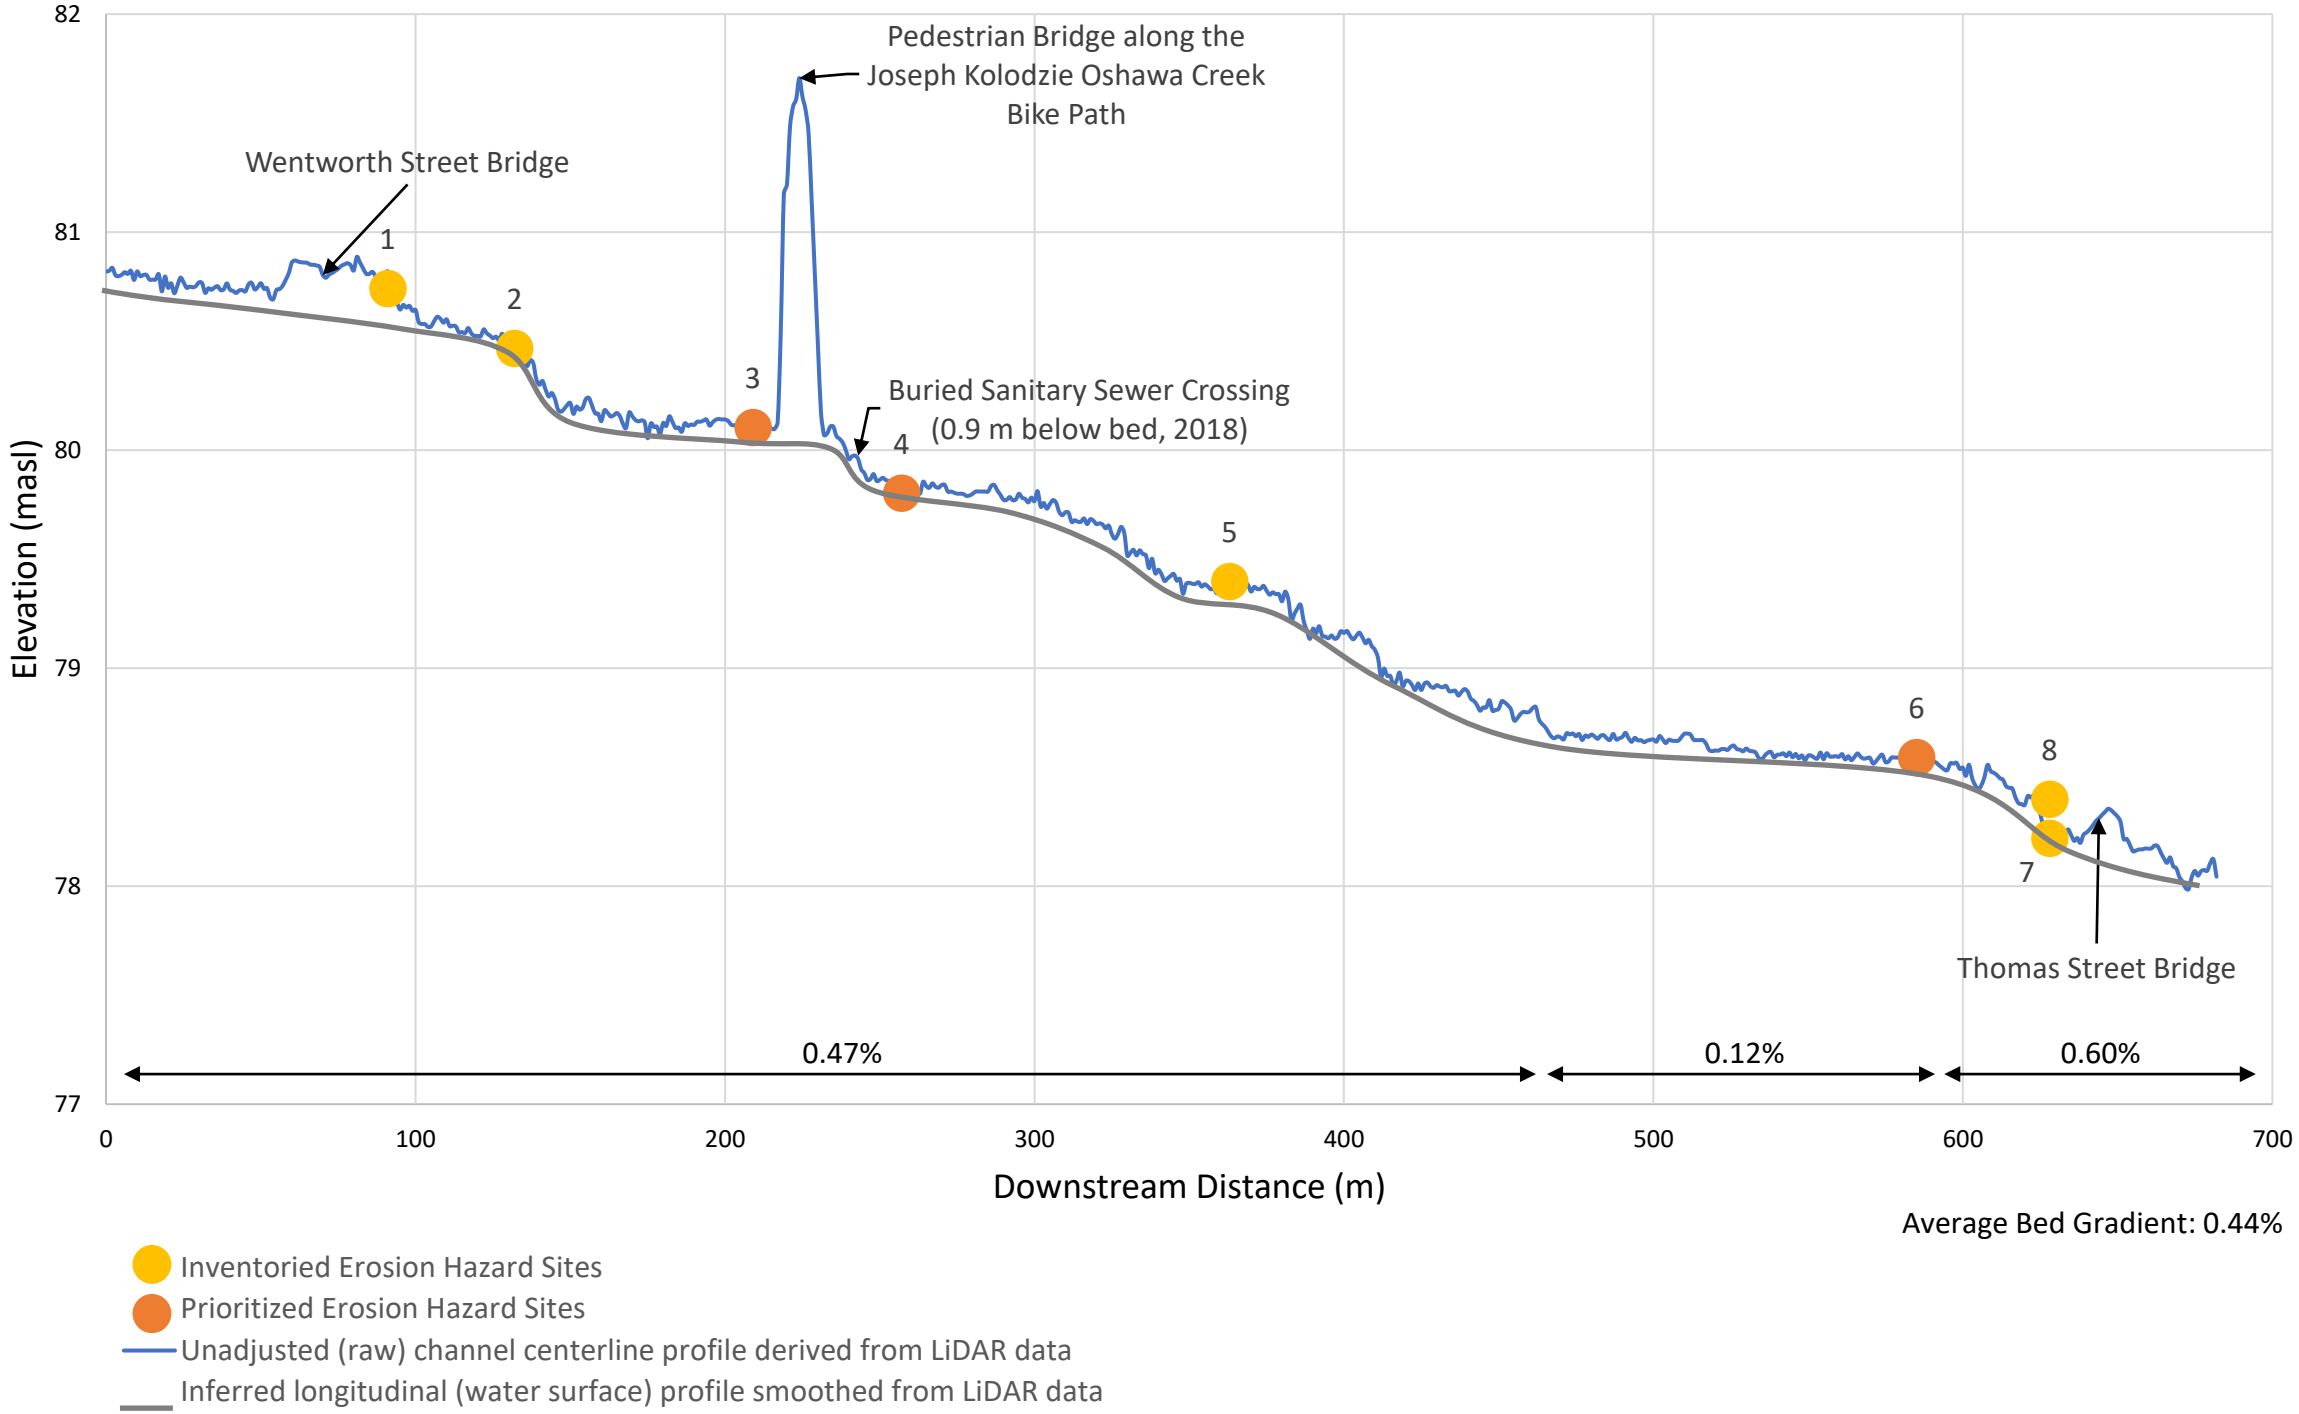
The channel is generally well connected to its floodplain as evidenced by low banks and overbank deposition. Average bed gradient is 0.44% along the entire study corridor, with no overall concavity/convexity in the longitudinal profile (**Figure 4**). Bed gradient is gentler than average between Sites 5 and 6 (0.2%) and steeper than average from Site 6 to the downstream end of the study corridor (0.6%). This difference may be explained by the original Thomas Street Bridge crossing, situated at approximately the same location as the change in gradient before its removal sometime between 1927 and 1954 (**Figure 5**). Sediment deposition upstream of the crossing, and subsequent erosion downstream of the crossing, could explain this abrupt change in gradient.

Figure 4. LiDAR-derived longitudinal profile of Oshawa Creek.

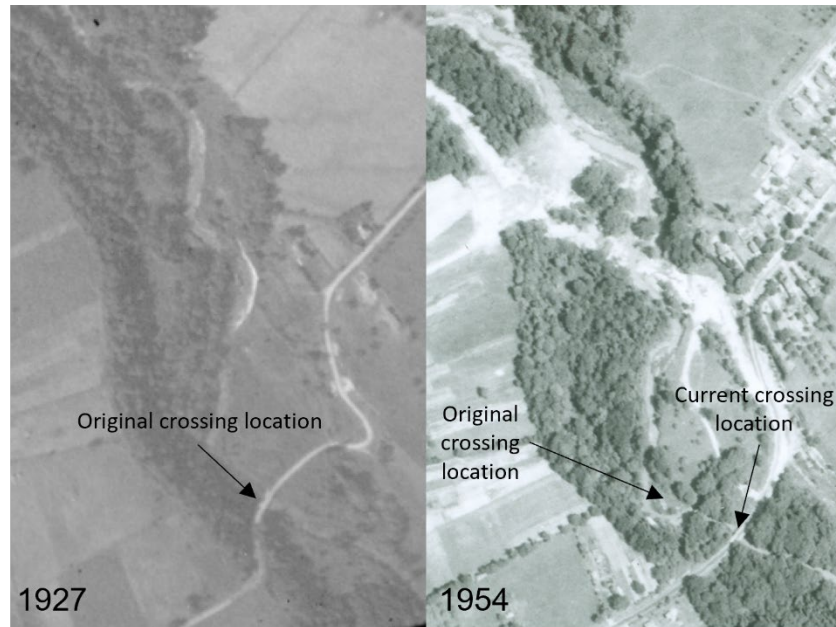
Figure 5. *Location of original and current Thomas Street Bridge crossing in 1927 and 1954 aerial photography. Original crossing was removed between 1927 and 1954.*

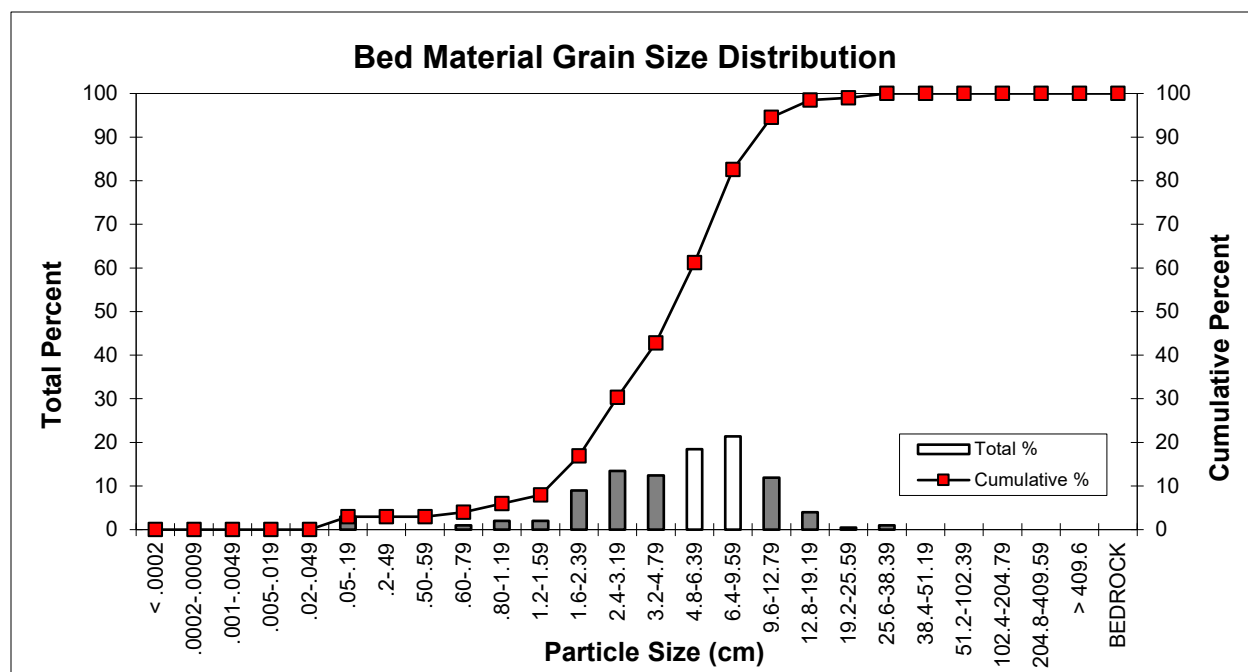
Bed materials within Oshawa Creek are relatively well sorted, ranging from coarse sand to cobbles, and are dominated by gravels and small cobbles (**Figure 6**). Extensive fine-grained deposits blanket pool bottoms and a thin veneer of sand embeds larger particles in pools and riffles, potentially sourced from eroding valley walls or transported from former headpond deposits from the Cedardale Dam, upstream of the study corridor (Palmer, 2020). The representative median grain size (D_{50}) of Oshawa Creek, within the study corridor, is approximately 50 mm (5 cm). There are several locations along the study corridor where underlying till is exposed on the bed (e.g., downstream of Site 4 and Site 6). Abundant woody debris has accumulated along the channel, derived mainly from downstream rafting of trees that have fallen into the channel following erosion and undercutting of adjacent banks. Conspicuous traces of organic matter in overbank areas demarcate the limits of recent flood inundation (**Photo 5**). Long sections of undercut bank expose elevated armoured (cobble) layers, providing at least localized evidence of historic degradation (down-cutting) from a former (higher) channel bed (**Photo 6**).

Figure 6. *Integrated grain size distribution of bed material from pebble counts (100 count at Site 3/4 and 100 count at Site 6) conducted along Oshawa Creek.*

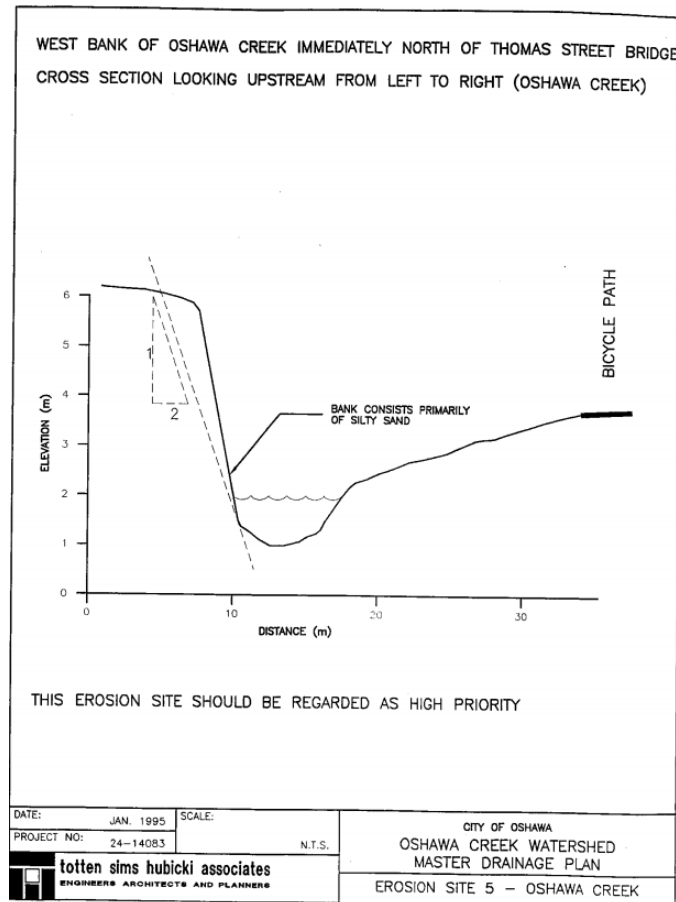
Figure 9. Upstream view of cross-section used by Totten Sims Hubicki Associates to identify the erosion hazard at Site 6 in 1995.

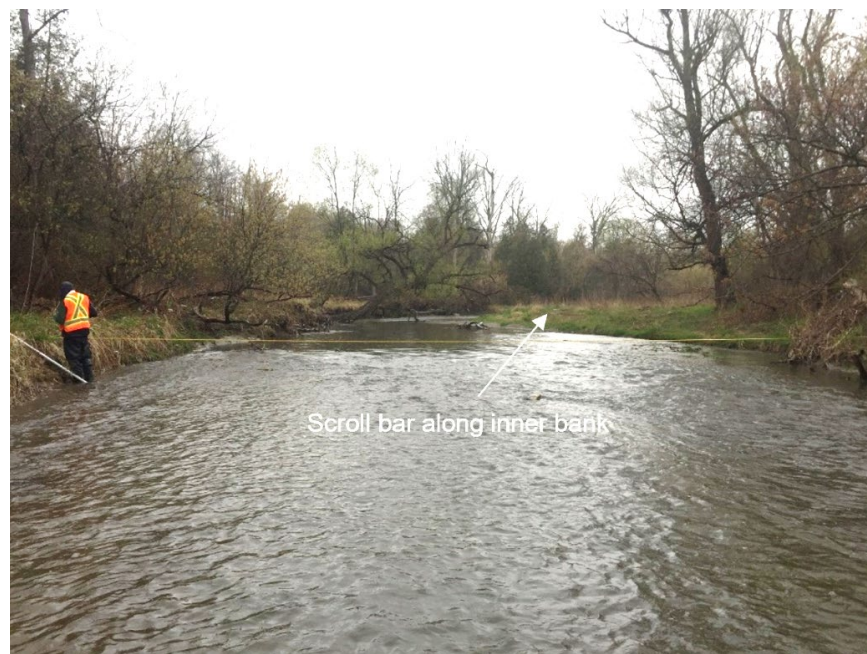
Photo 11. *Upstream view of channel approaching Site 6. A low, gentle eastern bank maintains good floodplain connectivity and helps attenuate flood energy. Upstream view.*

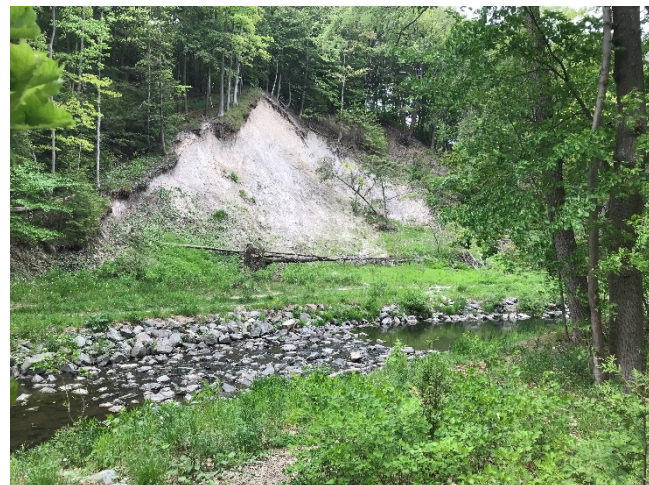
Photo 12. *Example of boulder-protected, slope-toe bench constructed along Wilket Creek, Toronto.*

This conceptual alternative aims to eliminate fluvial/valley wall interaction with the construction and protection of a low floodplain bench projecting slightly into the channel from the toe of the valley wall. **Photo 12** provides an example of a similar boulder (riprap) protected slope-toe bench for illustrative purposes.

conveyance/storage. The top of the bench and boulder revetment would be approximately coincident with the water surface elevation of the 2-year flow. Boulders would be keyed well

into the bank, slightly beyond the upstream limit of scour, in order to inhibit future outflanking. In addition,

boulders would smoothly tie-in with existing boulder toe protection that defines the downstream limit of scour. A vegetated boulder revetment is proposed to replace an existing and deteriorated boulder revetment that extends approximately 20 m from the eastern footing of the Thomas Street bridge. Existing boulders would be reused in the new structure. Secondary erosion from concentrated surface runoff from the adjacent trailhead parking lot and paved Bike Path would be intercepted by a drainage gate that directs flow into a slope drain integrated within the proposed boulder revetment.

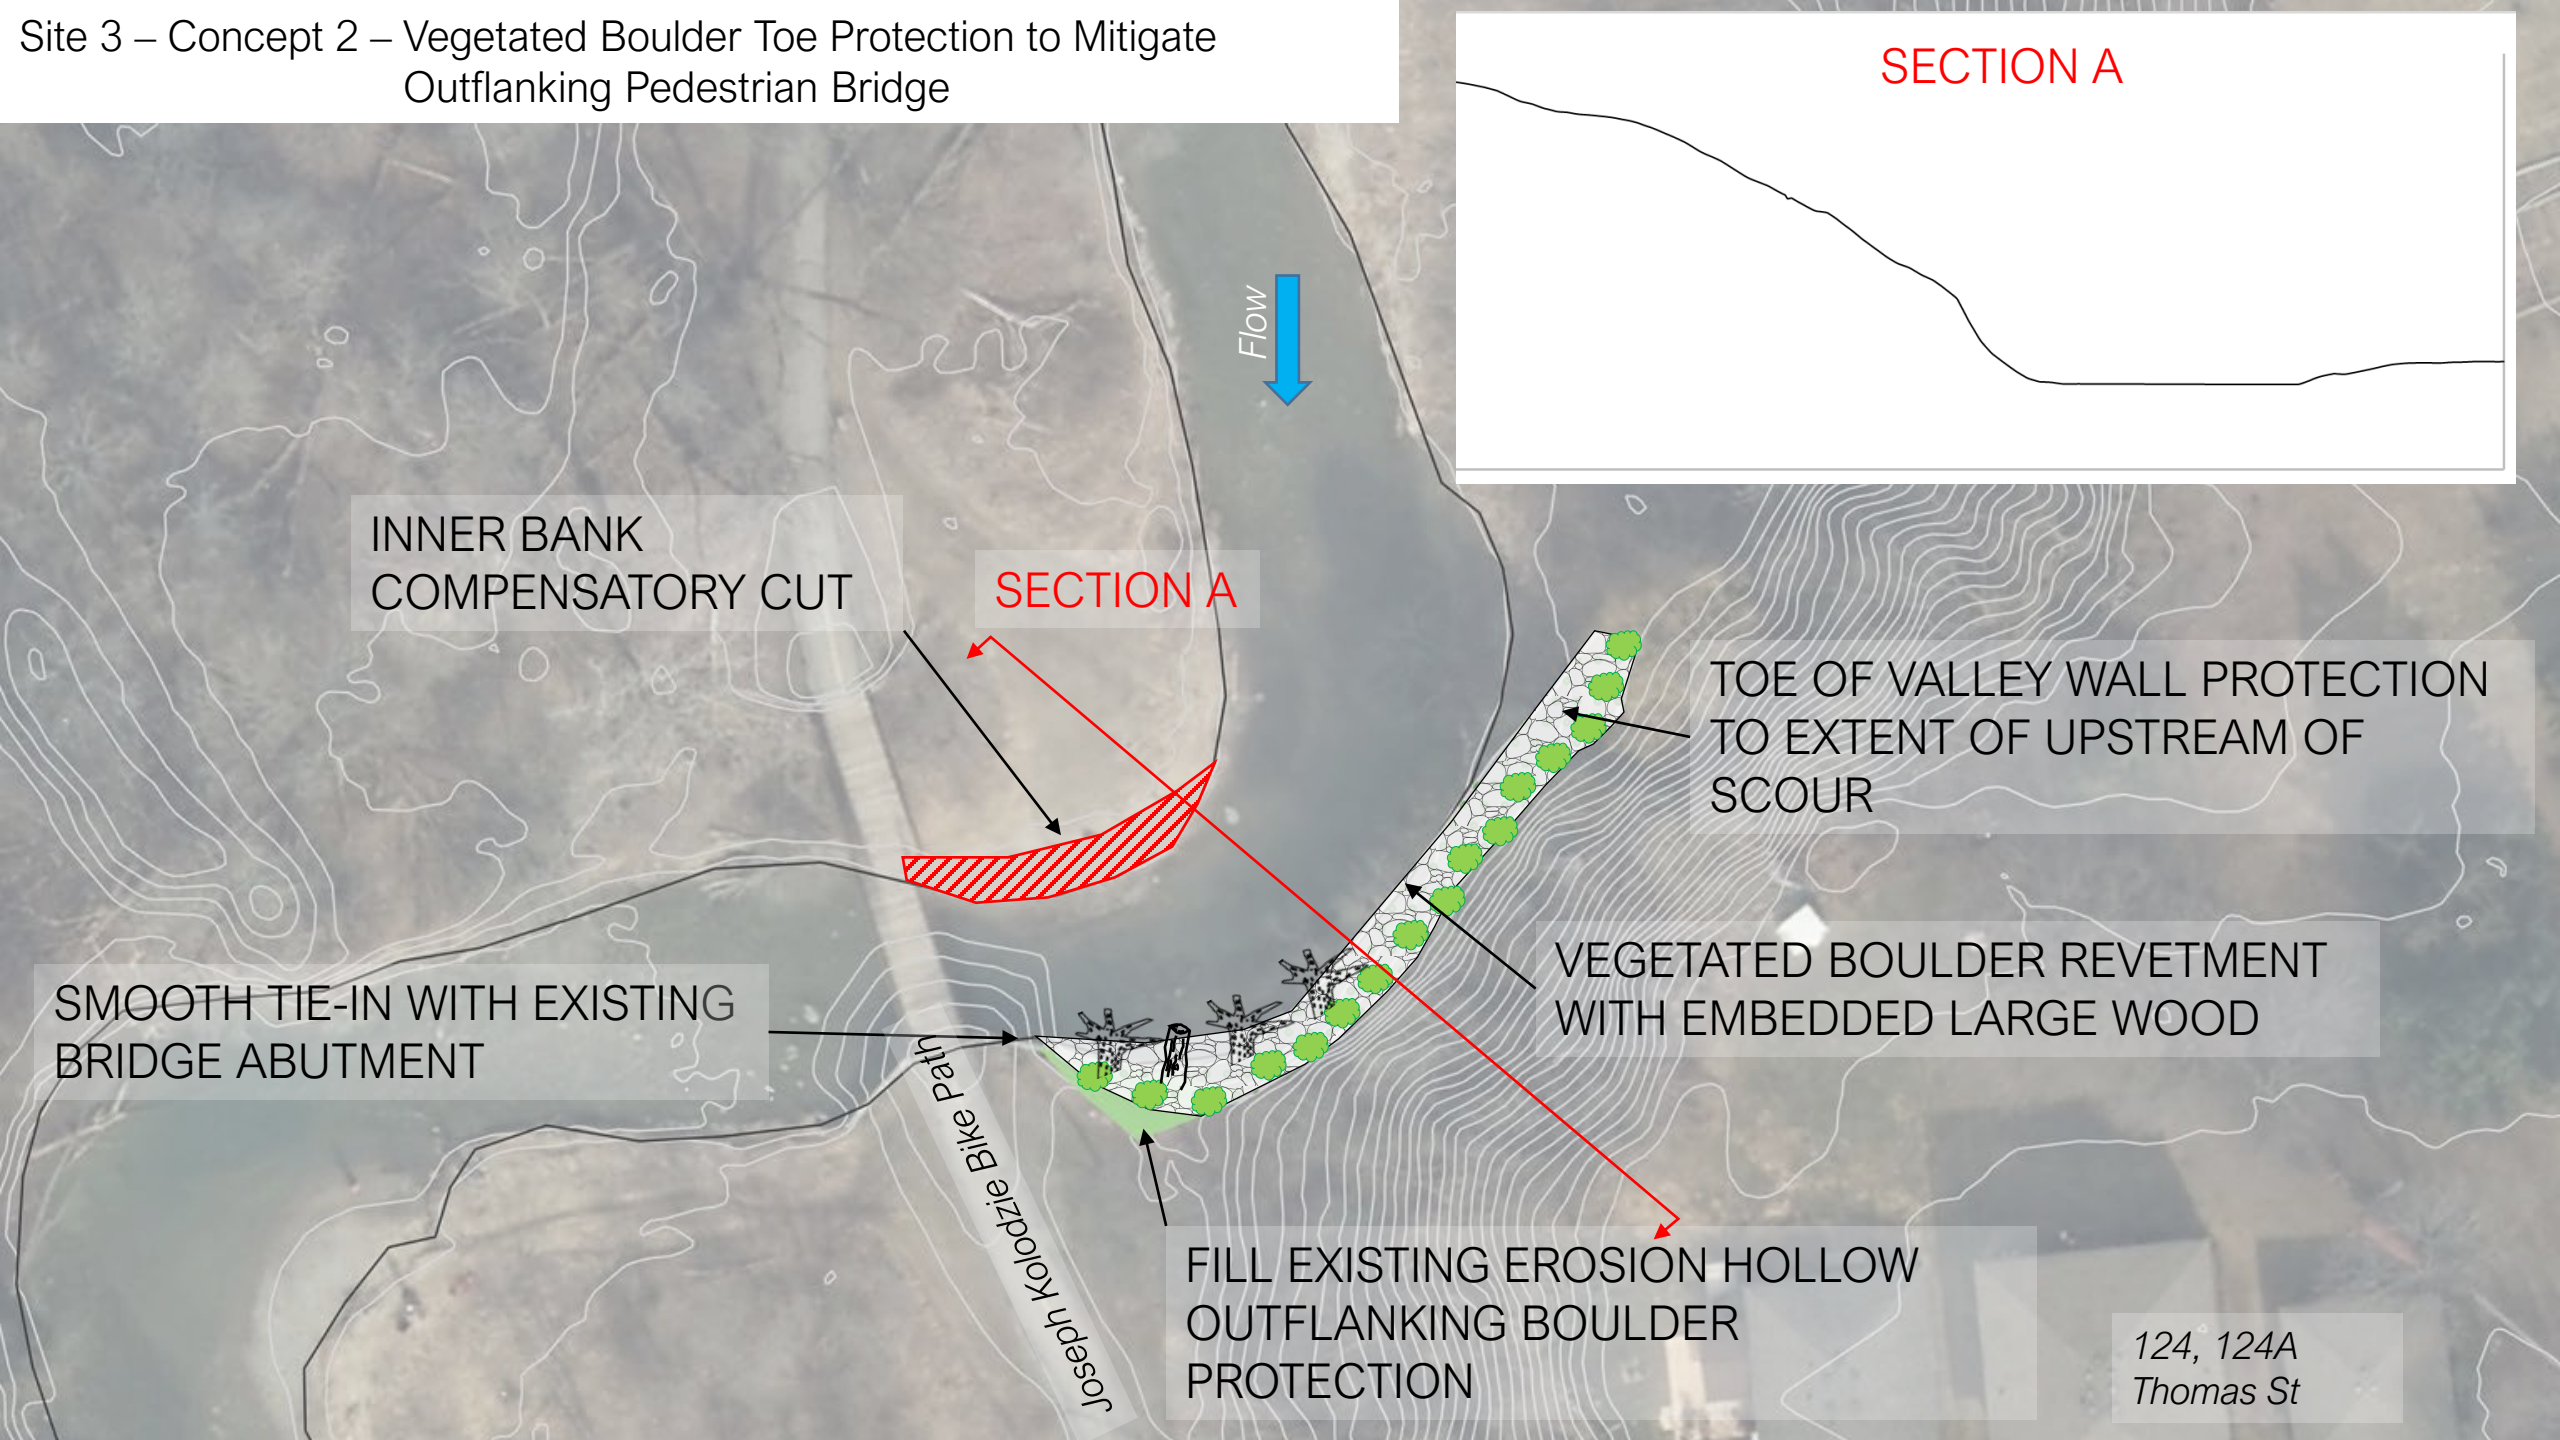
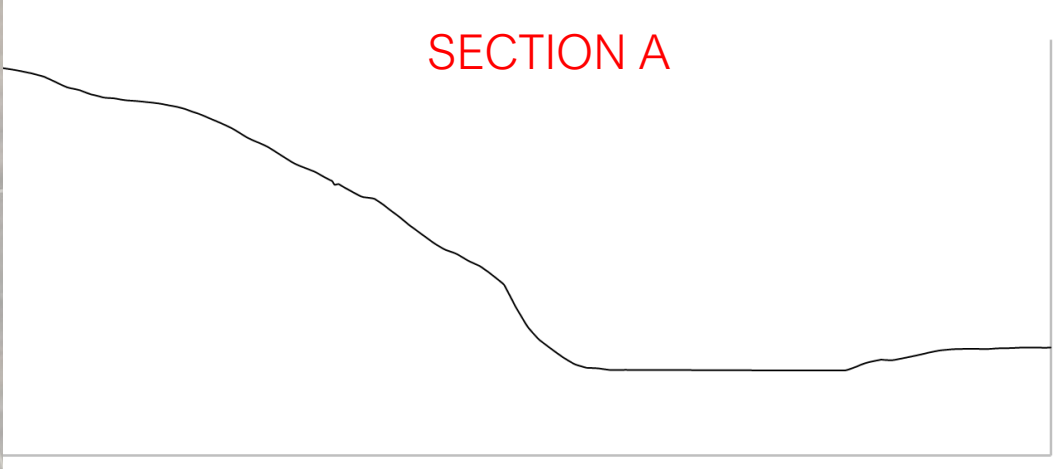
Site 3 – Concept 2 – Vegetated Boulder Toe Protection to Mitigate Outflanking Pedestrian Bridge

INNER BANK
COMPENSATORY CUT

FILL EXISTING EROSION HOLLOW
OUTFLANKING BOULDER
PROTECTION

Site 3	Feature at Risk:	Distance to Feature	Condition of Bank and/or Existing Erosion Protection:	Mechanism(s) of Failure:	Risk	Recommended Action(s):
	Pedestrian bridge and private property on valley crest	0 m (contact)	Functional, but deteriorating	Outflanking and/or undermining	High	Design and construct protection for toe of valley wall and bridge

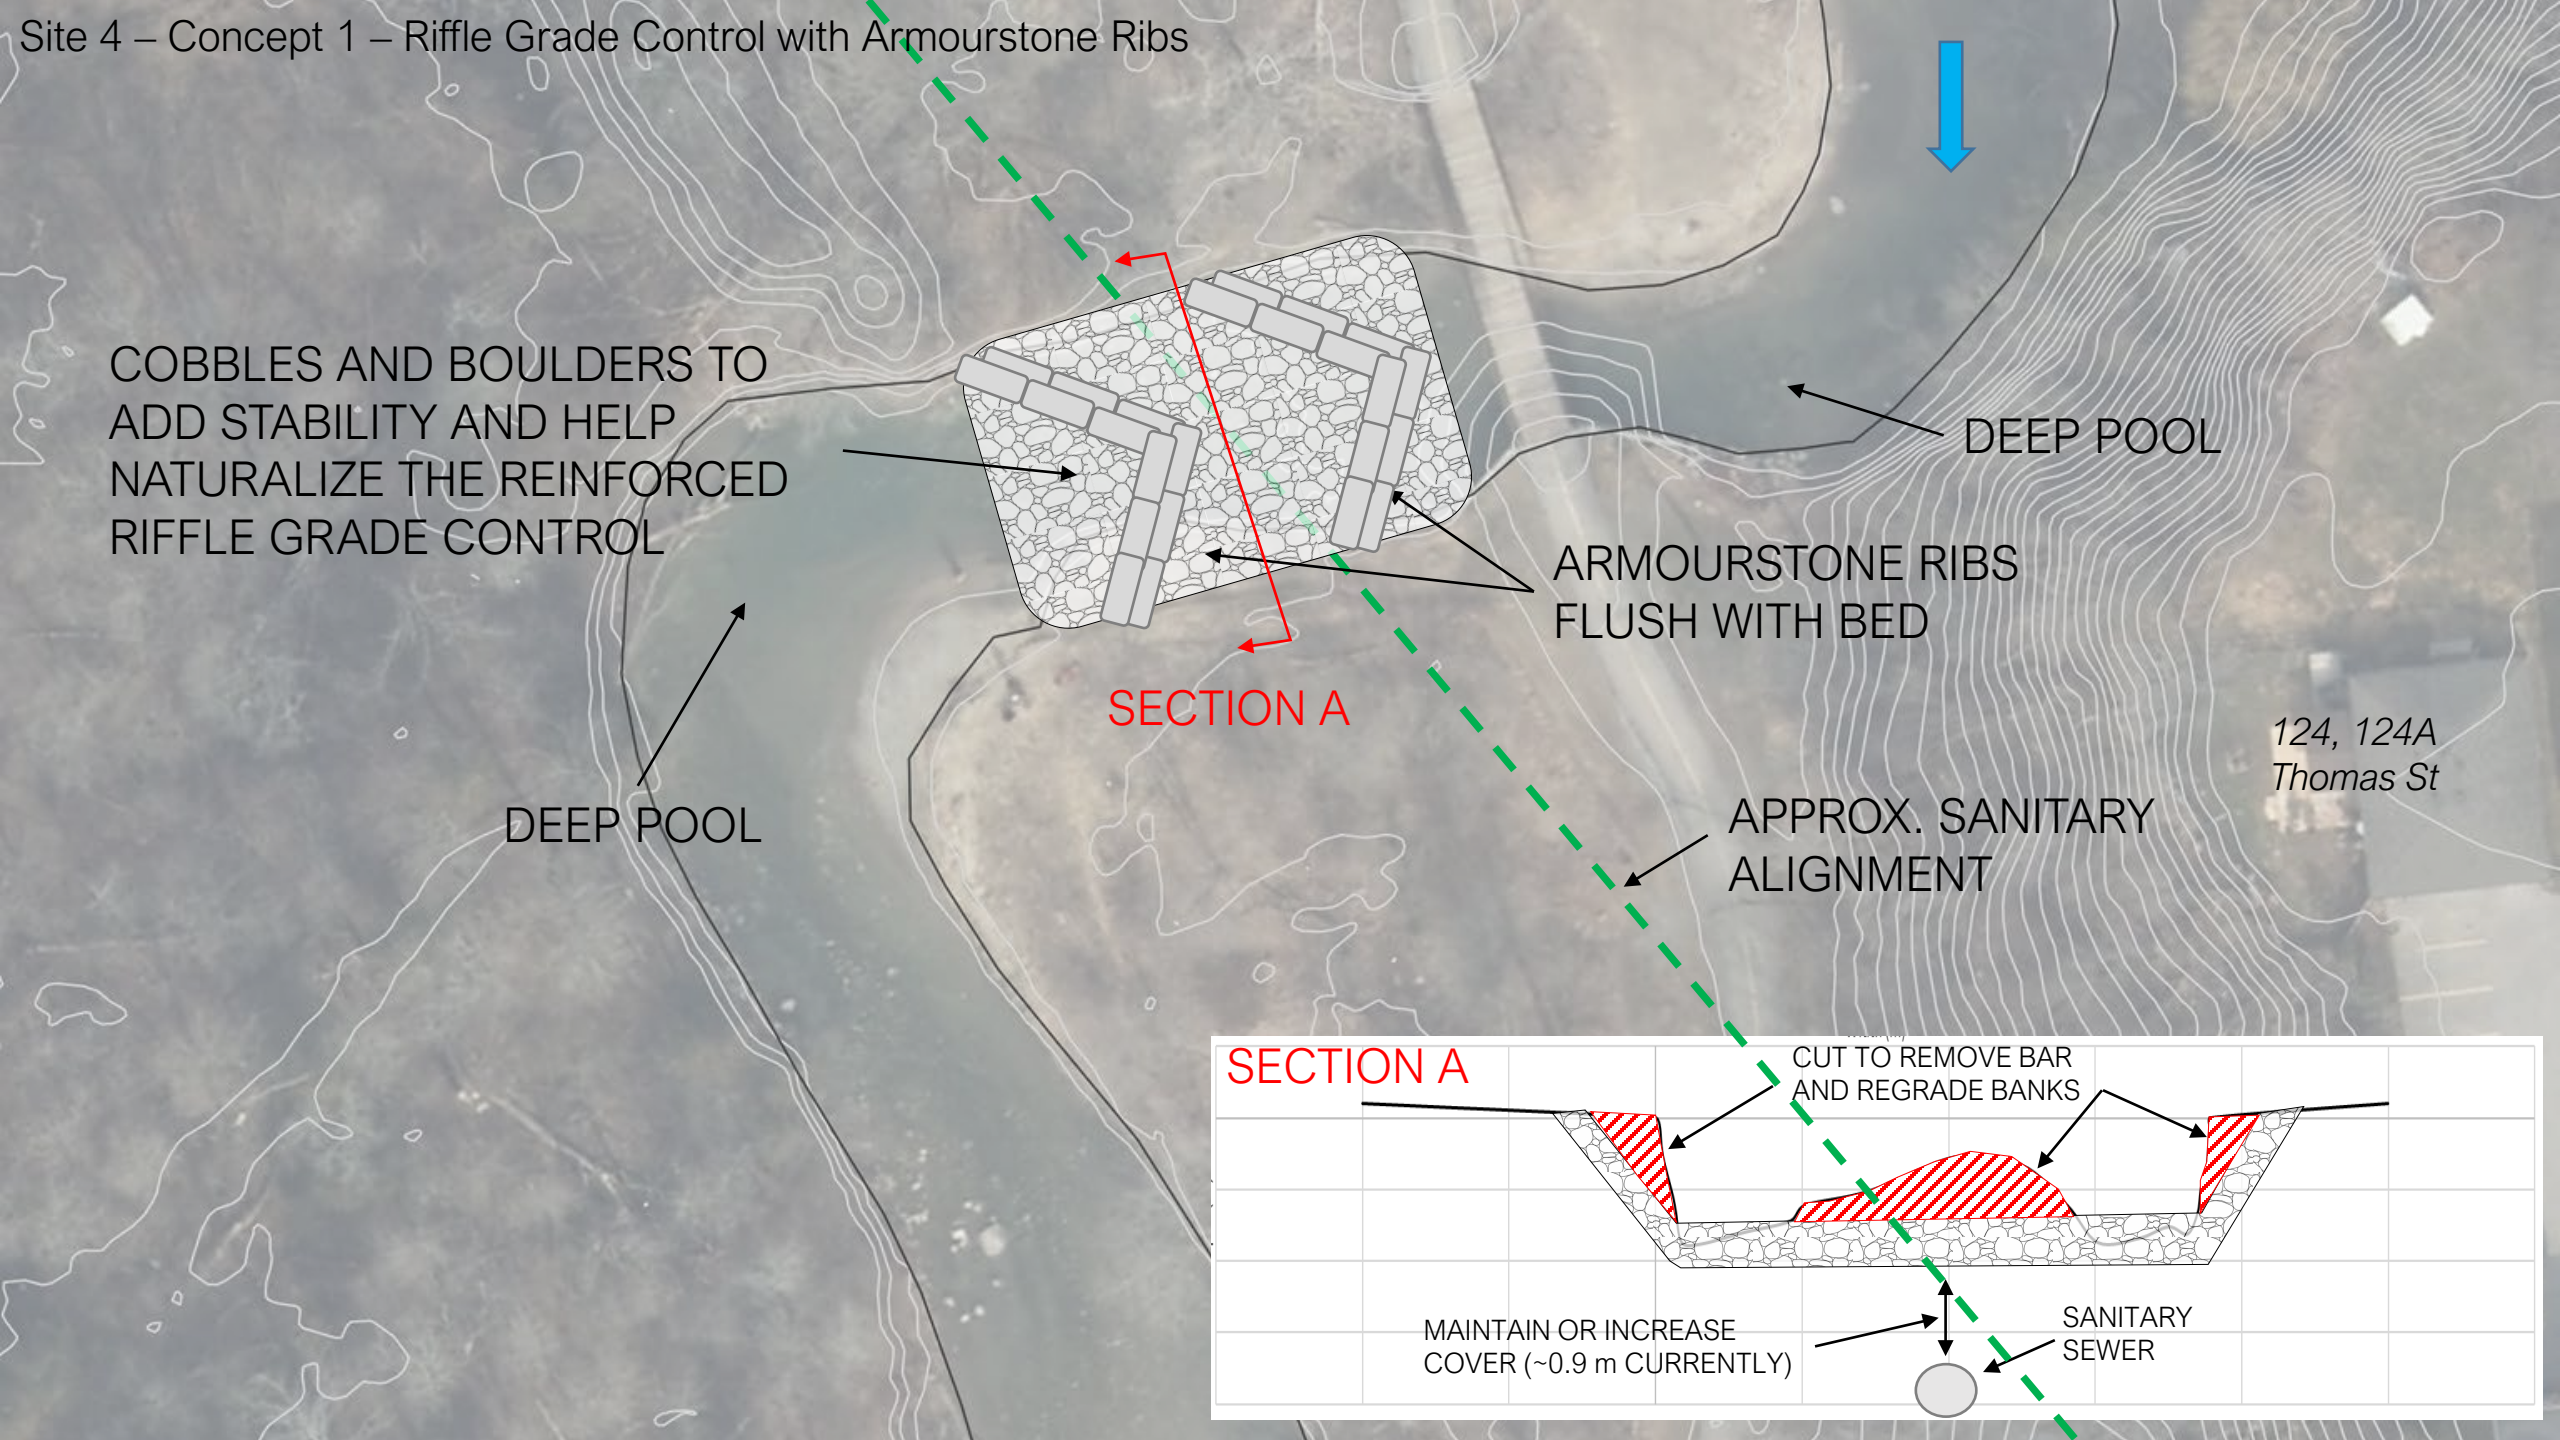
Site 4 – Concept 2 – Riffle Grade Control Structures and Wood Debris Bank Protection

EMBEDDED LARGE WOOD TO MINIMIZE RISK OF OUTFLANKING OF DOWNSTREAM RIFFLE

MAINTAIN OR INCREASE COVER (~0.9 m CURRENTLY)

Site 4	Feature at Risk:	Distance to Feature	Condition of Bank and/or Existing Erosion Protection:	Mechanism(s) of Failure:	Risk	Recommended Action(s):
	Sanitary sewer	0.9 m (depth of cover)	Steep, eroded banks; no protection from continued bed scour	Bed scour and medial bar migration	Moderate	Protect sanitary sewer (based on assumed works to be completed at Site 3)
