Fluvial Geomorphological Assessment of Oshawa Creek and Evaluation of Erosion Mitigation Strategies at Prioritized Sites

Thomas Street to Wentworth Street West

City of Oshawa

October 8, 2021

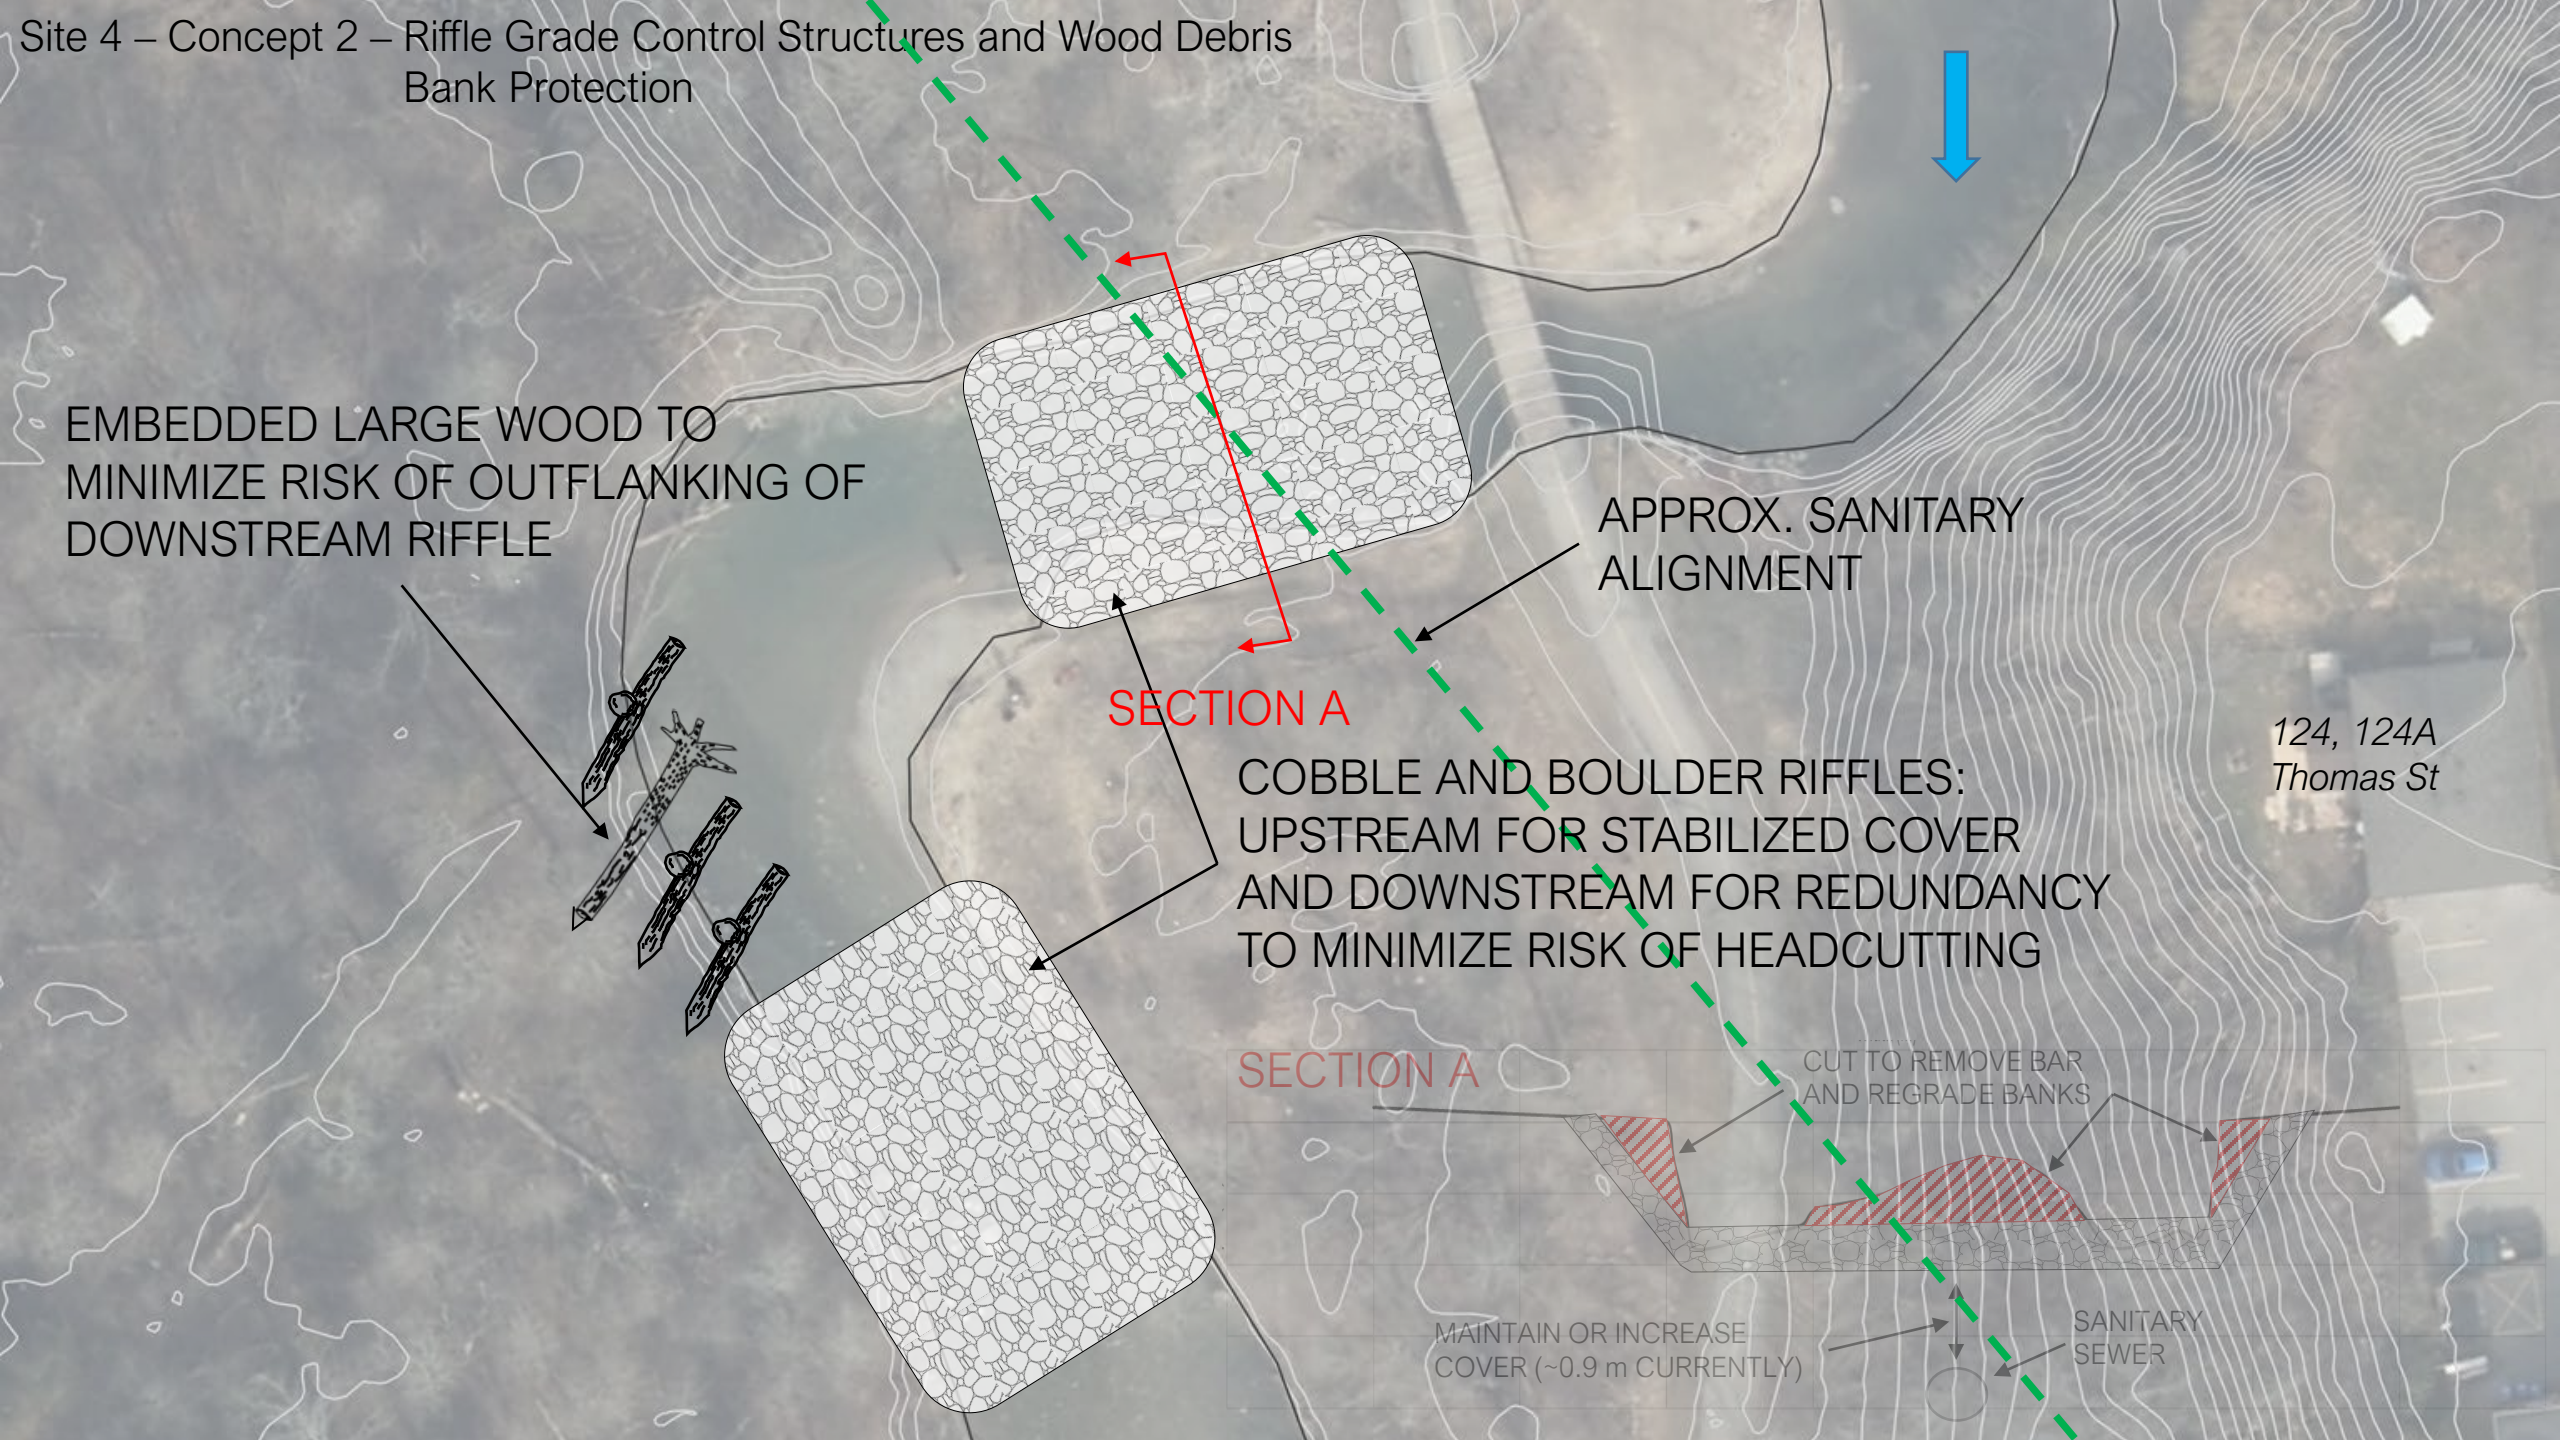
Site 6 – Concept 1 – Boulder Protected Slope Toe Bench and Surface Runoff Control

SMOOTH TIE-IN WITH EXISTING
BOULDER BANK PROTECTION

Site 6	Feature at Risk:	Distance to Feature	Condition of Bank and/or Existing Erosion Protection:	Mechanism(s) of Failure:	Risk	Recommended Action(s):
	Property at edge of adjacent tableland	10 m	Approximately 18 m high, 150 m long erosion scar along lower valley wall	Repeated fluvial scour and mass movements	High	Design and implement measures to protect valley wall from continued fluvial interaction
