RESEARCH REPORT

442 King Street East
Oshawa

Prepared by Melissa Cole
Melissadave.cole@gmail.com
September 2010

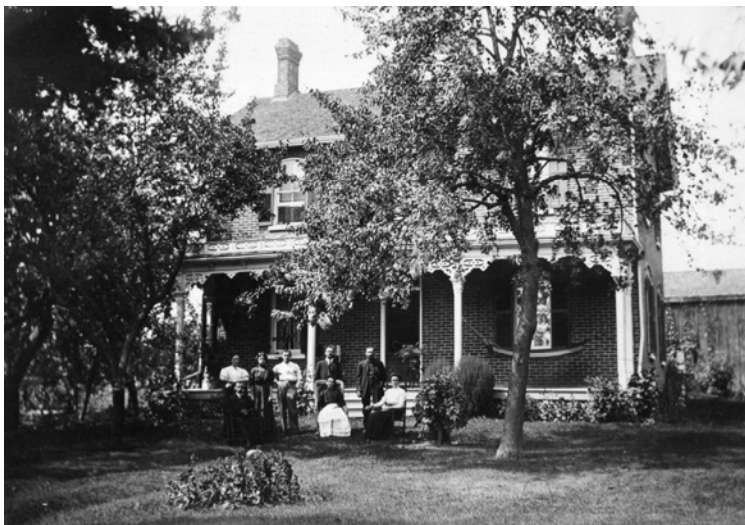
South Façade, 442 King Street East, Oshawa. Circa 1880

The original chimneys have been removed. At one time there would have been two internal chimneys, with decorative corbelling around the tops, that peaked the east and west facades.² This is evident in the photo of the Drew Family taken in front of 442 King Street East in circa 1880. On the north façade there is evidence of what would have been a third external chimney that has since been removed. The different shade of red brick work on the chimney would indicate that it would not have been original to the home.

² Photograph circa 1880 of the residence shows the chimneys that peaked the house on the east and west ends. See appendix A.

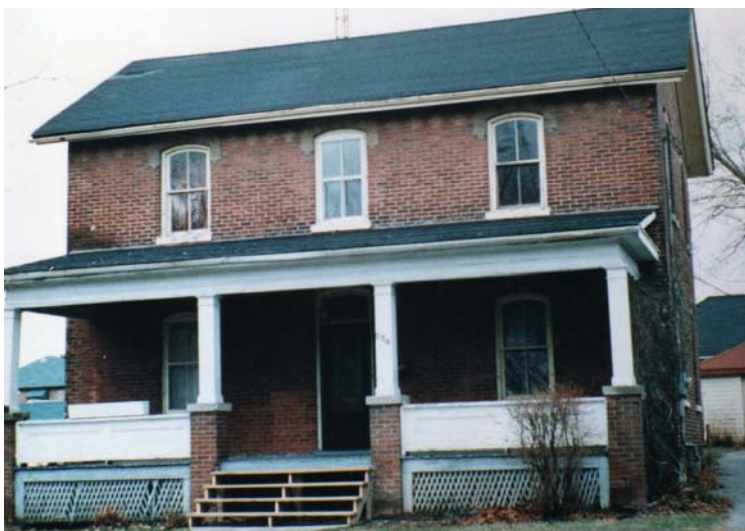
South Façade, 442 King Street East. 1989

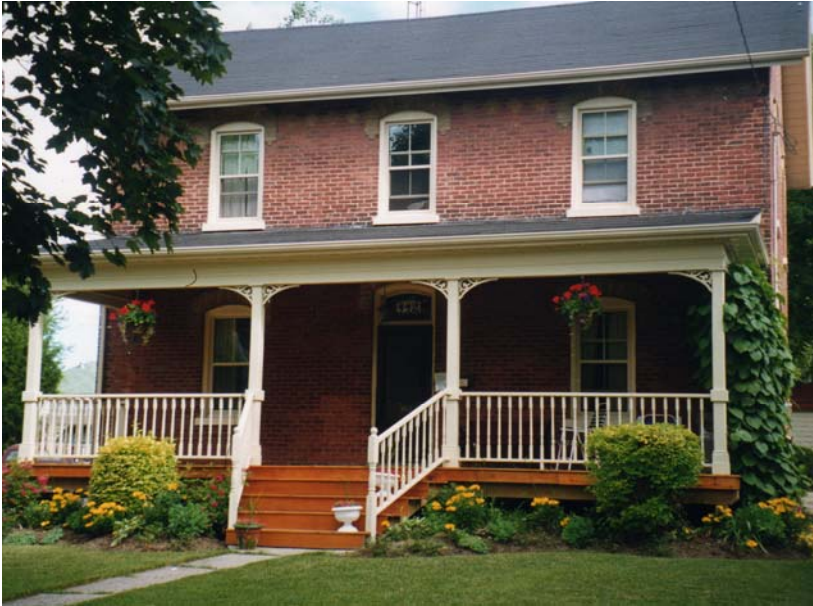
East Façade, 442 King Street East, 1998

The two storey portion of the dwelling is covered in red and buff brick. The rear extension or one storey addition on the north façade is clad in board and batten. The dichromatic brick work is featured in the drip mouldings over all the windows and front entranceway. Decorative buff crosses were created in bands along the front façade as well as on the gabled ends of the east and west façades where there are decorative bands of crosses that form a triangular pattern.

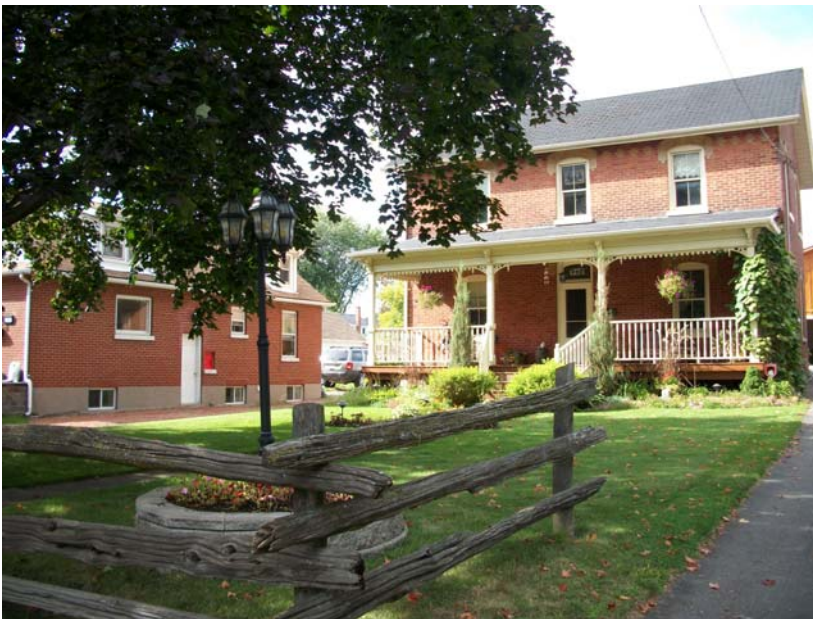
South Façade, 442 King Street East, September 2010

This stately two storey home has the symmetrical façade of the Georgian style, the low pitched roof of the neo-classical, the dichromatic brick drip mouldings around the windows and doors similar to those that would be found on an Italianate style home. A medium gabled roof has returned eaves. The building rests on its original fieldstone foundation.

The main façade faces south onto King Street East and features a three bay design with a central entranceway.

One of the many outstanding features of this house is the verandah (gallery) that runs the length of the front façade. Its roof is gabled and covered in asphalt similar to the rest of the house. Simple wooden posts give support while gingerbread trim hangs from a plain architrave.

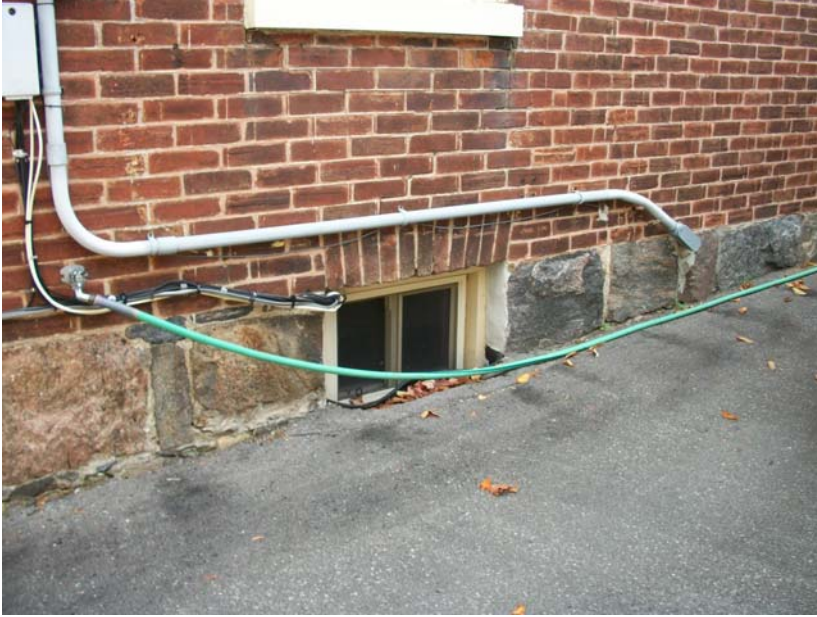
Basement Window, 442 King Street East, September 2010

The foundation is fieldstone.

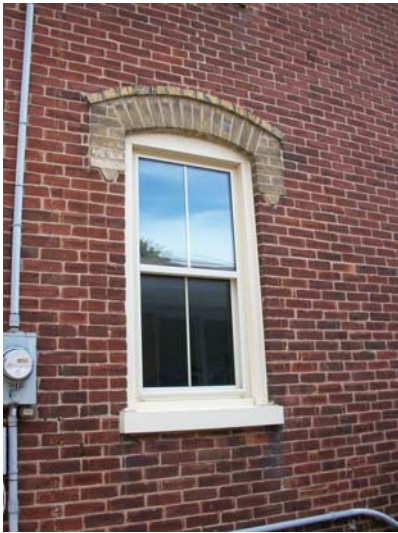
Drip Moulding

All window openings are flat with arched heads. The frames are flat with lugsills. The ground level openings feature 2 over 2 double hung sashes. The upper window openings also feature 2 over 2 double hung sashes. All the windows contain brick soldier courses. All sashes have been replaced but are sympathetic to resemble the design of the original sashes.

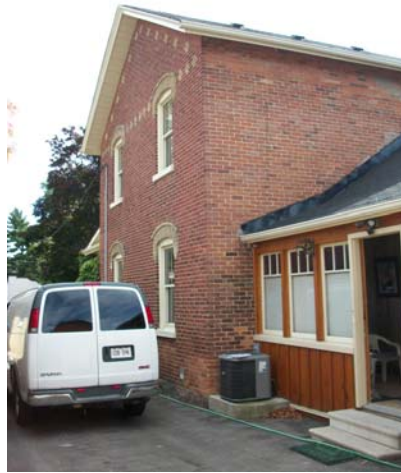
East Façade

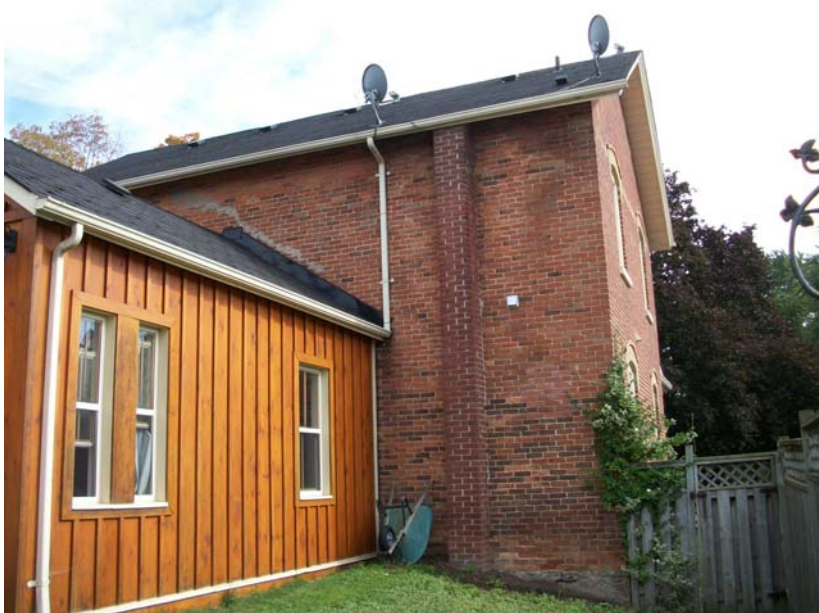
North West Façade, 442 King Street East, September 2010

A one storey extension built off the north facade may have originated as a summer kitchen or living area. This extension is covered in board and batten. It now contains the kitchen and a covered porch area.
