Geotechnical Investigation Report

Stevenson Road North, Oshawa

Gannett Fleming
Final Report

April 11, 2023
02112515.000-0100-GE-R-0001-00

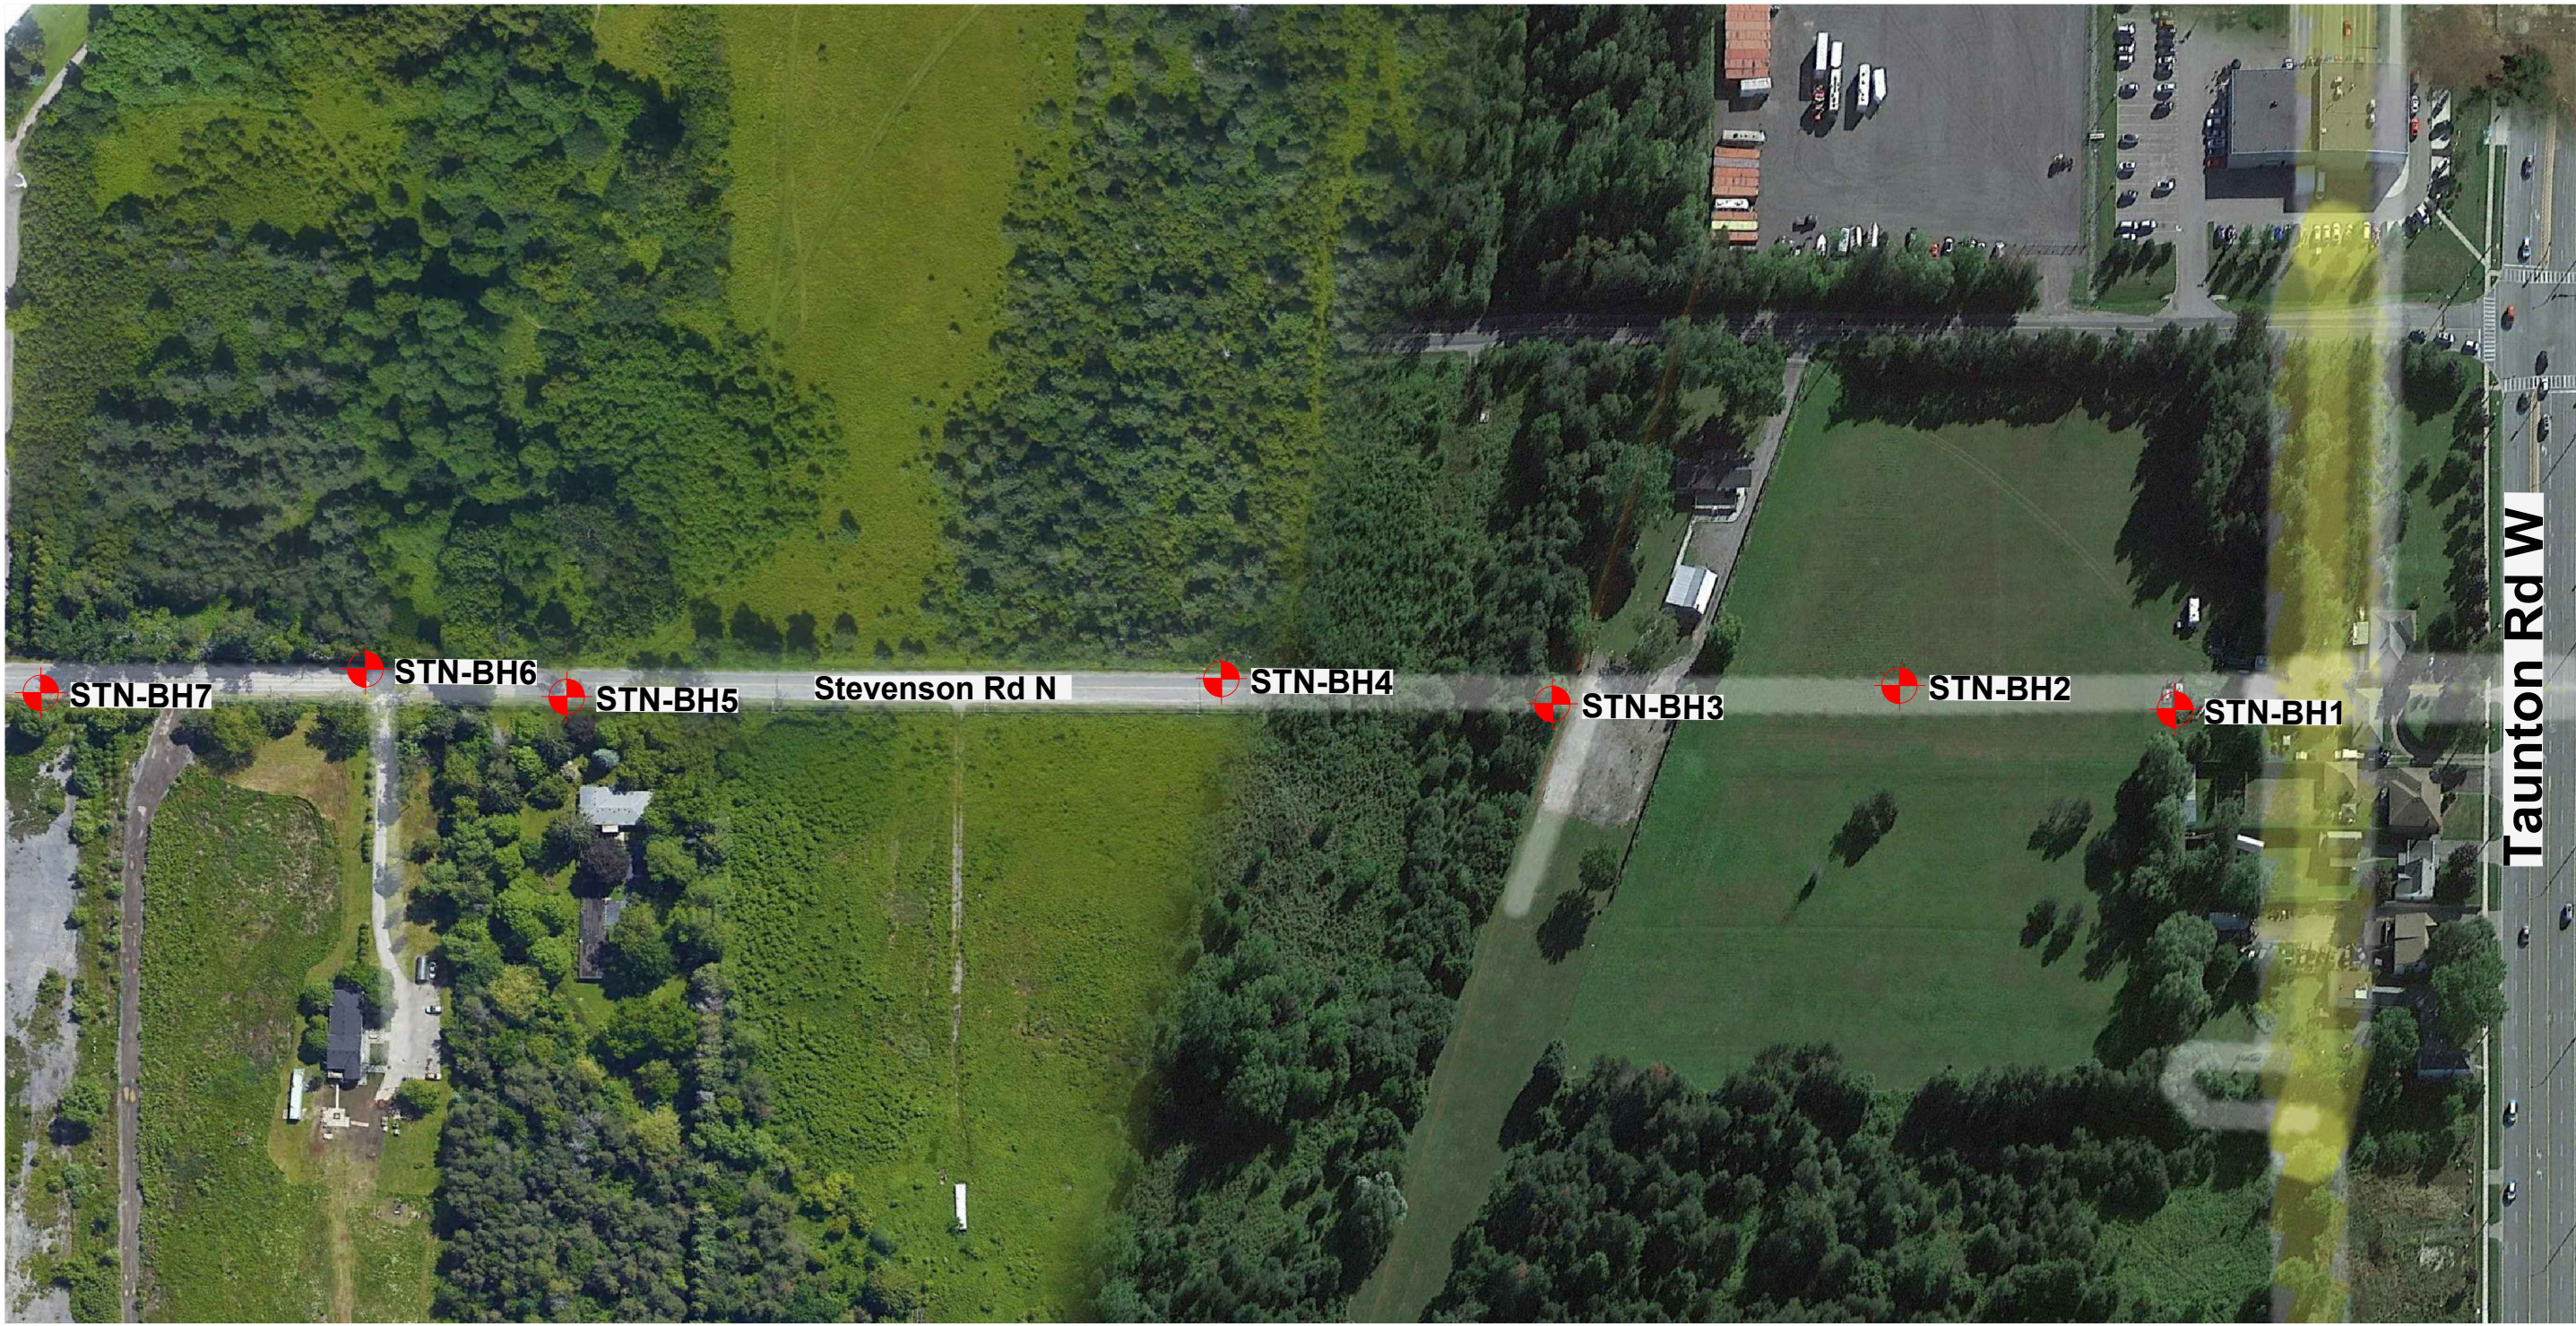
Borehole Location Plan

The approximate borehole locations are showed on the attached Borehole Locations Drawing provided in Appendix A. The subsurface conditions in the geotechnical boreholes are presented in the individual Borehole Logs (presented in Appendix B) and summarized in the following paragraphs.

The borehole locations were surveyed by Englobe using Sokkia GRX2 GNSS Receiver GPS connected to MAGNET Enterprise network referenced to UTM Zone 17T (NAD83) and presented in the attached Borehole Location Drawing in Appendix A. The information of the drilled boreholes is summarized in table 1.
